# SERVICE PROCEDURE

22525 / 22559  
JANUARY, 2023

**SUBJECT: SAFETY RECALL 22525 Variation 22559  
Hex Flange Lock Nut on certain IC Bus® RE Series  
buses built 04/28/2022 thru 08/02/2022.**

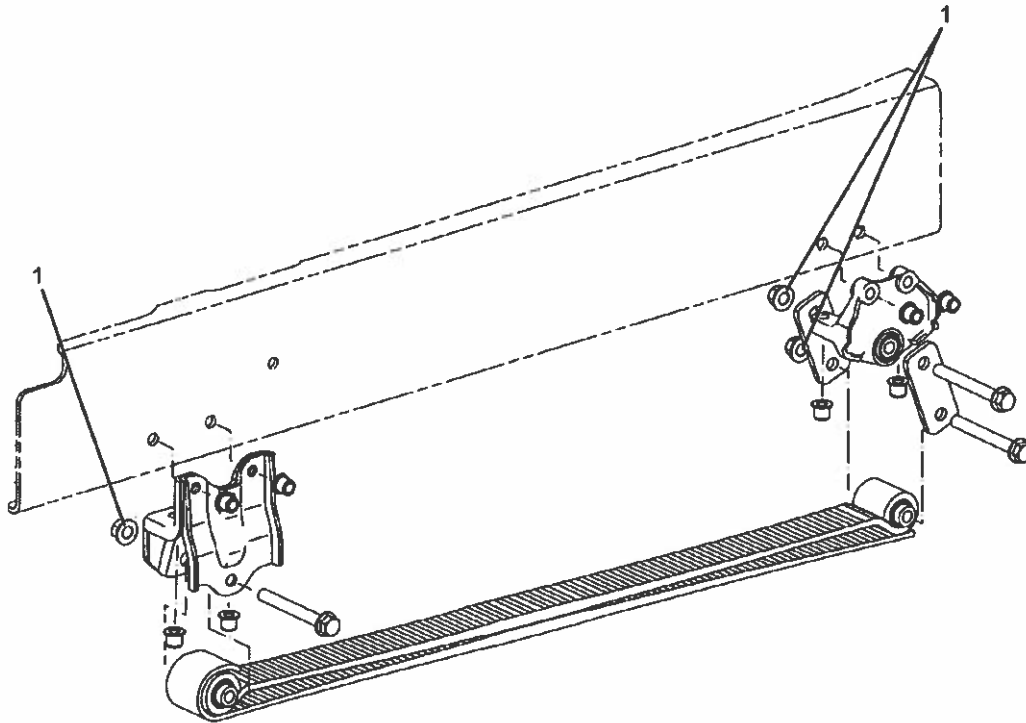
**Figure 1. Steer Axle Shackle**

1. Nut (3)

6. Access nuts (Figure 1, Item 1) securing the front steer axle shackle.

**NOTE:** After installation of each nut, ensure at least one thread is protruding past the top edge of the nut.

7. Remove and replace nuts (Figure 1, Item 1). Using a torque wrench, tighten nuts to 330 - 370 lb-ft (450 - 500 N·m).

8. Repeat Steps 6 and 7 for opposite side.

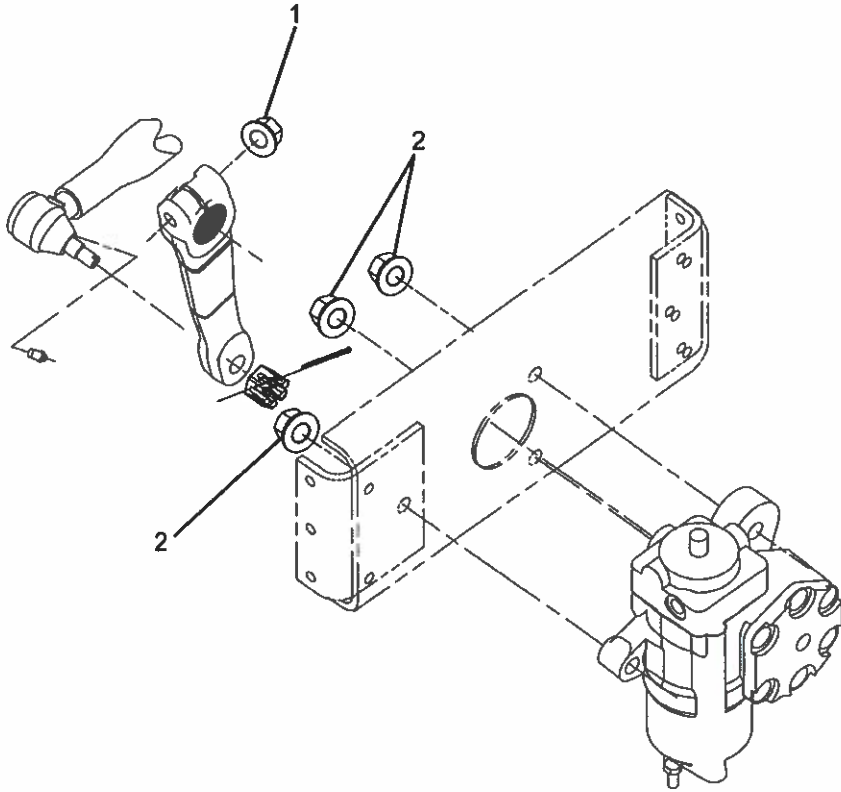
**Figure 2. TRW Pitman Arm Nut and Steering Gear Mounting**

1. Pitman arm nut
2. Steering gear nut (3)

9. Access Pitman arm nut (Figure 2, Item 1) securing pinch bolt.

**NOTE: After installation of each nut, ensure at least one thread is protruding past the top edge of the nut.**

10. Remove and replace nut. Using a torque wrench and backup wrench positioned on bolt, tighten nut to 330 - 370 lb-ft (450 - 500 N·m).
11. Access three steering gear mounting nuts (Figure 2, Item 2).

12. Remove and replace nuts one at a time. Using a torque wrench and backup wrench positioned on bolt, tighten nut to 330 - 370 lb-ft (450 - 500 N·m).

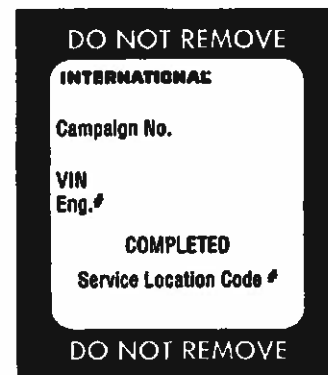
### **CAMPAIGN IDENTIFICATION LABEL**

Each vehicle corrected in accordance with this campaign must be marked with a CTS-1075 Campaign Identification Label.

Complete the label and attach on a clean surface next to the vehicle identification number (VIN) plate.
