# Recall Campaign Bulletin

Campaign No. 2023010004, January 2023

SUBJECT: **Model C-Class (203 platform)**  
**Model Year 2006**

## **Check Sliding Roof Bonding**

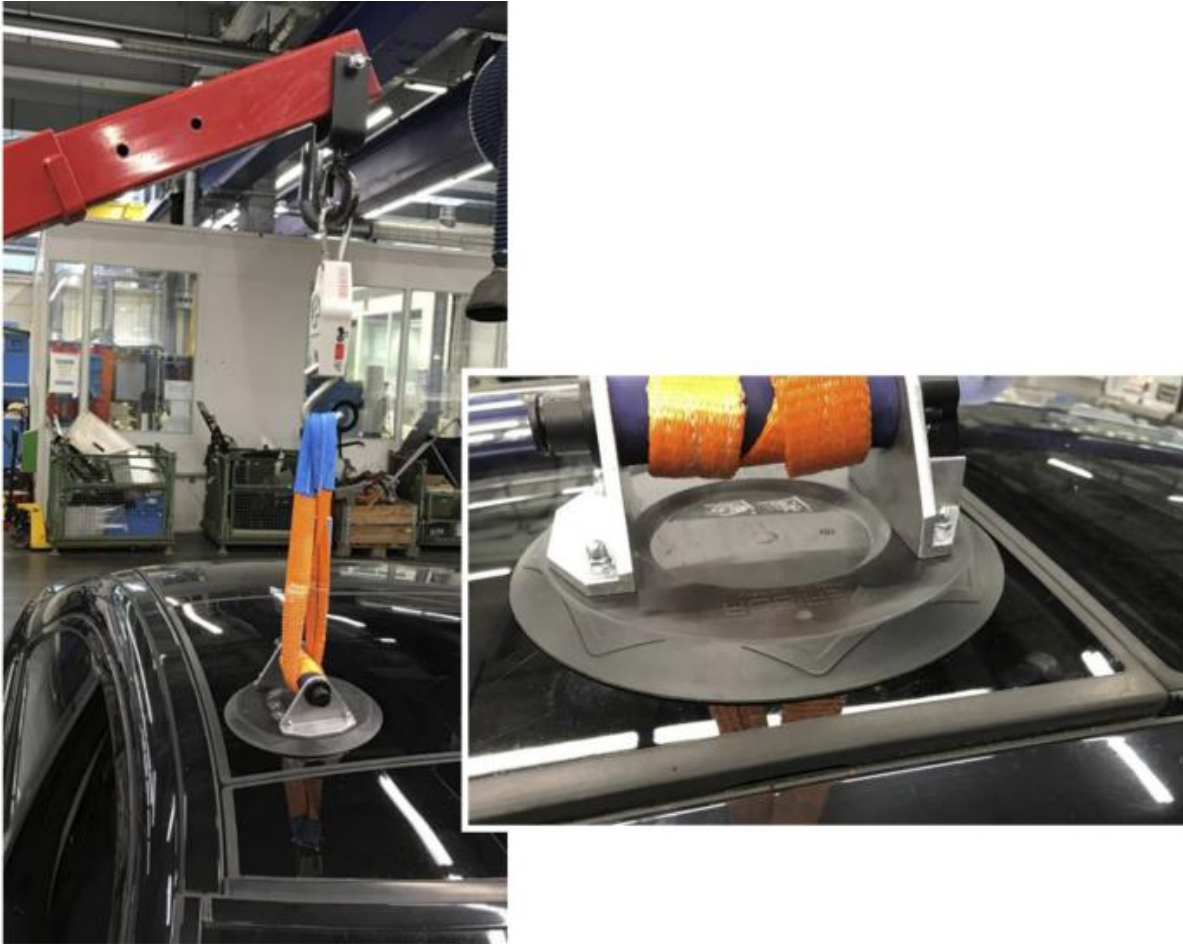
Figure 1

3. Position suction cup tool (figure 1) and pull up as **vertically** as possible (tolerance of  $\pm 10$  degrees) using lifting tool.

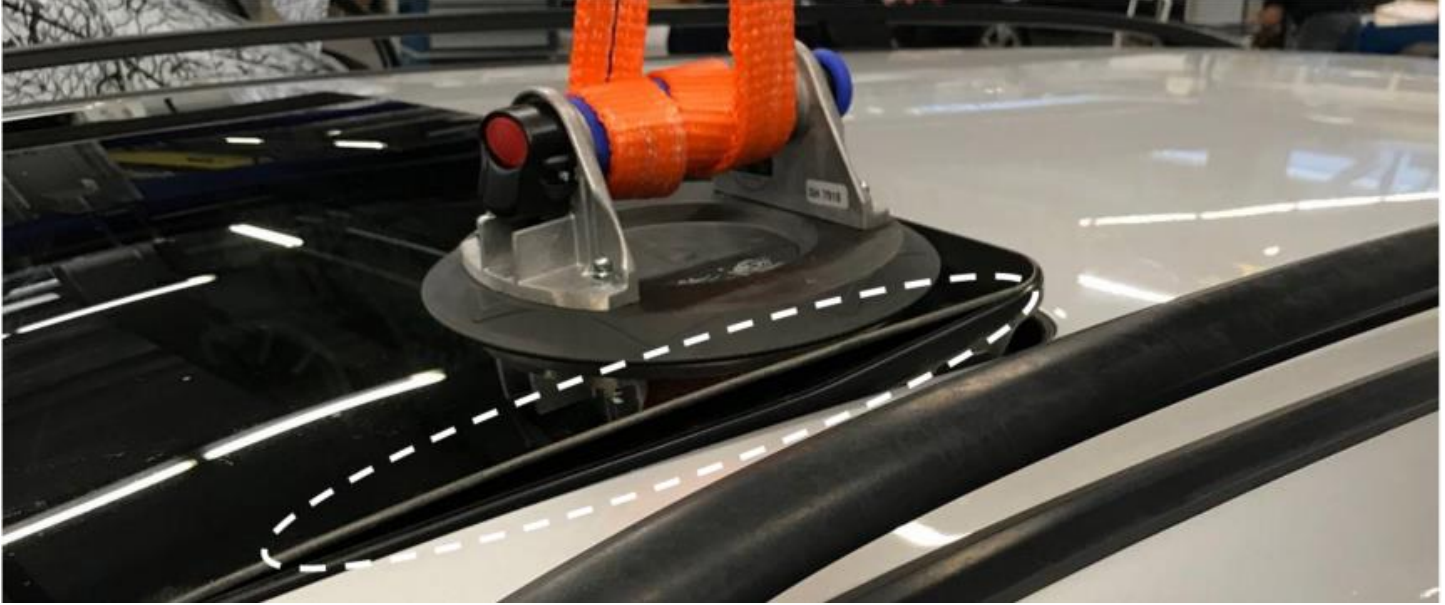
**i** If the panoramic sliding sunroof panel is detached from the padding of the sliding sunroof/ tilting roof frame at one of the test points (see Figure 3), replace the sliding sunroof panel.

Figure 3, not OK (shown here on a sliding sunroof)

- a. If the panoramic sliding sunroof panel is detached from the padding: Perform **work procedure**.
- b. If the panoramic sliding sunroof panel is **not** detached from the padding: Perform operation step 4 and **end the measure**.

1. Replace panoramic sliding sunroof panel (AR77.21-P-0500PB)
-
