## **IMPORTANT SAFETY RECALL**

**NHTSA RECALL NO. 23E098**

Villa International has decided that certain Newmar Corporation motor-homes equipped with Villa driver and passenger seating fail to conform to Federal Motor Vehicle Safety Standard NO. 207, "seating systems".

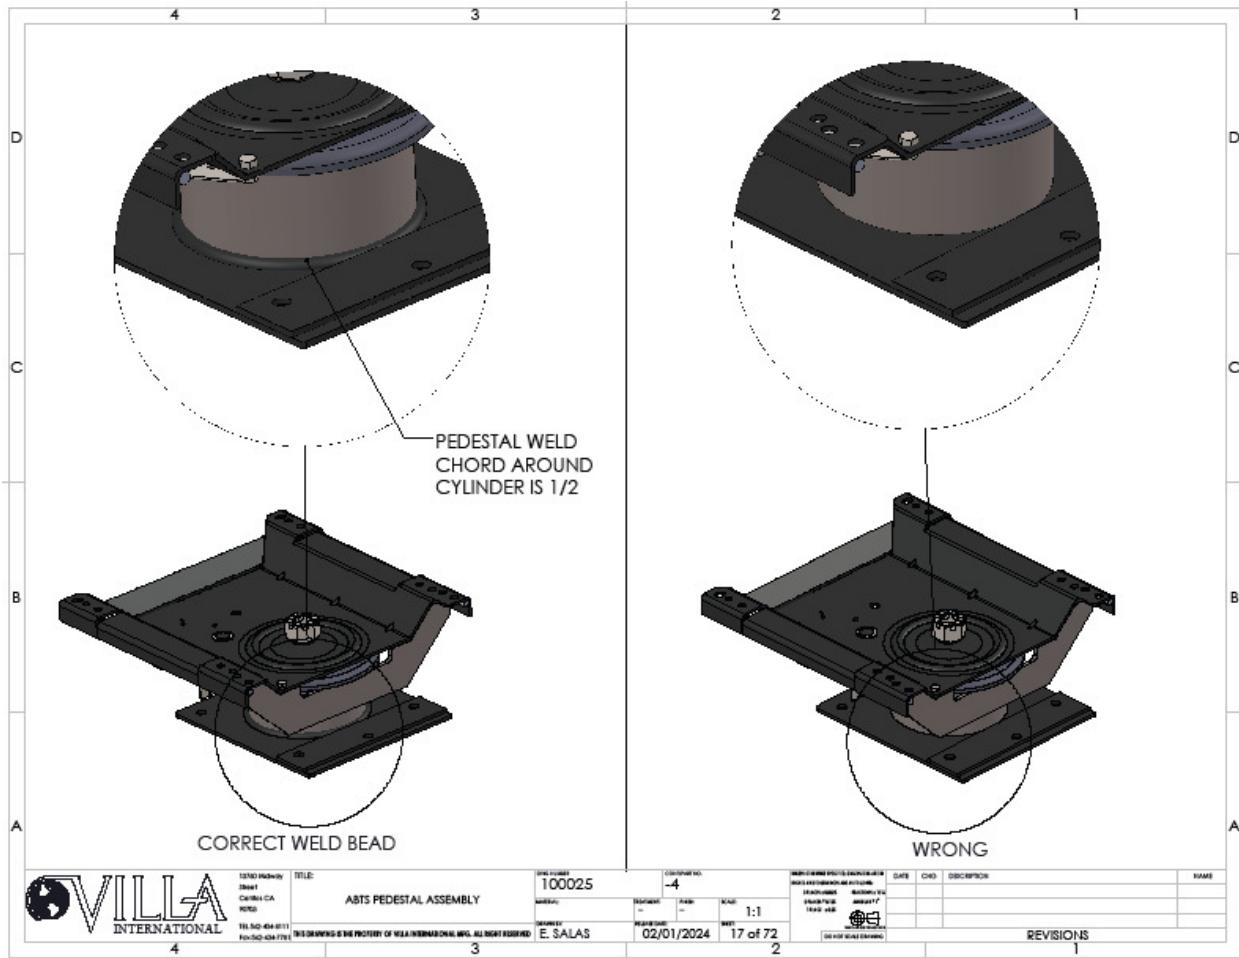
The defect concerns the seat pedestal that mounts to the vehicle floor. The attached drawing #100025 shows the defective pedestal without the weld bead and the correct pedestal with the weld bead. The pedestal incorrectly welded could fail in the event of a crash increasing the risk of injury.

The recall remedy is to inspect for the incorrect pedestal weld of the can to the mounting plate among the vehicles determined to be affected. The repair of vehicle seats found to have the defective pedestal will be to replace the defective pedestal with a new one.

Please contact your Newmar dealer as soon as possible to arrange an inspection date for your vehicle. Inspection photos of the pedestal weld areas per the attached drawings can also be sent to Villa to determine if the recall repair will be required. The pedestal inspection photos can be sent to [jim@villainternational.com](mailto:jim@villainternational.com).
