SIB 84 01 23

RECALL 23V-099: WIRELESS CHARGING TRAY WILL NOT RECOGNIZE DIGITAL KEY REMOVAL

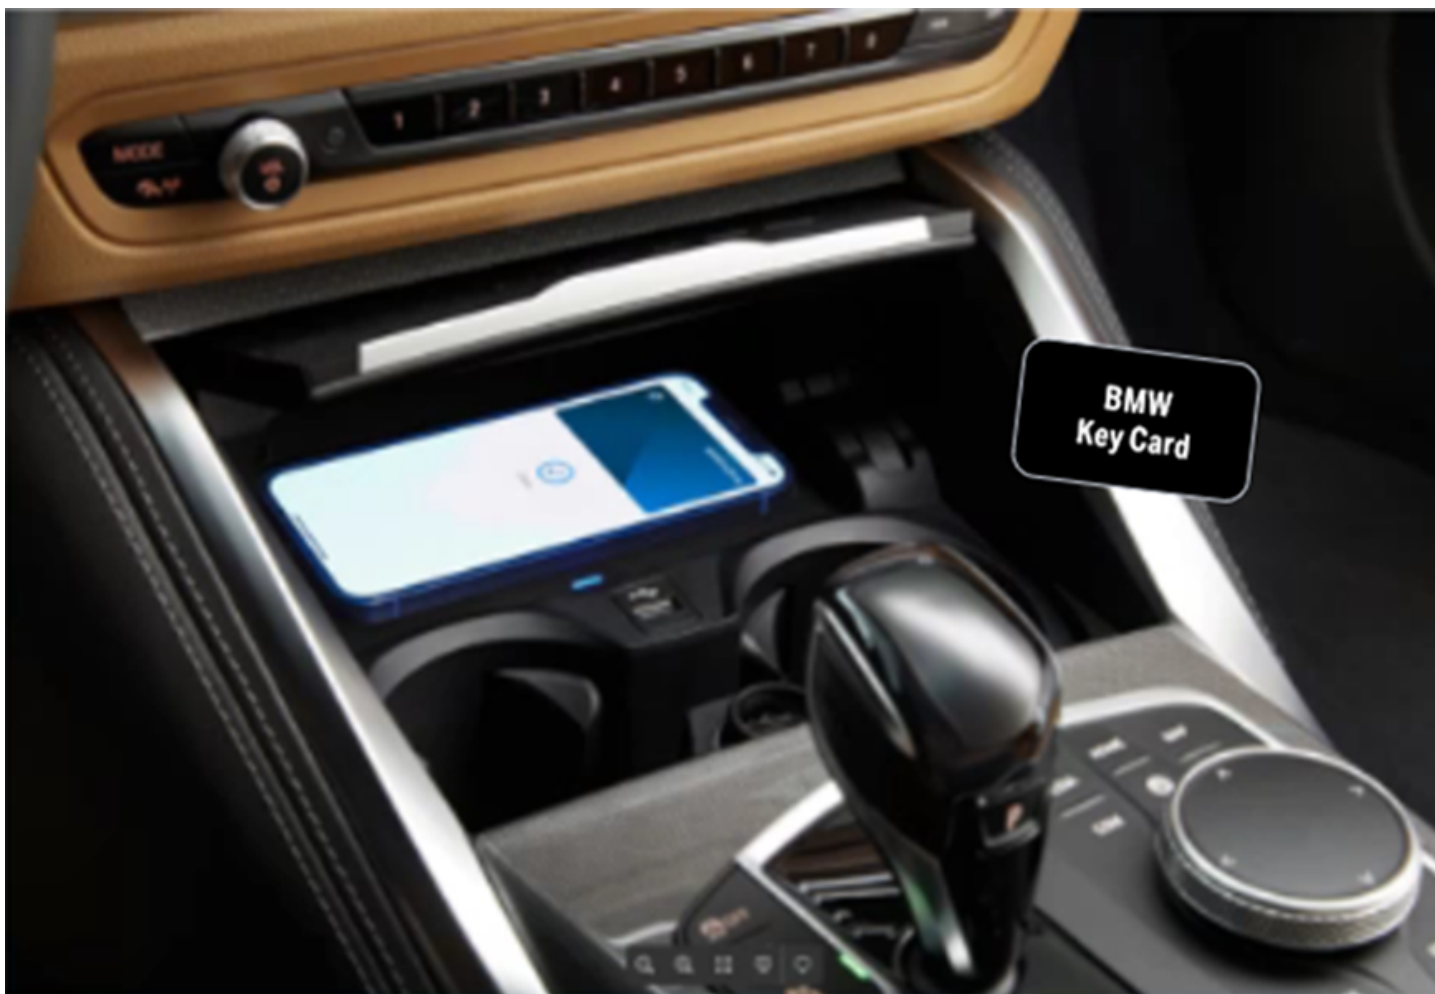
Example below: Wireless Charging Tray with either the BMW Key Card or a telephone with the Digital Key activated.

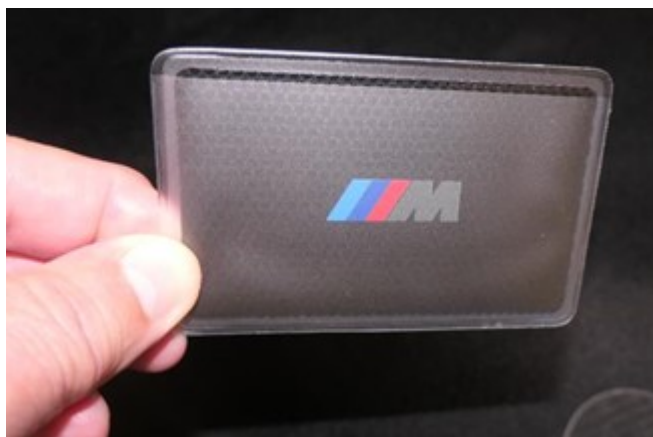
a. Remove the digital key (BMW Key Card) from the vehicle.

Card for an M model shown; cards for non-M models are similar.

b. The current BMW Key Card must be destroyed or damaged, and disposed of.
