SAFETY RECALL – NORTH AMERICA

High Voltage Battery Fuse

Reference: 53A / NHTSA 23V-303

Remedy available for:
2022-2023 (JL) Jeep® Wrangler 4XE PHEV

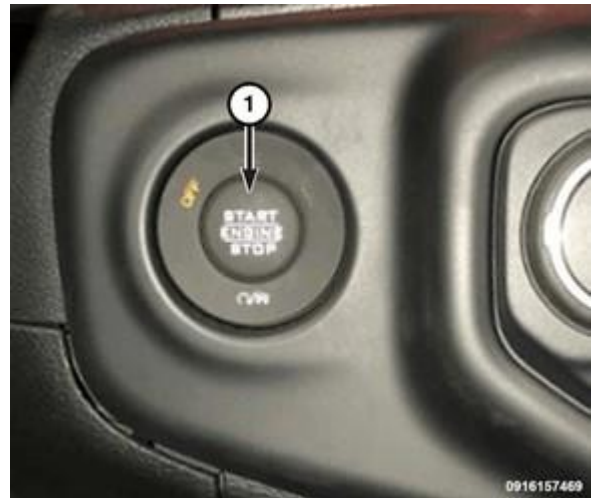
Figure 1 – Keyless Go Button

3. Inspect all orange high-voltage cables, and high-voltage components labeled with the high-voltage symbol for physical damage. If damage is present, extra caution must be taken to avoid contact with unprotected high-voltage. Do not insert probes, tools, objects or fluids into damaged high-voltage cables or components.
4. Disconnect any charging equipment. Do not plug in the EVSE Recharge Coupler when working on the vehicle.
5. Turn the ignition to Off by pressing the keyless go button (1) and move keys away from the car a minimum of 20 feet (Figure 1).

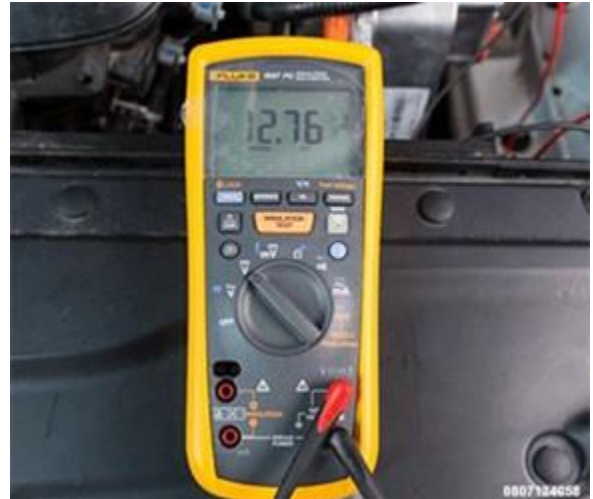
Figure 5 – Fluke Meter, Multi 126-1587

14. Use of an insulation tester such as the Fluke Meter, Multi 126-1587 is recommended for PHEV circuit testing. Perform the multi-meter functionality tests per the manufacturer's directions. Verify the multi-meter is operating correctly by measuring voltage from a known good power source, such as the vehicle's 12-volt battery. If at any point during the procedure, the multi-meter settings are changed, or the probes are repositioned in the meter, verification with a known good power source must be repeated (Figure 5).

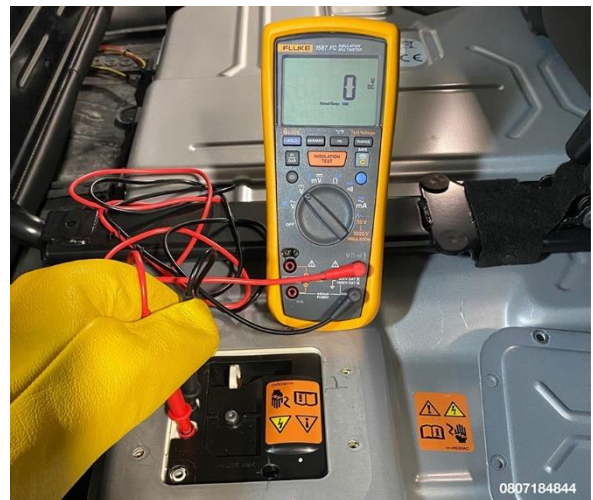
Figure 6 – Measuring at High Voltage Test Points

15. Using the Fluke multi-meter, measure the voltage at the high voltage positive and high voltage negative test points (Figure 6):
- Measure for voltage between the positive and negative high voltage test points.
 - Measure for voltage between positive test point and chassis ground.
 - Measure for voltage between negative test point and chassis ground.

16. The voltage reading should be 0 volts. (Some residual voltage may be present, up to 2.0 volts may be normal) (Figure 6).
- If the voltage measured is below 2 volts, it is safe to work on the high-voltage components with the exception of the high-voltage battery internal components.

- If the voltage is greater than 60 volts, an internal condition exists within the high voltage battery such as stuck contactors, that are preventing it from being powered down. This should be accompanied by contactor stuck DTCs. Do not attempt to carry out testing on any of the vehicle's high-voltage components or wiring. The HV Battery Pack requires replacement. Reference the HV BATTERY SERVICING WITH WELDED CONTACTOR(S) procedure at the top of the HV PHEV BATTERY REMOVAL AND INSTALLATION procedure for safely removing a high voltage battery that will not power down (Refer to 08 - Electrical/Battery System/BATTERY/Removal and Installation).

- If the voltage is between 2.0 volts and 60 volts, the HV system is safe to work on, however there is a problem that should be diagnosed. Disconnect each of the following HV modules one at a time and check the voltage at the test points. If the voltage drops to 2.0 volts or less, the faulted module has been found. Reconnect each module before continuing to the next.

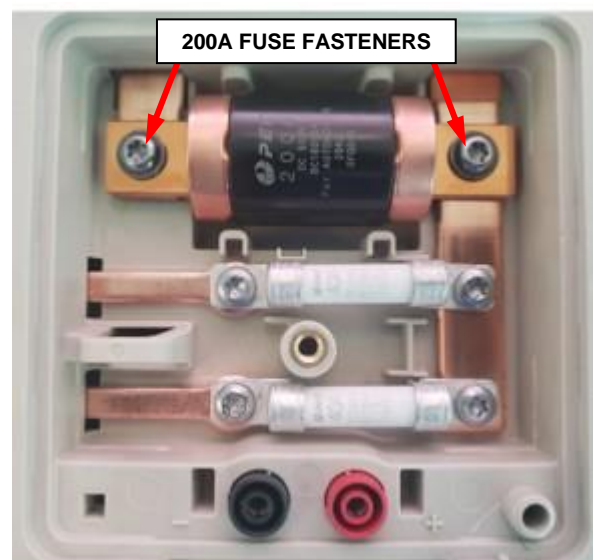
Figure 8 – 200A Fuse Fasteners

2. Inspect the 200A fuse fasteners in the fuse tray under the fuse cover (Figure 8).

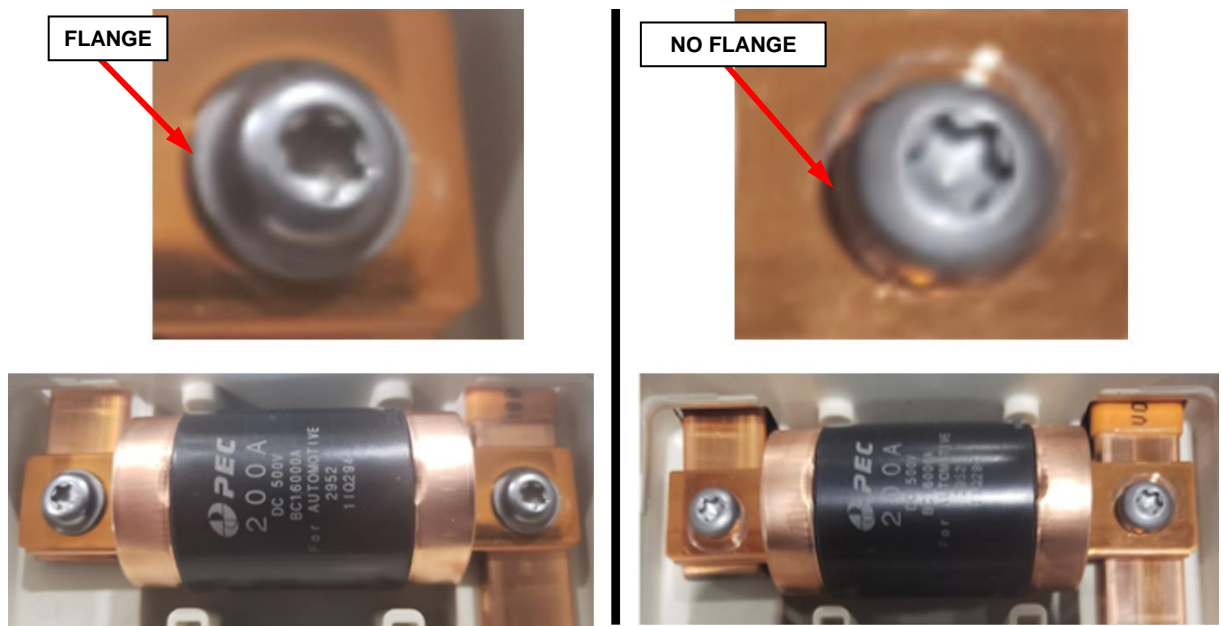
3. Do the 200A fuse fasteners have a flange around the screw head or not as shown in (Figure 9)?
- **Correct Screws - Flange Head:** No further action required. Vehicle may be reassembled. Proceed to **Step 10**.
 - **Incorrect Screws – No Flange:** Continue with **Step 4**.

Correct Screws - Flange Head

Incorrect Screws – No Flange

4. Remove the incorrect fasteners securing the 200A fuse then also remove the fuse (Figure 9).

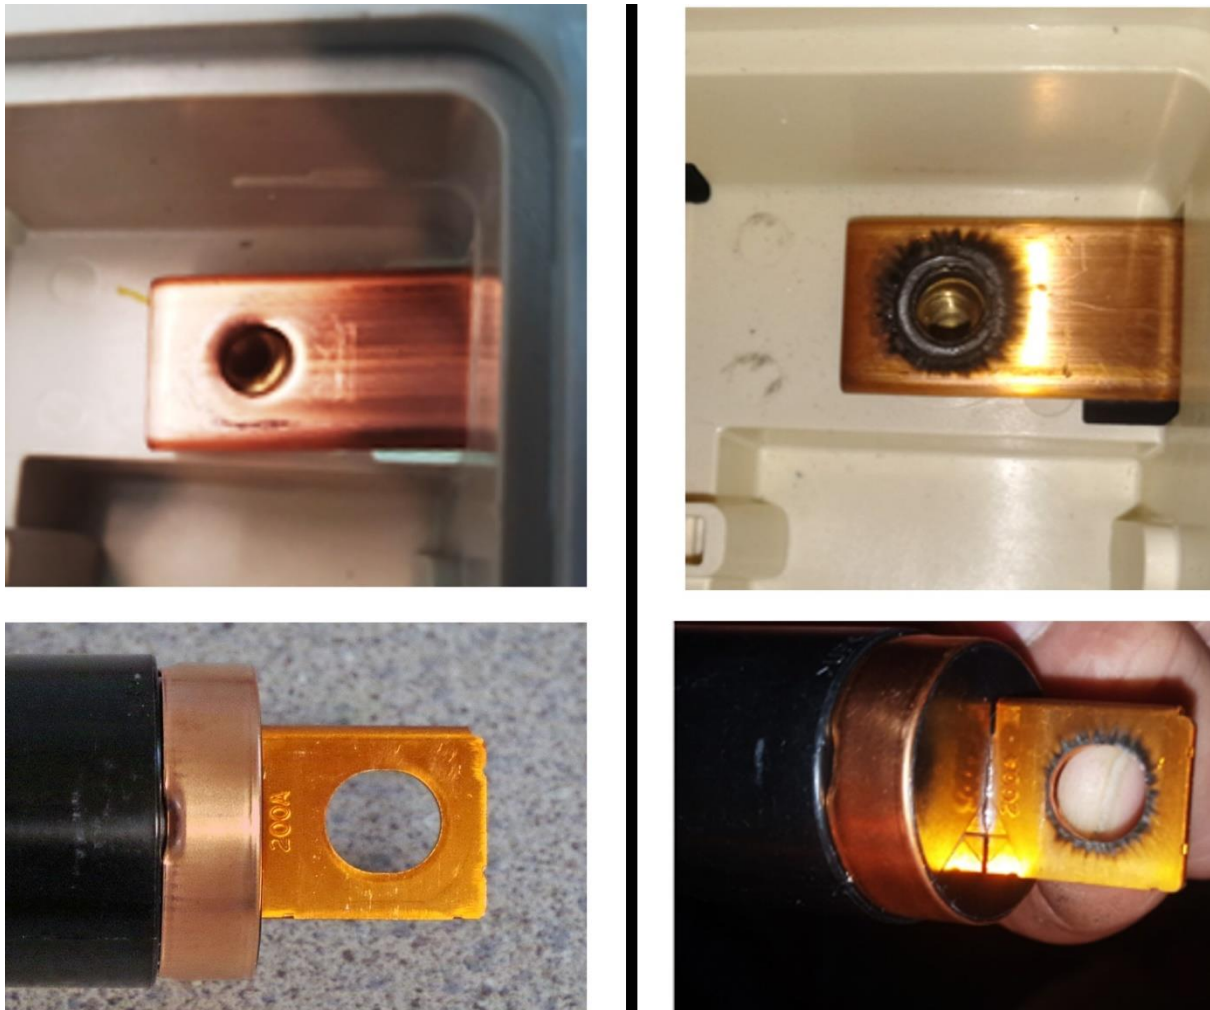
5. Inspect the 200A fuse and bus bar contacts for any signs of carbon marking as shown in (Figure 10).

Good Contacts No Carbon Marking

Signs of Carbon Marking

7. Were the bus bar contacts clean or carbon marked as shown in (Figure 10)?
 - **Clean, no Carbon Marks:** Replace the 200A fuse and fasteners. Continue with **Step 8**.
 - **Visible Carbon Marks:** Battery will require replacement Proceed to **Section C**.
8. Order and obtain the 200A fuse kit with proper screws. The photographs taken previously will be required to place the parts order.
9. Replace the 200A fuse and fasteners from the kit then tighten the screws to 5.7 N·m (50 in. lbs.) (Figure 8)
10. Install the fuse cover then tighten the cover screw to 6 N·m (53 in. lbs.) (Figure 7).
11. Power up the HV battery system.

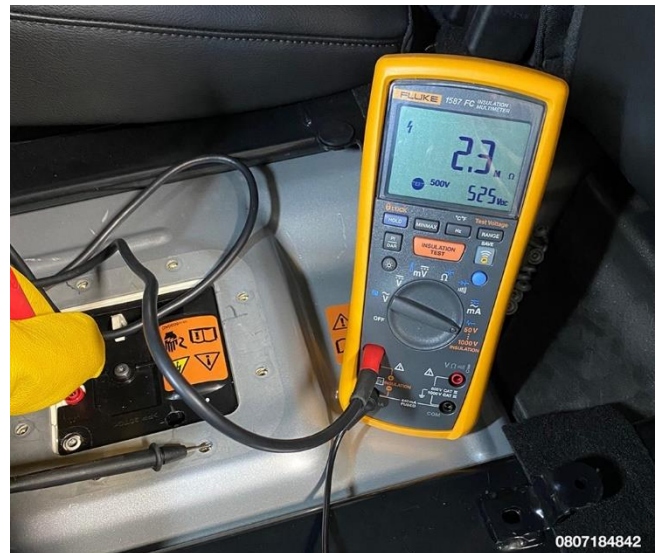
Figure 11 – Measure and Record Isolation Resistance Between HV Positive Test Point and Chassis Ground

13. Using the Meter, Multi 126-1587 measure and record the isolation resistance between the high voltage positive test point and chassis ground (Figure 11).

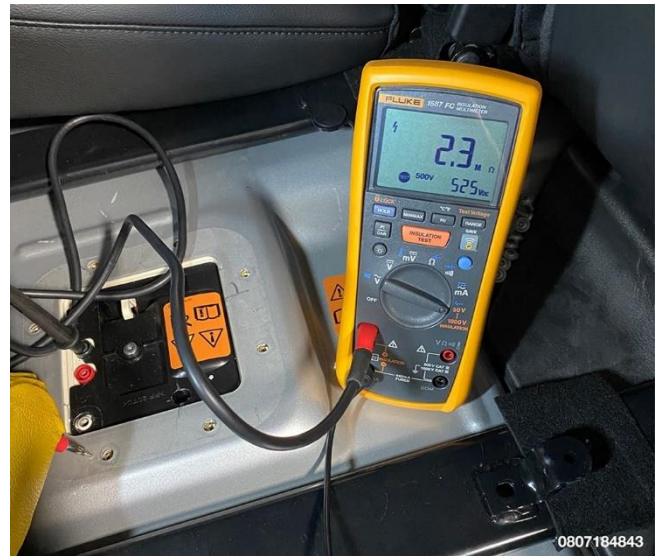
Figure 12 – Measure and Record Isolation Resistance Between HV Negative Test Point and Chassis Ground

- Using the Meter, Multi 126-1587 measure and record the isolation resistance between the high voltage negative test point and chassis ground (Figure 12).
- Isolation resistance should be 2.3 Mohms (+/- .2). If the measured isolation resistance is outside of this range, a loss of isolation condition exists within the high voltage circuitry. **Do not continue the High Voltage Power Up procedure until the condition causing the loss of isolation is corrected.**¹

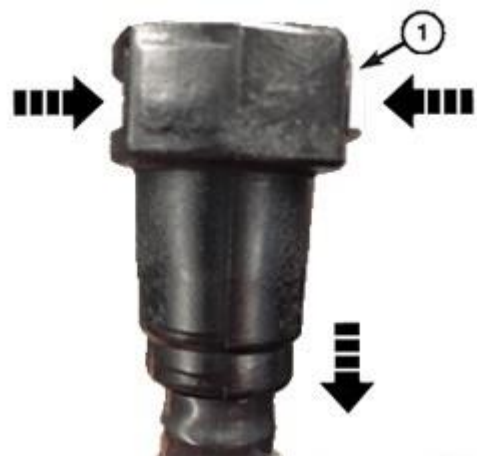
Figure 18 – Hose Connections

- Push in and hold both sides of the gray release (1) on the quick coupling (Figure 18).
- Pull the quick coupling away from air cleaner body cover.

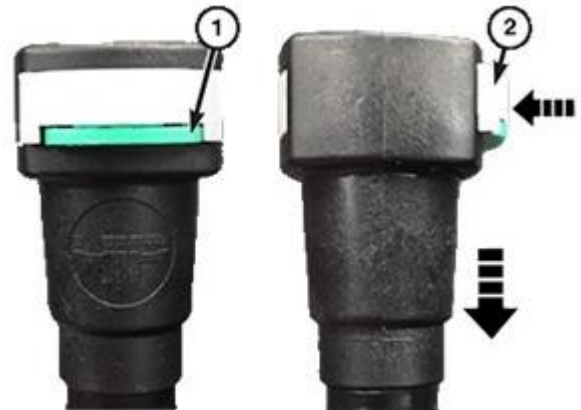
Figure 19 – Hose Connections

- Do not press on the green anti-tampering feature (1) (Figure 19).
- Push in and hold only the side of the release (2) with the green anti-tampering feature and pull the quick coupling away from air cleaner body cover.

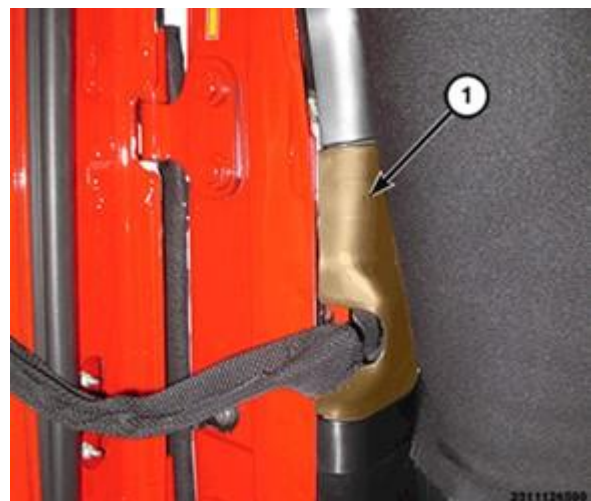
Figure 24 – B-pillar Trim Cover

- 20. Using a trim stick, release and remove the B-pillar trim cover (1) (Figure 24).

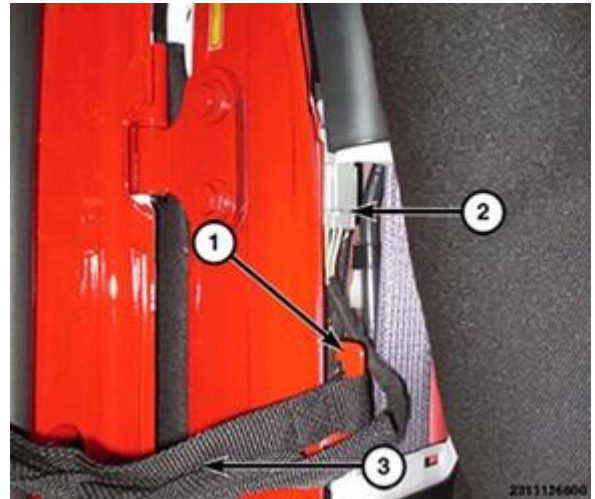
Figure 25 – Harness to Support Bracket

21. Disconnect the wire harness connector (2) and release the door tether from the support bracket (1) (Figure 25).

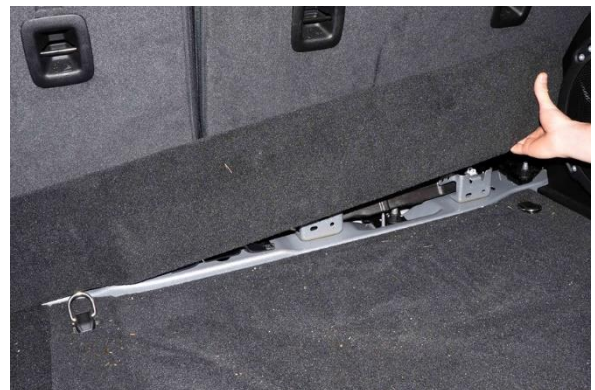
Figure 30 – Gap Hider

29. Remove the rear seat to load floor gap hider (Figure 30).

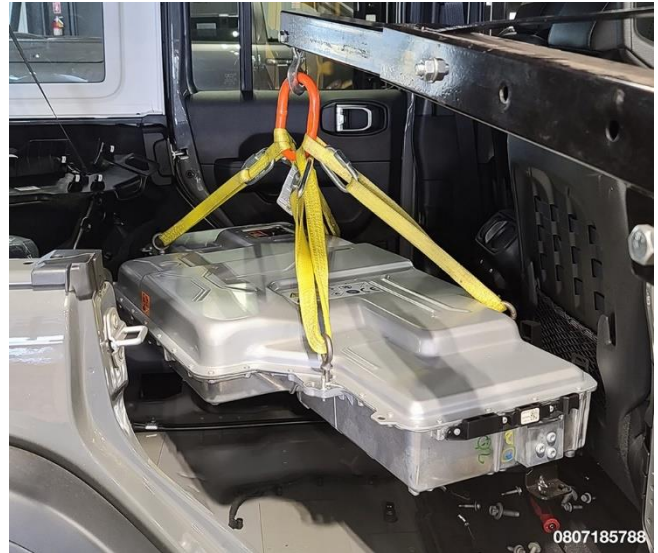
Figure 40 – Lift Straps

43. Connect the Lift Straps, HV Battery 2035200080 to the eyebolts and the lifting device. Adjust the straps so that the battery will be level during lifting as shown in the picture (Figure 40).
44. Remove the HV battery pack from the vehicle.

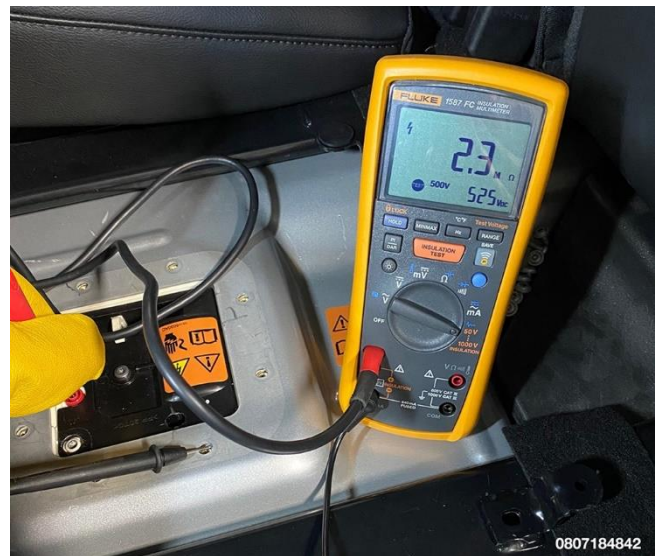
Figure 42 – Measure and Record Isolation Resistance Between HV Positive Test Point and Chassis Ground

- 58. Using the Meter, Multi 126-1587 measure and record the isolation resistance between the high voltage positive test point and chassis ground (Figure 42).

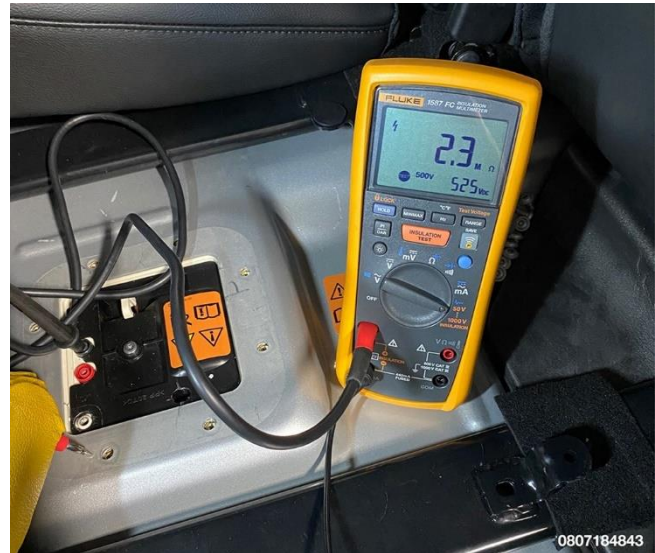
Figure 43 – Measure and Record Isolation Resistance Between HV Negative Test Point and Chassis Ground

- 59. Using the Meter, Multi 126-1587 measure and record the isolation resistance between the high voltage negative test point and chassis ground (Figure 43).
- 60. Isolation resistance should be 2.3 Mohms (+/- .2). If the measured isolation resistance is outside of this range, a loss of isolation condition exists within the high voltage circuitry. **Do not continue the High Voltage Power Up procedure until the condition causing the loss of isolation is corrected.**

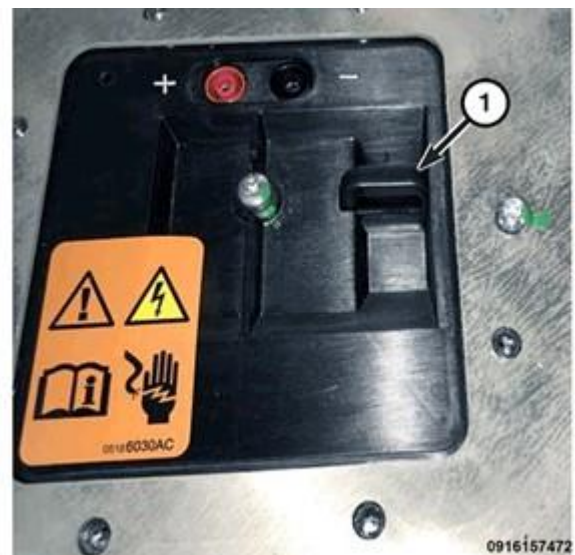
Figure 44 – Service Lockout Loop

- 61. If required, remove the lockout-tagout padlock from the service lockout loop (1) (Figure 44).

62. Install the test points access cover (1) to the battery pack and securely tighten the eight M6 Torx screws (2), identified with blue circles (Figure 44).
63. Remove the cover, connect the negative battery cable to the IBS and tighten the fastener (1) to 10N·m (7 ft. lbs.) (Figure 45).
64. Install the F09 (5 amp) IDCM fuse (3) in the Power Distribution Center (PDC) (Figure 45).
65. Connect the IBS harness connector (2) (Figure 45).
66. Using the scan tool, delete any DTCs that may have set due to the IDCM fuse being removed. Turn the key OFF and wait 2 minutes,
67. Use the scan tool and flash program the BPCM with the latest software.
68. Use the scan tool and perform the “Enable Contactor for Service” procedure in BPCM.
