# NON COMPLIANCE RECALL

**Volvo Trucks North America**

Number Release RVXX2314 01

Volvo Vehicle GVWR/GAWR Label VNL, VHD

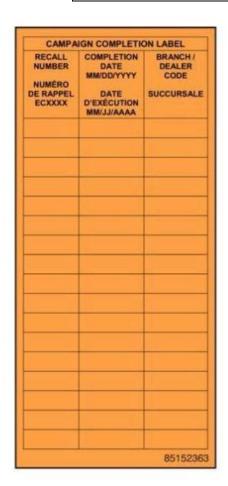
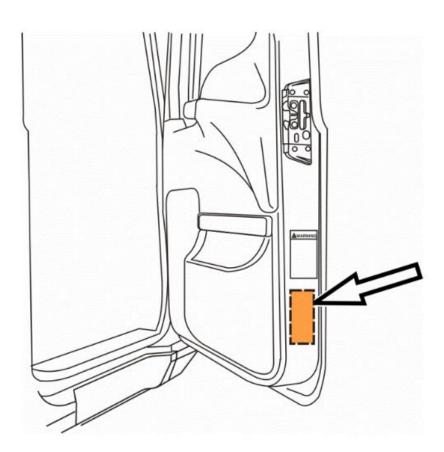
Label Placement- Conventional Chassis Configuration

A campaign completion label (part number 85152363) needs to be installed on truck if not previously installed. To signify the campaign has been completed, use a permanent marker (Such as a Sharpe ®) to write the recall number, completion date (MM/DD/YYY) and dealer code on the label. The label is to be applied to the inside of the passenger door as shown in the illustrations below.
