# Safety Recall

## N232432520 Improper Air Bag Deployment

**Release Date:** February 2024

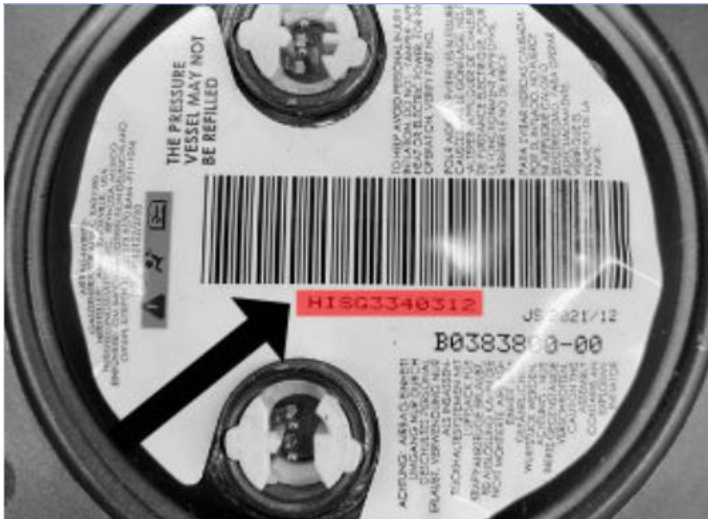
6087079

1. Remove the Airbag Steering Wheel Module. Refer to *Airbag Steering Wheel Module Replacement* in SI.

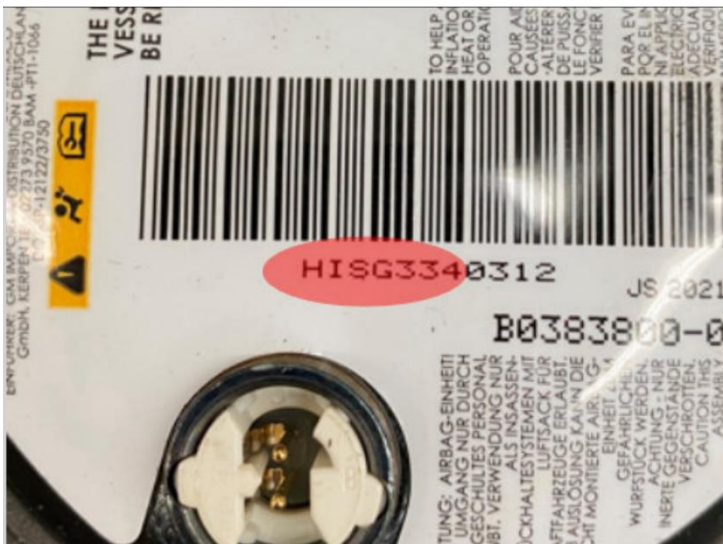
6148316

2. Locate the lot number on the back of the airbag inflator

- If the lot number **begins with** HISG334, HITG334, OR HIUG333, proceed to step three.
- If the lot number **does not begin** with HISG334, HITG334, OR HIUG333, no further action is required. Record the serial number of the steering wheel airbag. Reinstall the steering wheel airbag assembly. Refer to *Steering Wheel Airbag Replacement* in SI.

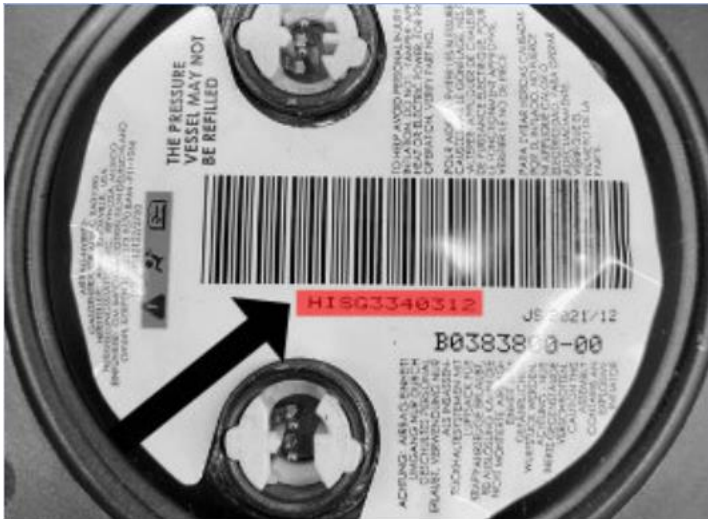
6087079

3. Record the serial number of the removed Steering Wheel Airbag.
4. Record the serial number of the new service steering wheel airbag.
5. Install the NEW Airbag Steering Wheel Module. Refer to Airbag Steering Wheel Module Replacement in SI. **DO NOT DEPLOY THE OLD AIRBAG.**

**Note:** The removed steering wheel airbag module **MUST** be defaced on the airbag cover (customer facing side) with a paint pen or permanent marker to prevent it from being reused.
