## RECALL 24V095 / 2024-078 REMEDY INSTRUCTIONS

Make(s): CONCORD Model(s): CNC321DSF Model Year(s): 2023 - 2024	Repair Code: RC-005-01-00-004488 Allotted Time: 3.00 HRS. Inspection Code: N/A Allotted Time: N/A
	Concern: The lower control arm brackets that are part of the air ride suspension kit, may fracture the welds and fail.	Photo(s) Required: NO Prior Authorization Required: YES Part(s) Kit Number: F007-01424 Part(s) Return: NO, FIELD DESTROY

# 2023 - 2024 Coachmen Concord/Autoflex Suspension

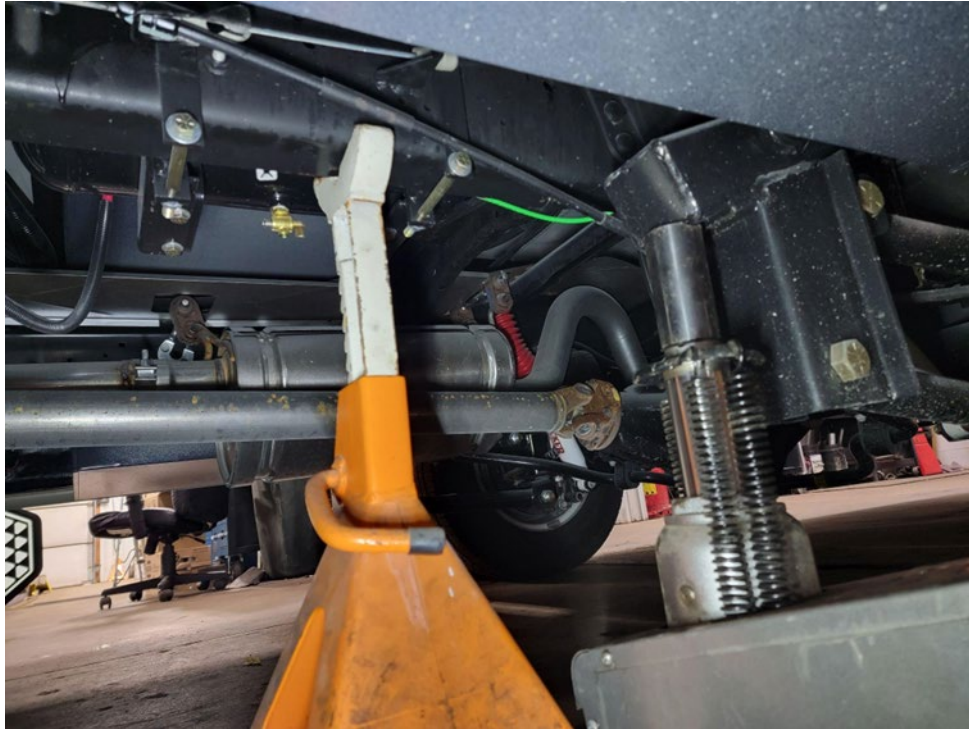
Figure 1

- Place vehicle in park on flat ground and remove key from ignition.
- Block front wheels to prevent vehicle from rolling.
- Jack up the rear of the RV by lifting in front of the rear axle along frame rail and support both sides with jack stands (See Figure 1). At this time the rear wheels may not be off the ground. This is normal.
- Place jack stands under frame.(See Figure 1)
- **Optional** - If removing wheels, use a floor jack to lift the rear axle under the center of the differential until all rear wheels are off the ground. Remove wheels. (It is not necessary to remove the wheels but it may help with accessibility.)

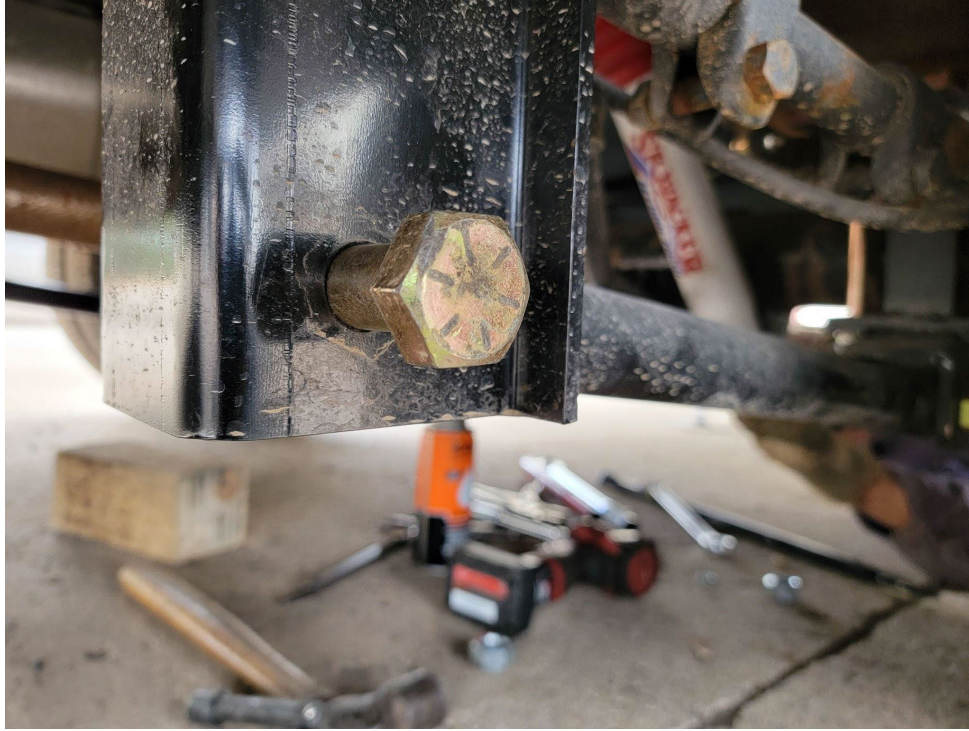
Figure 2 - Driver Side Shown

- Remove both 1-5/16 nuts from lower torque arms. Both bolts will remain in place for now.(Figure 2)
- Remove the (2) 9/16 nuts holding the lower air bag plate to the axle bracket.(Figure 3) The second nut is on the back side of the axle and can not be seen in Figure 3.

- Once tight, move to the rear set and tighten to 145 lb-ft.
- Tighten the 1-5/16 lower torque arm bolts to 400 lb-ft. (Figure 2)
- Recheck torque on all 8 Nuts and bolts on driver and passenger side.

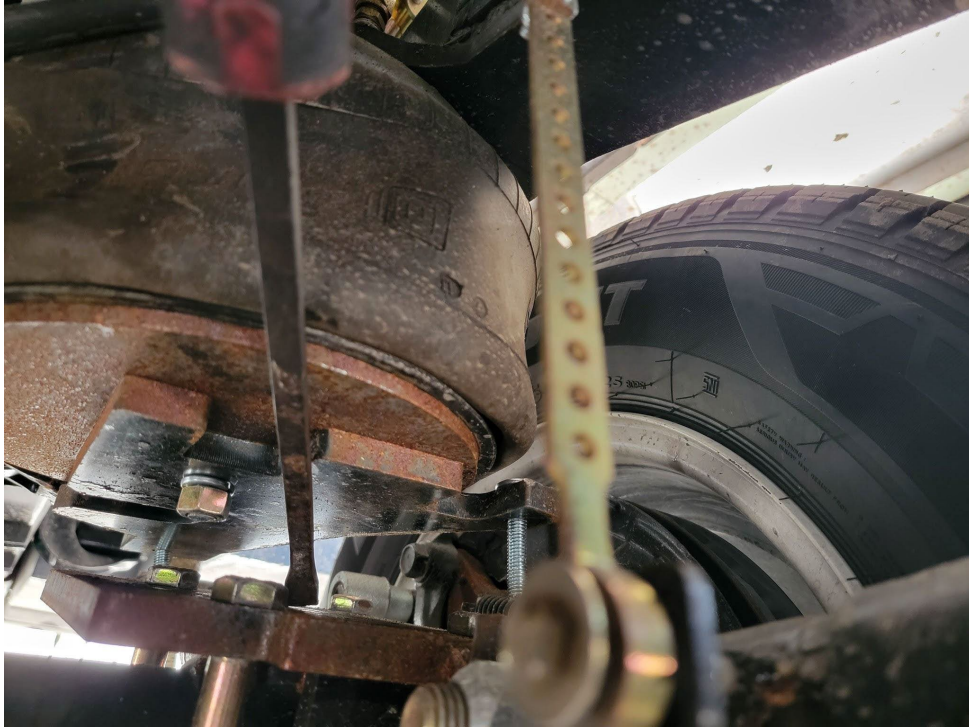
Figure 4 - Driver Side Shown

- Using a pry bar, compress the air bags upward to gain access to the top axle bracket.(Figure 4)
- Use locking pliers or hose clamp pliers to close off the exhaust tube at the leveling valve.(Figure 5) This creates a vacuum in the air bag and will keep it compressed for easy access.
- Use a 15/16 wrench on top (Figure 6) and 15/16 socket on bottom (Figure 7) to remove the 4 bolts holding the lower axle bracket in place.
- Remove lower bracket and discard.

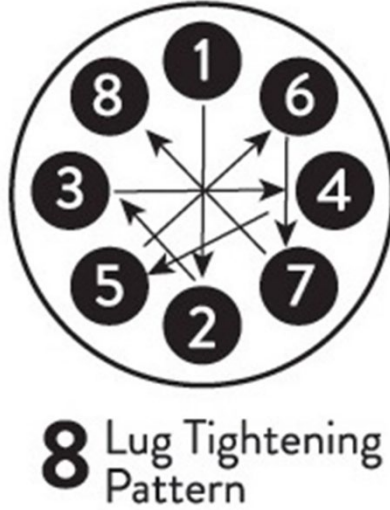
Figure 8 - Lug Tightening sequence

HiSpec wheels - 140 ft/lbs; identified as using the original black Ford lug nuts.  
Ion wheels - 120 ft/lbs; identified as using conical chrome plated lugs

- If wheels were removed, re-install, referring to lug tightening pattern and torque specs. (Figure 8)
- Remove jack stands, lower jacks, and allow air bags to air up. Test drive to ensure successful repair.
