February 1, 2017

05715 Version 2

Safety Recall: Front Passenger's Airbag Inflator Can Be Over-Pressurized (Phase 2)

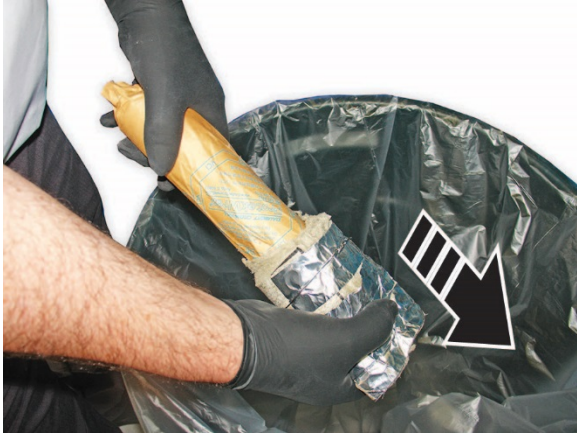
- Hold the paper wrapping the inflator with one hand and slide the insulation off into the trash.
NOTE: The insulation is securely wrapped around the inflator. You may have to use some force to slide the insulation off. Do not cut the insulation and be careful that you do not move the white or orange plastic ends.

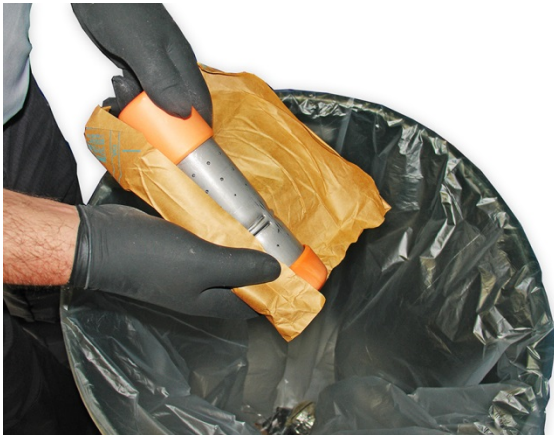
- Remove the wrapping paper and drop it into the trash.

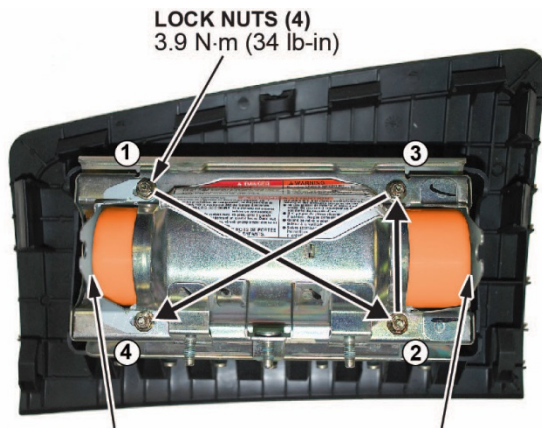
15. Install the new 5 mm locknuts and torque them in sequence to **3.9 N•m (34 lb-in)**.

Be sure there are no gaps between the inflator ends and the inflator brackets

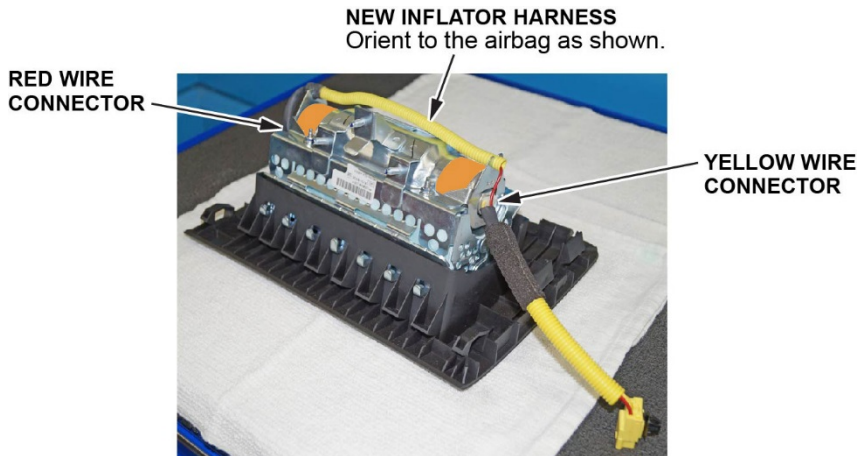
- Make sure the airbag and harness are aligned as shown.
NOTE: Make sure you have the orientation correct as shown below. If you connect the harness incorrectly, the harness cannot be removed, and you will not be able to reinstall the airbag because the harness will be too short.
