## April 24, 2015

01229-01601 Version 5

# Safety Recall: Transmission Does Not Engage Park

Year	Model	VIN Range
2015	TLX V6 with 9-speed A/T	Check the iN VIN status for eligibility

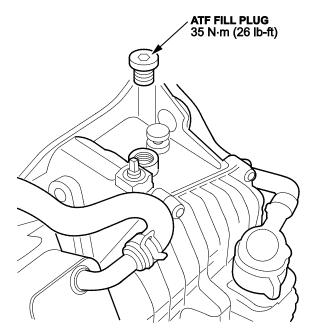
- 4. Remove the ATF fill plug.

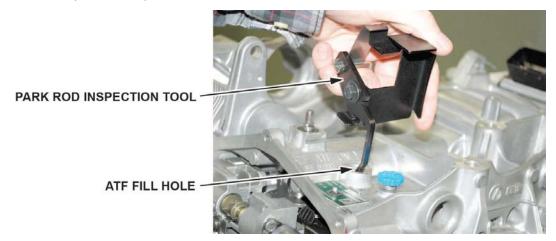
5. Insert the park rod inspection tool into the ATF fill hole as shown.

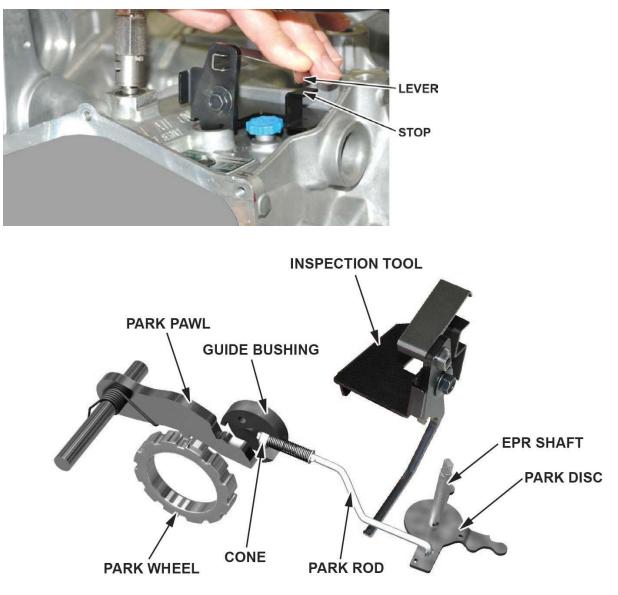
6. Press the lever all the way down until it touches the stop; repeat this three times.

- 7. Remove the park rod inspection tool.
- 8. Use the electronic gear selector to shift the transmission into Park. NOTE: Do not apply the electric parking brake.
- 9. Try to push the vehicle several feet.
- If you cannot move the vehicle, the park rod is OK. Go to step 10 to flush the transmission.
- If you can roll the vehicle, the transmission is no good. Replace the transmission (do not do the following flush procedure). Refer to the electronic service manual.

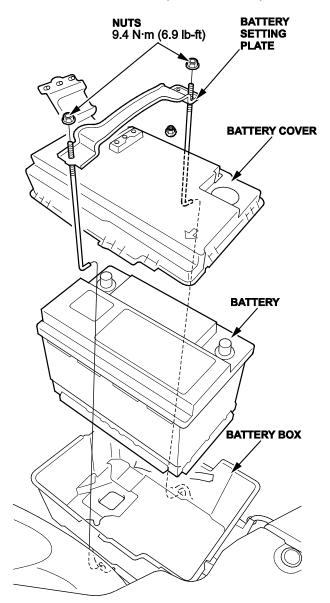
- 10. Press the ENGINE START/STOP button to set the power mode to OFF.
- 11. Do the 12-volt battery disconnection procedure.
- 12. Remove the 12-volt battery and the battery box.

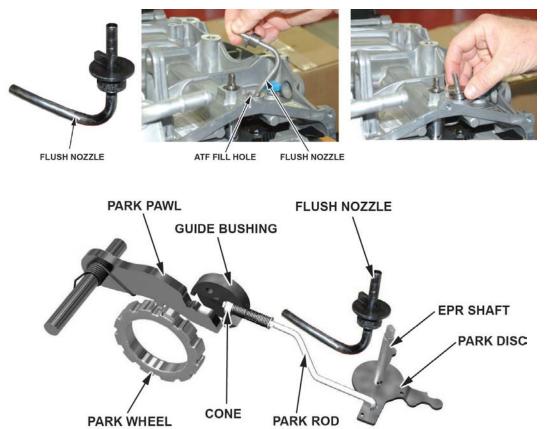
13. Insert the flush nozzle into the ATF fill hole as shown.

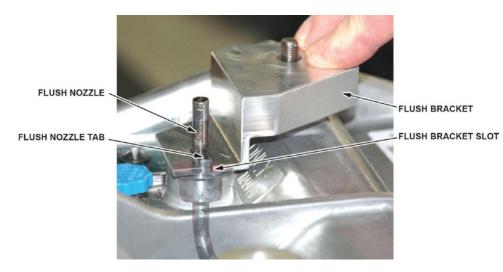
14. Install the flush bracket as shown.

NOTE: The tab on the flush nozzle should align with the slot in the bracket. If the tab is not aligned with the bracket, it will not flush the correct area.

Note: If you cannot thread the nut on because there is not enough room on the threaded shaft, the flush nozzle and flush bracket are not properly aligned. Remove the tools and repeat steps 13 thru 15.

INCORRECT

NOT ALIGNED WITH SLOT IN BRACKET

NO THREADS AVAILABLE ON SHAFT CORRECT

THREADS AVAILABLE ON SHAFT

TAB ON FLUSH NOZZLE ALIGNED WITH SLOT IN BRACKET

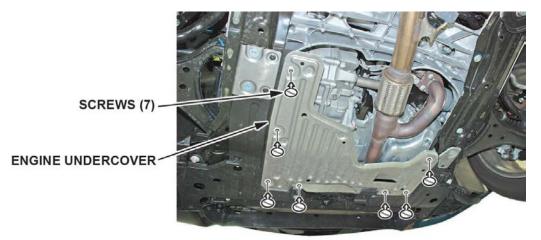
16. Raise the vehicle. Remove the engine undercover by removing the seven screws.

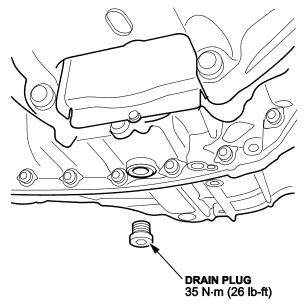
17. Drain the ATF.

- 18. Reinstall the drain plug and torque it to 35 N•m (26 lb-ft).
- 19. If this is the first time using the flush kit, go to HOW TO PRIME THE PUMP on page 16.
- 20. Make sure the flush pump is primed. A primed pump should have ATF in the hoses and about 2 quarts of ATF in the bucket. If you need information about priming the pump, **go to HOW TO PRIME THE PUMP on page 16.**
- 21. Add 6 quarts of ATF to the bucket. There should be a total of 8 quarts of ATF.

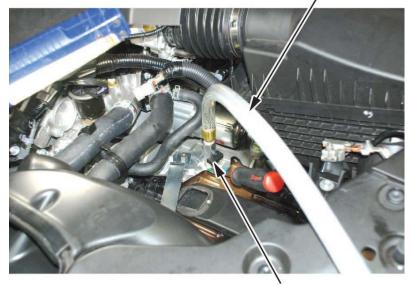
22. Attach the flush hose to the flush nozzle.

FLUSH HOSE

FLUSH HOSE VALVE CLOSED

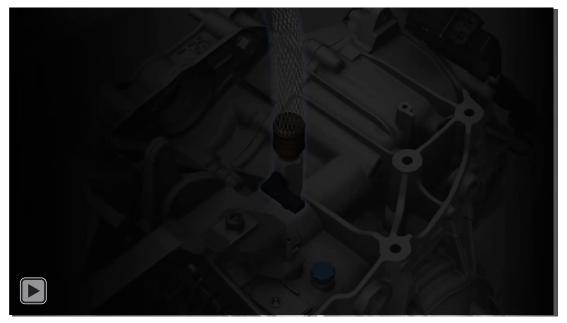
23. Open the valve on the flush hose.

#### FLUSH HOSE VALVE OPEN

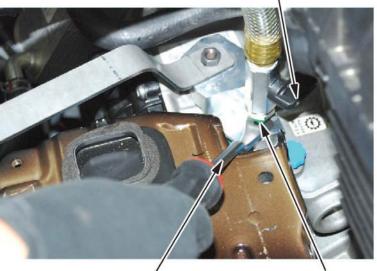
- 26. After you cycle the lever 5 times, continue to run the pump until there are only 2 quarts of ATF left in the bucket, then turn off the pump. NOTE: **Do not let the ATF in the bucket drop below 2 quarts** because you will damage the pump if you run the pump dry.
- 27. Close the valve, and remove the flush hose by prying up on the green quick release tab using a panel removal tool while gently pulling up on the hose.

**GREEN QUICK**

## FLUSH HOSE VALVE CLOSED

PRY TOOL

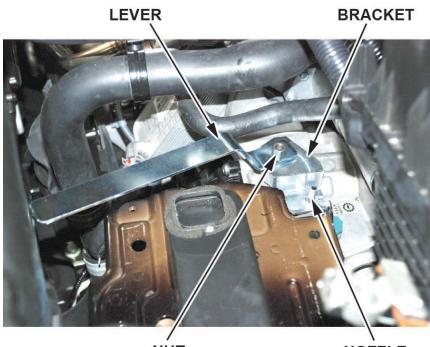
**RELEASE TAB** 28. Remove the nut, handle, bracket, and nozzle from the vehicle.

NÚT

NOZZLE

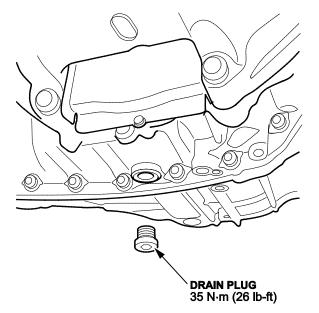
29. Raise the vehicle and drain the ATF that was used to flush the transmission, then reinstall the drain plug.

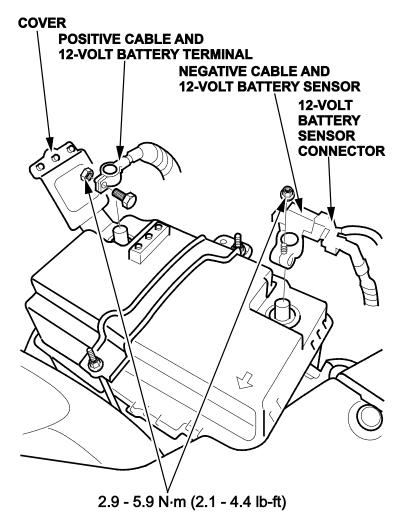
- 30. Lower the vehicle and refill the transmission with 3.5 quarts of new ATF Type 3.0 (or later) and install the fill plug.
- 31. Reinstall and reconnect the 12-volt battery.

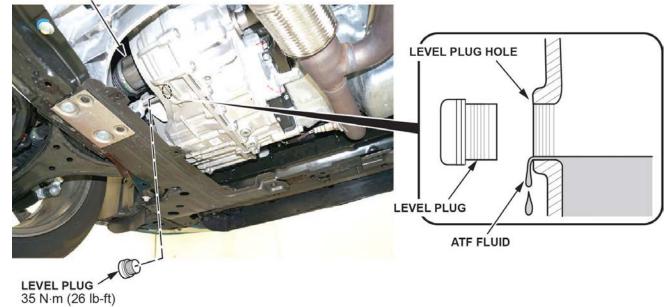
- 41. Remove the level plug located by the left side drive shaft.
- If ATF is flowing out of the hole, wait until the ATF slows to a drip, then reinstall the level plug.
- If no ATF comes out of the hole, lower the vehicle, and add more ATF as necessary. Raise the vehicle and recheck.
  - LEFT SIDE DRIVE SHAFT

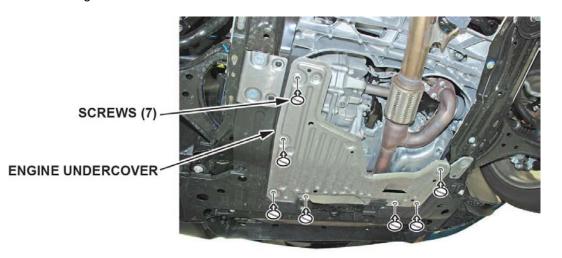
42. Install the engine undercover.

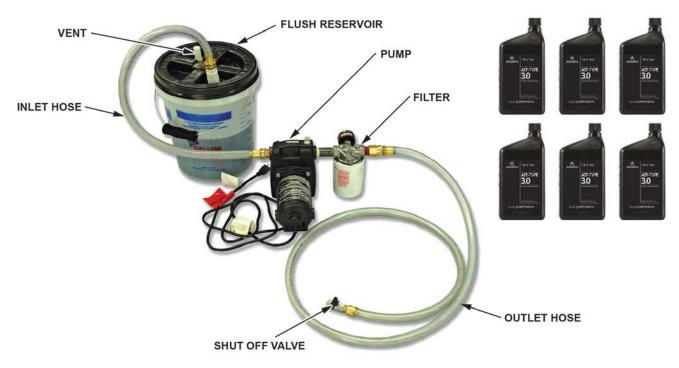
1. Assemble the flush kit as shown.

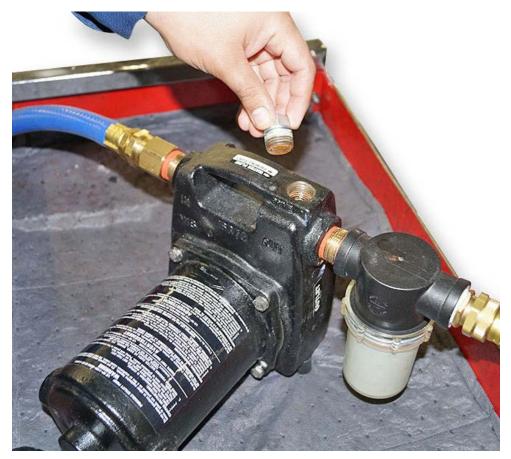
2. Remove the priming plug.

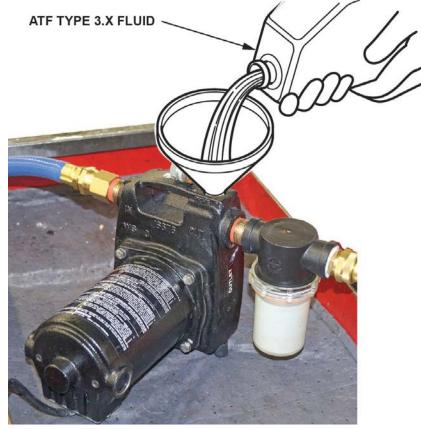
3. Add about 1 quart of ATF Type 3.0 (or later) to the pump.

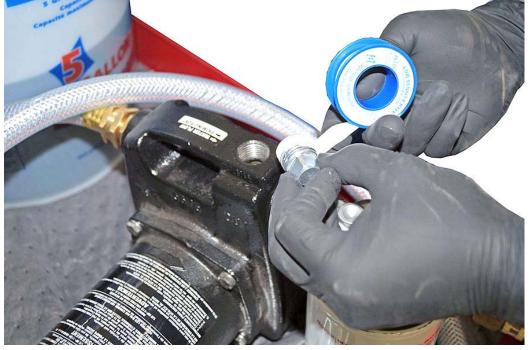
4. Apply Teflon tape to the priming plug, then reinstall it.

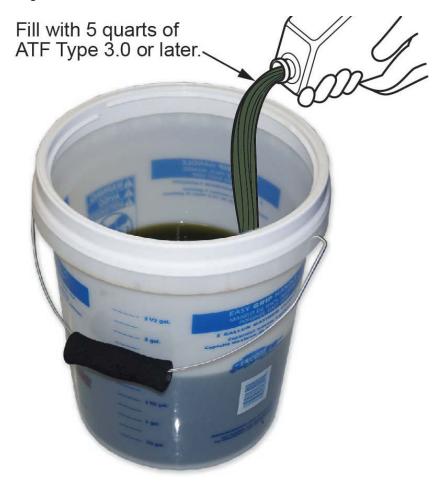
Fill the bucket with 5 quarts of ATF Type 3.0 (or later). NOTE: Make sure you use only ATF Type 3.0 (or later) fluid because if you mix in other types of ATF, you may damage the transmission.

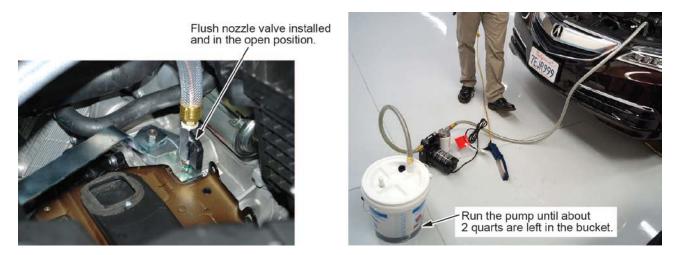
6. When the flush nozzle is installed on a vehicle, attach the flush hose to it. Open the valve and run the pump. Confirm ATF fills the filter housing and several inches of the outlet hose. This is confirmed when there is ATF in both hoses and about two quarts of ATF left in the bucket. NOTE: Make sure you drain the ATF from the vehicle before you do the transmission flush.
