Subject: N202303030 - Service Update
Park Brake Caliper Guide Pin Missing Retention Clip

Models: 2020 Chevrolet Corvette

N202303030 Park Brake Caliper Guide Pin Missing Retention Clip

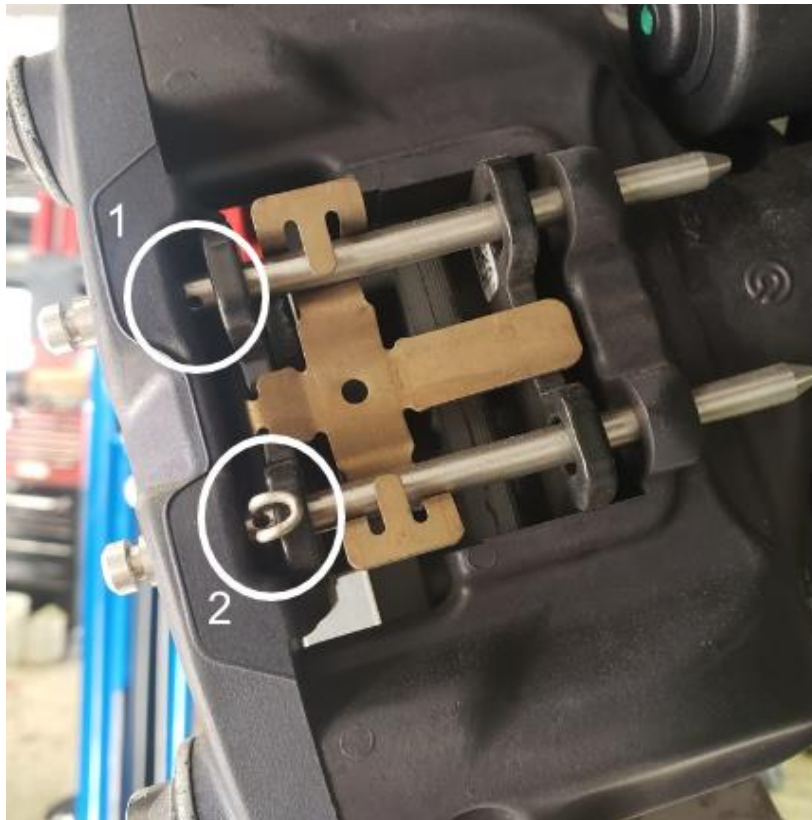
5609080

Condition	Certain 2020 model year Chevrolet Corvette vehicles may be missing the park brake caliper guide pin retention clip. A dislocated pin may damage the wheel.
Correction	Dealers will inspect for retaining clip, and if necessary, replace the missing clip.

1. Using a borescope or a flashlight and mirror, inspect both the left and right rear parking brake calipers to determine if they are missing the retaining clip, as shown above.
 - If any retaining clips are missing on either caliper, as shown in by 1 above, proceed to step 2.
 - If no retaining clips are missing on either caliper, as shown by 2 above, no further action is required.
2. Lift the vehicle. Refer to *Lifting and Jacking the Vehicle* in SI.
3. Remove the rear wheels. Refer to *Tire and Wheel Removal and Installation* in SI.
4. Replace any missing retaining clips.
5. Reinstall the rear wheels. Refer to *Tire and Wheel Removal and Installation* in SI.
6. Lower the vehicle.
