PRODUCT CAMPAIGN BULLETIN

NUMBER: WRG-21R
DATE: 08/24/21
REVISED: 12/09/21
NHTSA ID: 21V587

SUBJECT: Fuel Pump Impeller Failure

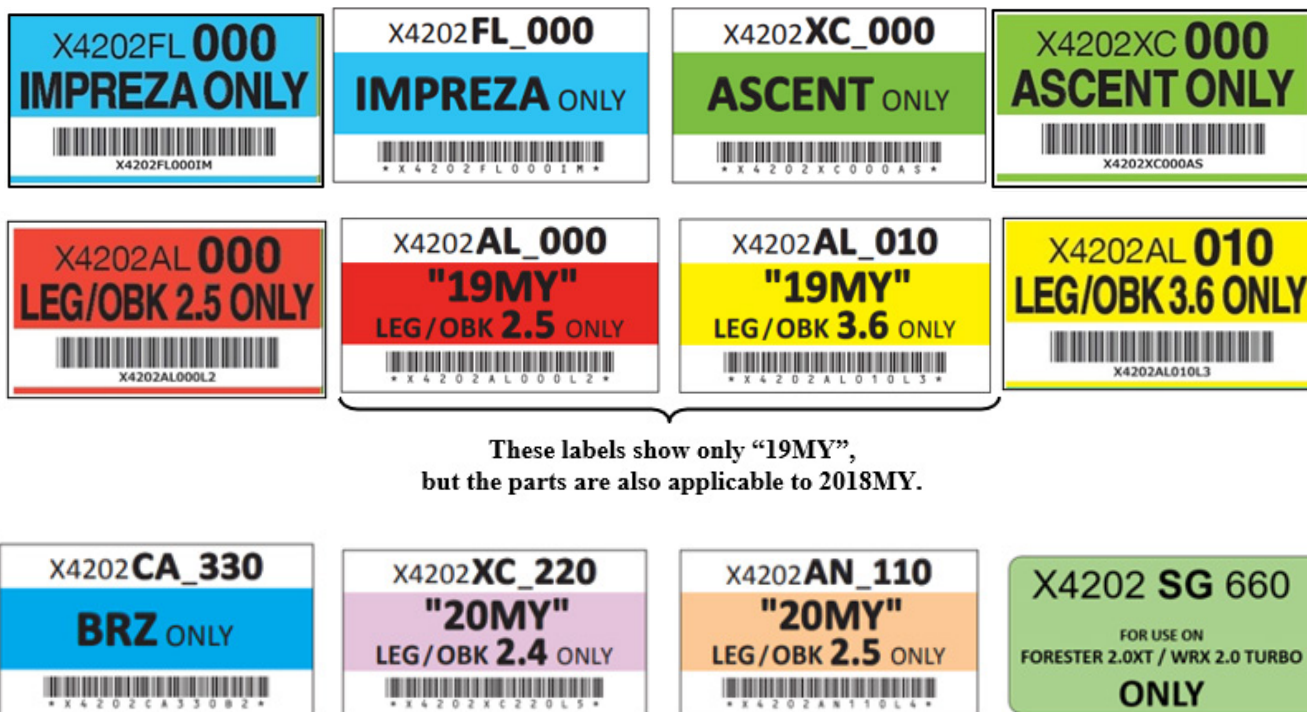
The parts required to perform these repairs have been assembled into Fuel Pump Kits, numbered for each model and labeled accordingly as shown below to help insure installation of the proper kit into the applicable model.

These labels show only "19MY",
but the parts are also applicable to 2018MY.

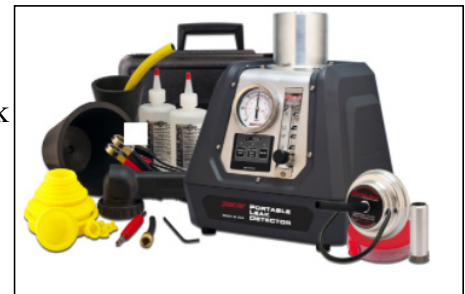
- **Redline Detection Smoke Pro (RDL-95-0051).** Used for leak testing the fuel tank chamber and fuel pump assembly. This is already a required essential Subaru Special Service Tool.

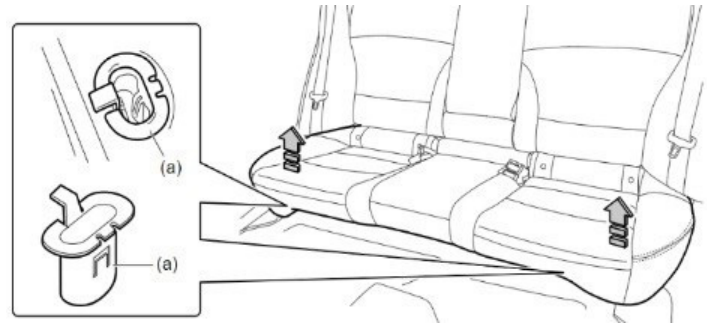
When removing the rear seat cushion (all models except Ascent & BRZ), if the plastic retaining clips (a) (p.n. **64396KA010** for 18-19 Legacy / Outback and **64333FJ000** for Impreza, WRX, Forester, and 20 Legacy / Outback) in the floor come out, they become **one-time use** items and **MUST** be replaced during reassembly. When installing the seat cushion, always confirm the seat belt buckles are returned to the proper positions.

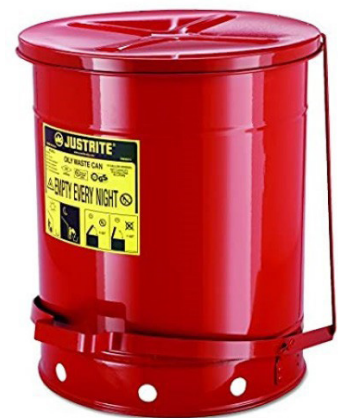
IMPORTANT: When performing these procedures, shop cloths contaminated with gasoline will be created. It is **CRITICAL** they be handled safely and following proper disposal guidelines. Always store contaminated shop cloths in an approved safety can as shown here.

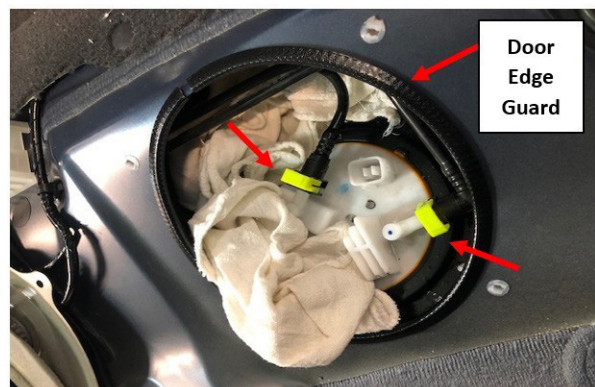
After removing the rear seat cushion assembly and the (main) fuel pump access cover, use a length of small hose (sliced lengthwise), vinyl door edge guard as shown here or electrical tape to cover the edge of the access opening in the floor panel. This will protect any removed fuel line(s) and Technician hands from cuts or abrasions resulting from sharp edges. The photo here shows the power harness unplugged and shop cloths in place to absorb residual fuel that may remain in the lines after removal from the pump assembly.

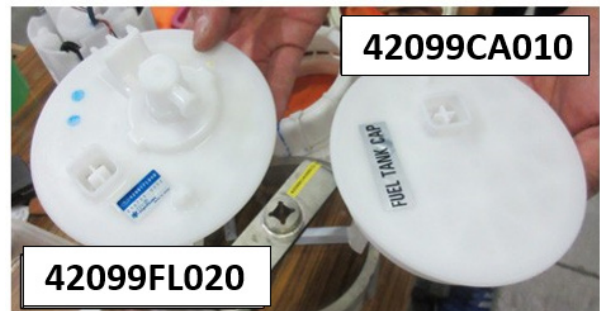
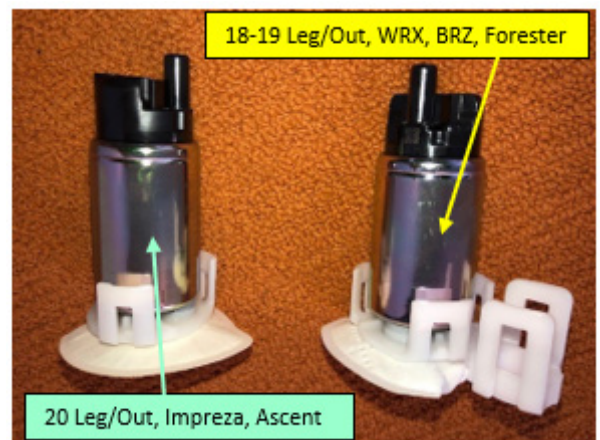
NOTE: When searching STIS for the applicable Service Manual procedures for reference, select **Fuel Filter REMOVAL** to get the detailed procedure for separating the pump / filter sock assembly from the complete fuel pump assembly. Fuel Filter removal is **NOT** required to complete this procedure. The replacement pumps come with a new filter sock already in place as shown here.

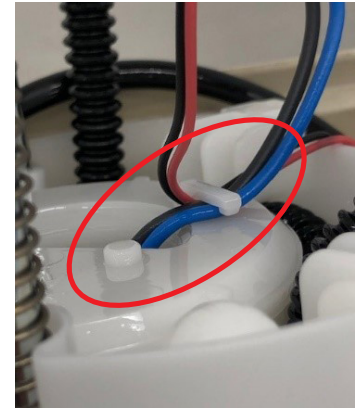
When reinstalling the thinner (Black / Red) fuel sender wires into the 2 retaining clips, they go into the clips first and are held in place by the thicker fuel pump harness wires.

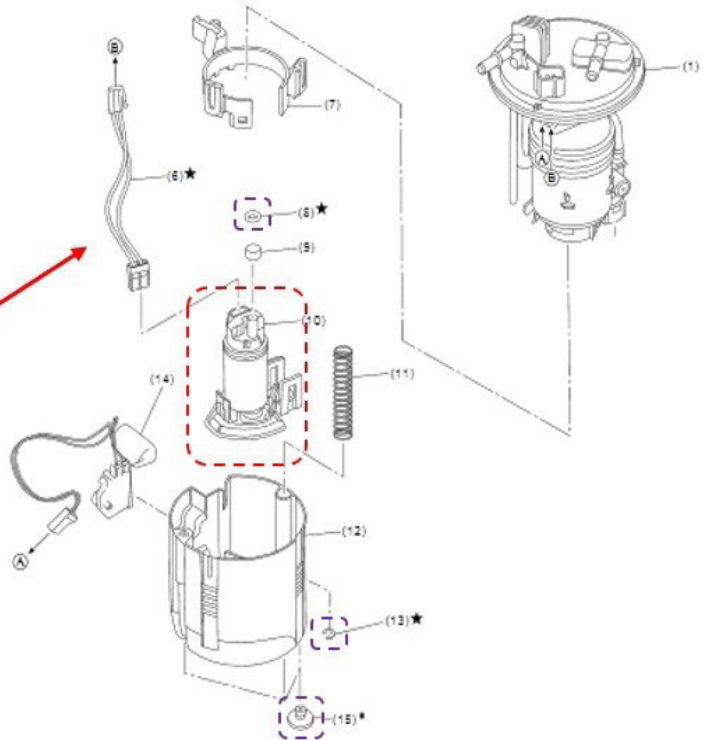
- : Main component to be replaced
- : * One-Time use parts included in kit

For this Campaign procedure, the connector cable (6) does not need to be replaced.

However, if either of the following conditions are found, replace it.

- Cracking of the harness insulation or
- Deformation / discoloration of any connector or terminal.

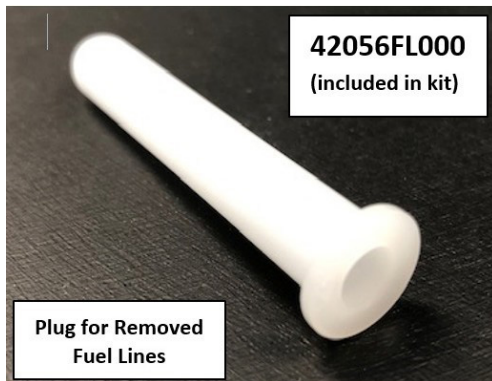
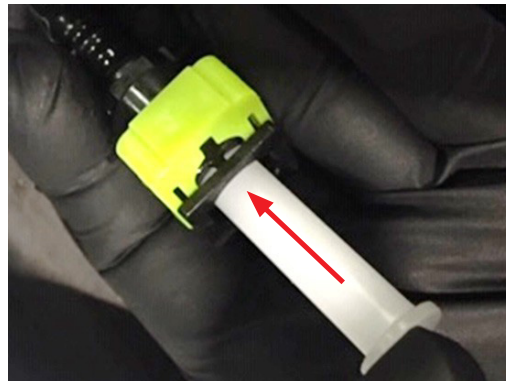
Release the quick disconnect fitting at the fuel pump outlet pipe. **While covering the fuel pipe with a clean shop cloth to catch any residual pressurized fuel**, slide the fuel delivery pipe off the fuel pump outlet. Insert the plastic temporary plug supplied in the kit into the removed fuel delivery pipe. The one-time use temporary plug is included in the replacement fuel pump parts kit.

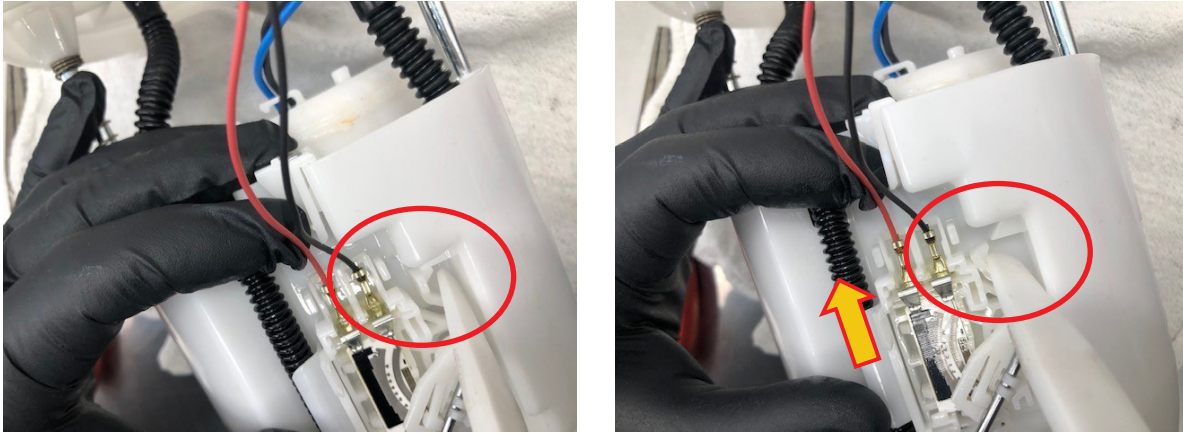
IMPORTANT: If any damage e.g. distorted or melting plastic connectors, overheated wiring or terminals is identified, the harness **MUST** be replaced. Release the retaining clip (a plastic trim tool is being used here) and slide the sending unit upward. **NEVER** touch the contact surface of the sending unit and use care to avoid bending or otherwise damaging the float arm and contact point.

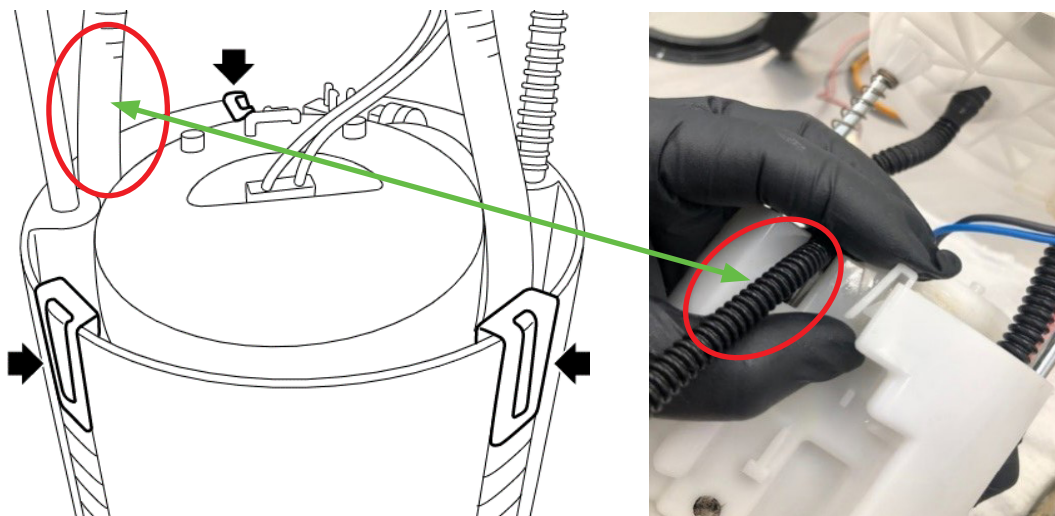
- **CAREFULLY** disconnect both the fuel pump and fuel sending unit harness connectors and remove the wiring from the retaining clips. Note the wire routing prior to disassembly for reference during reassembly.
- Compress the spring (fuel filter assembly) and remove / discard the (one-time use) c-clip (ring clip).
- **IMPORTANT:** When releasing the retaining claws as described in the following steps, move them **only as far as needed** to disengage them. If any break, the affected component must be replaced.
- Release the retaining claw for the tube at the bottom of the fuel chamber.
- **CAREFULLY** release the 3 claws for the pump holder from the fuel chamber then raise the pump / filter assembly upward.

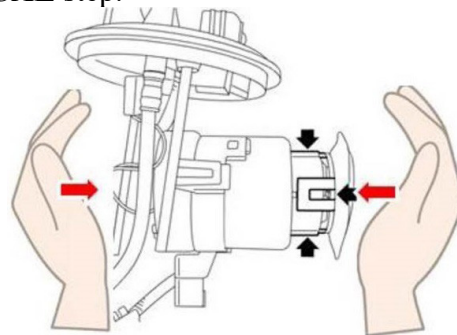
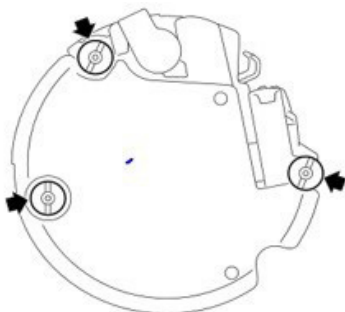
- Install the new fuel pump into the fuel filter assembly. Using the image below as a guide, lay the partially reassembled pump assembly on the bench horizontally and insert the new pump into the fuel filter assembly. Using both hands, **CAREFULLY** press the new pump and filter assemblies together until a “click” is heard from ALL of the new fuel pump’s retaining claws. If the new pump does not fully seat and lock into position, make sure the old o-ring (A) is not still in the bore as shown above. See **Appendix A** starting on pg. 57 for more information and a video on this **CRITICAL** step.

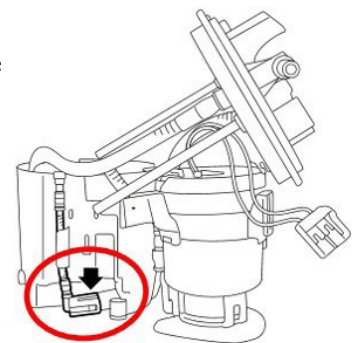
- Replace all 3 rubber cushions (feet) on the bottom of the fuel chamber, replacements are included in the kit. Failure to replace these may result in a later noise complaint.
- **CAREFULLY** refit the tube assembly back into the fuel chamber until it clicks into position.
- Refit the tube back on to the bottom side of the fuel chamber.

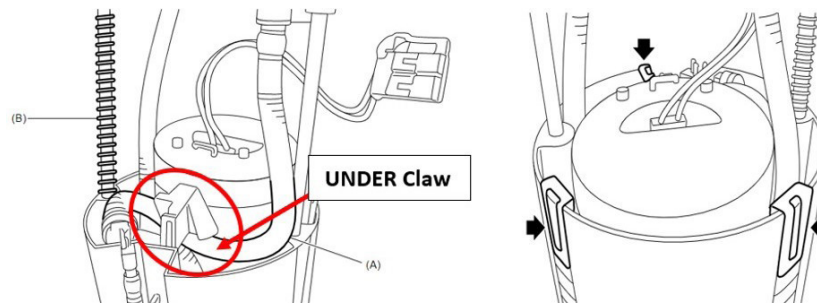
- Refit the spring **(B)** to the rod with the snap ring groove then re-install the pump / filter assembly into the fuel chamber. **IMPORTANT:** Confirm tube **(A)** is routed **UNDER** the retaining claw then lock all 3 claws in place.

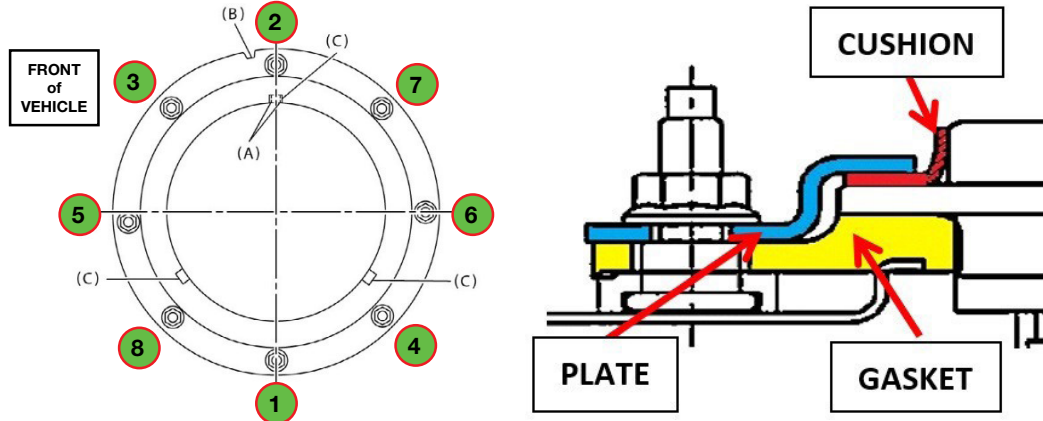
- **CRITICAL:** Lightly hand tighten all nuts in the sequence shown below. Complete tightening of the 8 retaining nuts to the specified torque: **4.4 Nm, (3.2 ft. lbs. or 38 inch- pounds)** following the sequence shown below. **NEVER** use air or electric powered tools to tighten these nuts as the studs may be damaged.

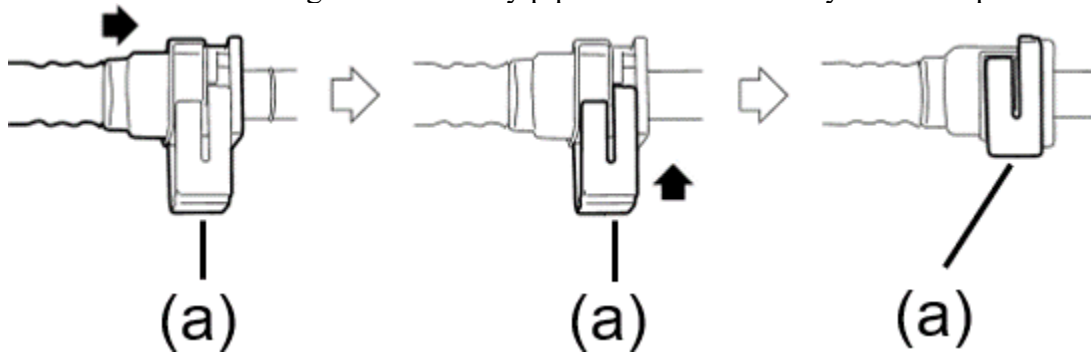
- Remove and discard the plastic temporary plug from the fuel delivery pipe and re-connect the pipe to the fuel pump outlet tube. Make sure the connector is all the way onto the outlet tube then lock the slider. Tug on the delivery pipe to be sure it is fully locked in place.

IMPORTANT REMINDERS: Discard the plastic fuel line plug as it is a one-time use item. Reusing the plug may damage the connector's internal o-ring and cause a fuel leak.

- Ensure both the pipe and tube are clean and dry
- If the slider does not move easily, confirm the pipe is engaged on the tube
- **ALWAYS** confirm the pipe is fully engaged after connecting and check for any leaks

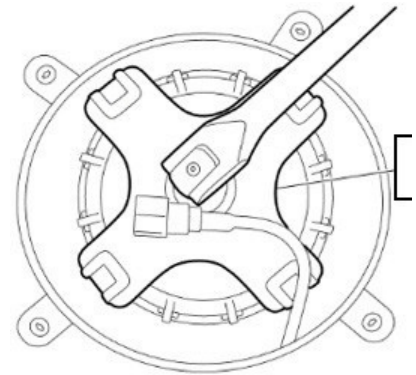
- Once the fuel pump assembly has been removed, install the applicable plastic plug tool into the fuel tank opening to prevent contamination from entering the tank and fuel vapors from accumulating in the vehicle interior. If the plug is not available, cover the opening with a clean shop cloth. The plug is not required when replacing the complete fuel pump assembly due to the very short time the tank will be open for that repair.

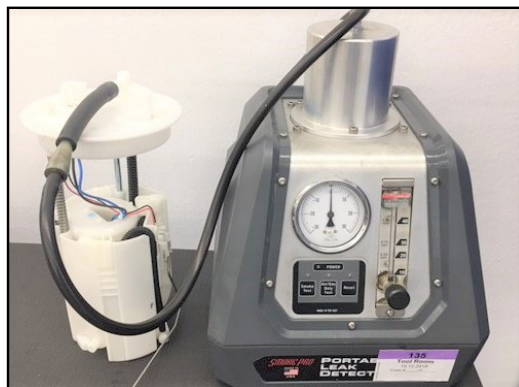
- Leak test the fuel pump assembly to confirm there are no leaks PRIOR TO reinstalling the assembly into the fuel tank. Using the Redline Smoke Pro, apply approximately **0.45PSI (3.1Kpa)** to the pump assembly as shown. Confirm the applied pressure can be held for **10 seconds**. If the pressure can be held, continue with installation. If pressure cannot be held, check the jet pump seating and o-ring condition. If the pump does not pass the leak test and disassembly is required, it is **IMPORTANT** to never reuse the one-time use o-ring.

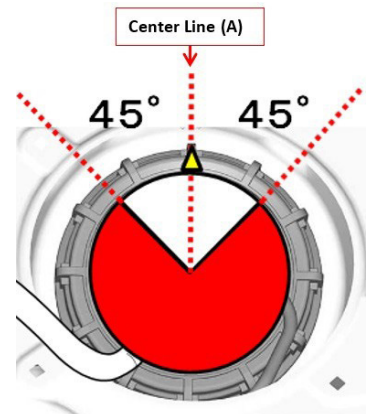
11. **CAUTION: SLOWLY** tighten the new ring nut to **130 Nm (96 ft. lbs.)** while paying close attention to make sure the fuel pump does not rotate along with the ring nut. If the pump were to turn more than 45 degrees, the fuel level sensor will likely be damaged. When properly tightened, the index mark on the ring nut Δ should align with the fuel pump indexing arrow Δ (Center Line (A)).

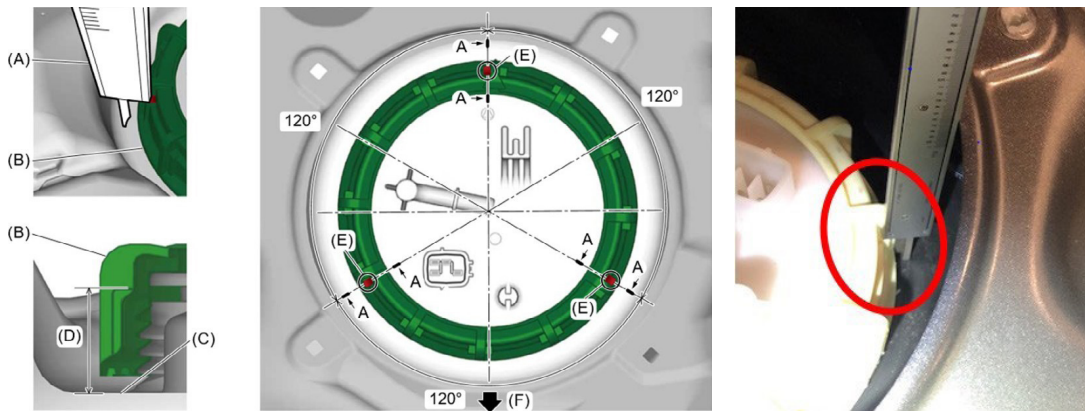
12. **CRITICAL:** Using a caliper with depth gauge, measure the dimension in 3 positions between the top of the ring nut and the top of fuel tank as shown in the illustration and photo (inset) below. The difference between the three measurements cannot exceed $\pm 1.5\text{mm}$ or $.060$ inch.

- If the difference between any of the three measurements exceeds $\pm 1.5\text{mm}$ or $.060$ inch, loosen and re-tighten the ring nut to correct any cross-threading.
- If the ring nut or fuel pump gasket are deformed, cracked or damaged, they **MUST** be replaced.

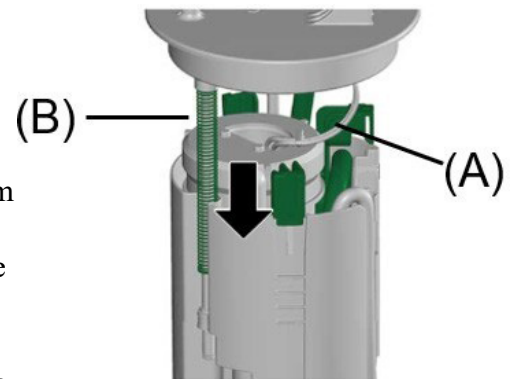
9. Install the fuel filter assembly to the fuel chamber assembly. Position tube (A) and spring (B) for the fuel filter assembly as shown in the figure.
 - Confirm the fuel tube routing and make sure all the claws securing the fuel chamber to the fuel filter assembly are fully engaged as shown in the photos shown below.

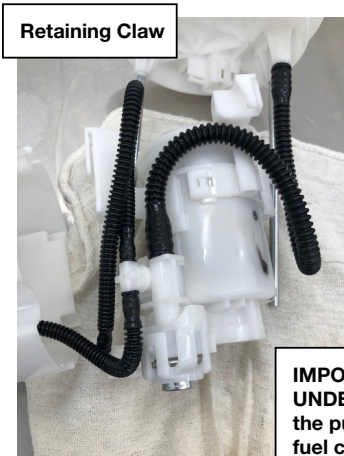
IMPORTANT: Confirm this fuel hose runs **UNDER** the retaining claw when installing the pump / filter assembly back into the fuel chamber as shown here.

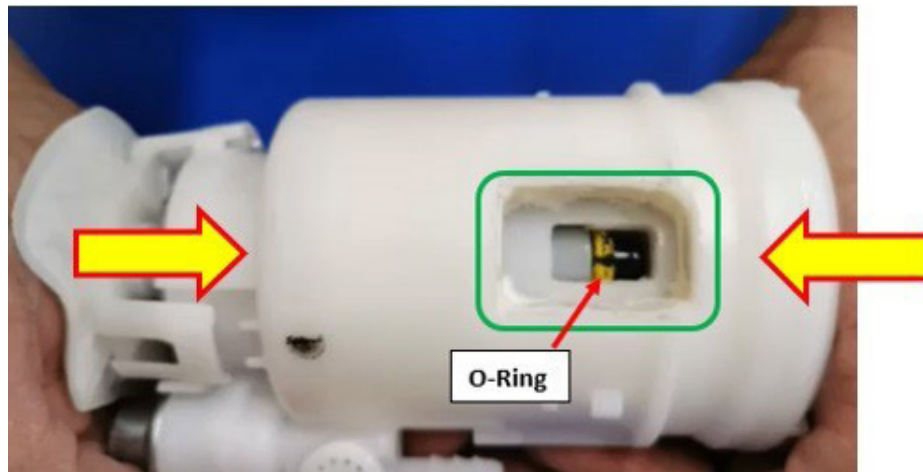
The images below are snapshots from a video which shows how the o-ring can become compromised when repeated attempts are made to press / force the new fuel pump back into the filter housing. A small “window” was cut into the filter housing used here to visually demonstrate how when repeated attempts are made to get the new pump to engage the retaining claws of the original filter housing, the o-ring can become dislodged from the fuel pump outlet tube and damaged. The new o-ring shown below has been colored YELLOW to make it easier to see.

CRITICAL TIP: Align and press the new fuel pump **FIRMLY, SQUARELY** and **STRAIGHT** into the filter housing in ONE smooth, continuous motion.
