Dealer Service Instructions for:

# **Safety Recall S09 / NHTSA 16V-114 Occupant Classification Module**

**2015 (UF) Chrysler 200**

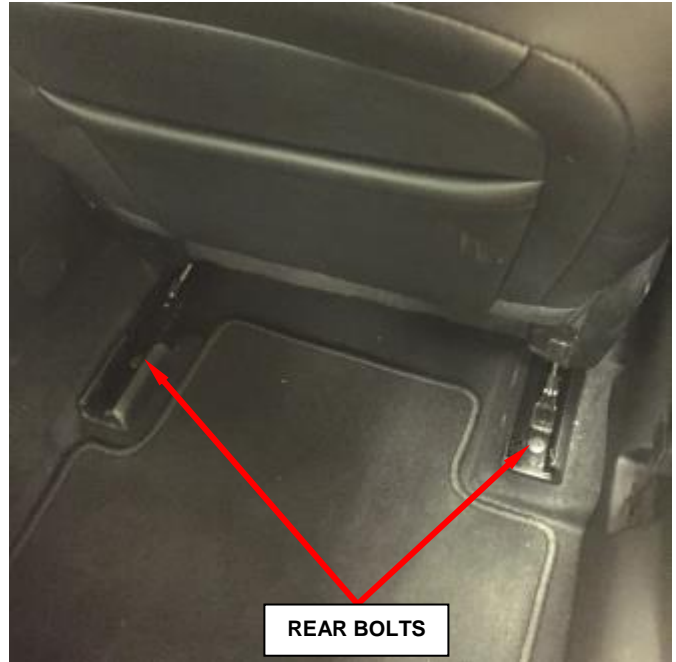
**Figure 1 – Seat Rear Bolts**

b. Remove the passenger front seat rear bolts (Figure 1).

72. Move the passenger front seat to the full forward position.
73. **Install the driver and passenger seat rear bolts and tighten to 44 ft. lbs. (60 N·m) (Figure 1).**

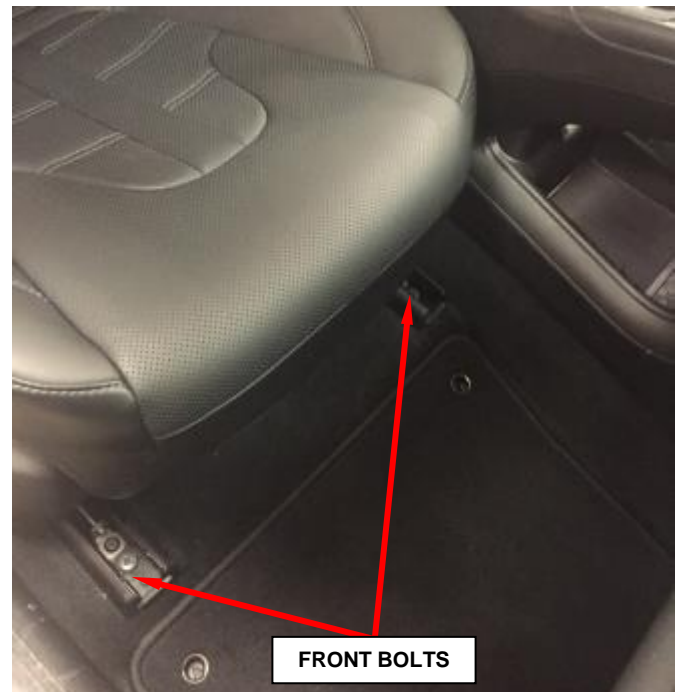
**Figure 2 – Seat Front Bolts**

d. Remove the passenger front seat front bolts (Figure 2).

59. Connect all the passenger seat electrical connectors to the body wire harness.
60. Install the passenger seat front bolts and tighten to 44 ft. lbs. (60 N·m) (Figure 2).

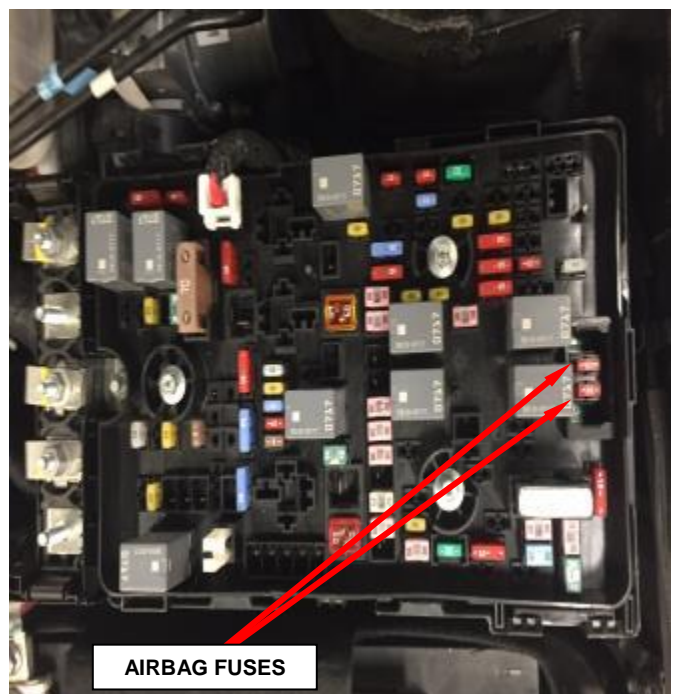
**Figure 3 – Airbag Fuses**

- e. Repeat steps a through d to remove the driver front seat, **if the CSWM requires replacement.**
- f. Disconnect and isolate the negative battery cable. If equipped with an Intelligent Battery Sensor (IBS), disconnect the IBS connector first before disconnecting the negative battery cable. Wait two minutes for the system capacitor to discharge before further service.
- g. Remove airbag fuses F96 and F97 from the power distribution center (Figure 3).

65. Check to be certain that nobody is in the vehicle then turn the ignition switch to the “ON” position and exit the vehicle and close the doors.
66. Install the airbag fuses in the power distribution center (Figure 3).

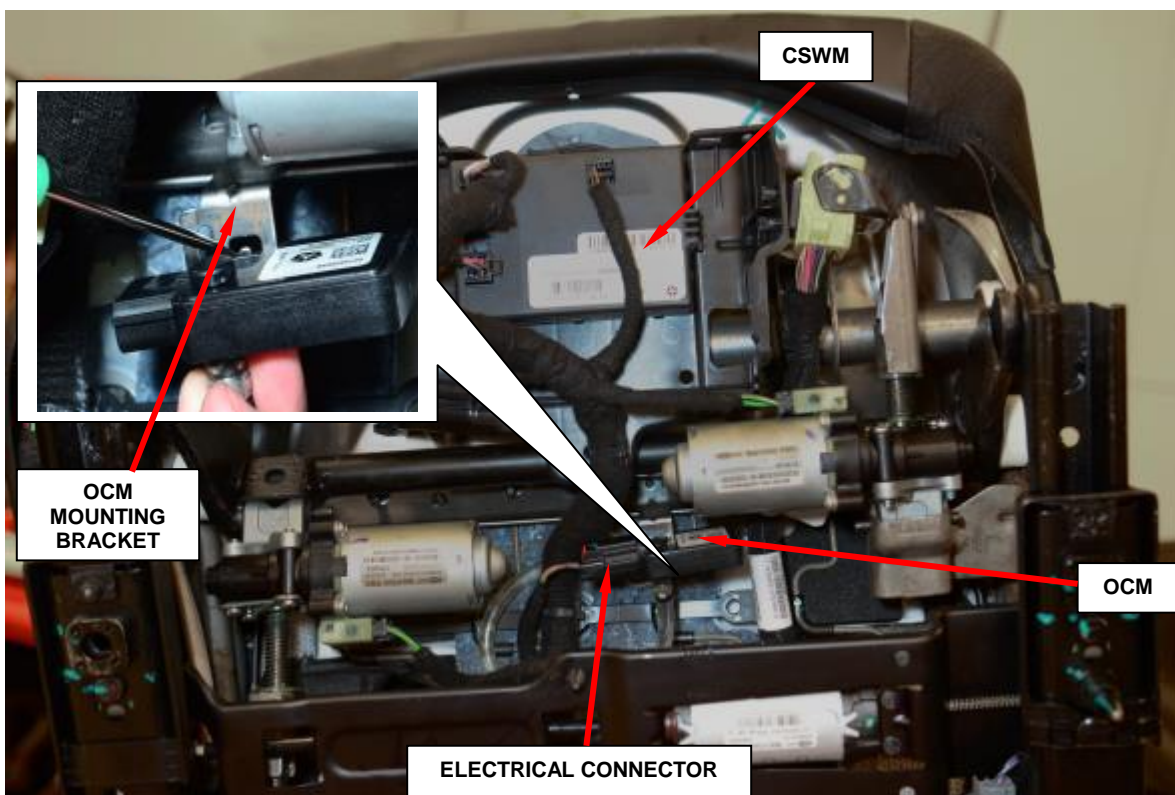
**Figure 4 – Occupant Classification Module (OCM)**

- In Section A., if the CSWM part number ended in “AE” the **CSWM does not need replacement**, continue with **Step 2**.
  - In Section A., if the CSWM part number ended in “AD” or older, **replace the CSWM** and continue with **Step 2** (Figure 4).
  - **If the vehicle is not equipped with a CSWM, continue with Step 2.**
2. Disconnect the wire harness electrical connector from the Occupant Classification Module (OCM) beneath the inboard front corner of the passenger seat cushion pan (Figure 4).
  3. Using a small flat-bladed screwdriver or a small pick tool, carefully pry the latch tab integral to the OCM mount to release it from the blade of the mounting bracket beneath the inboard front corner of the passenger seat cushion (Figure 4).

28. Install the two push-in plastic fasteners that secure the OCM assembly to the passenger seat cushion pan (Figure 13).
29. Route the pressure hose away from sharp or moving objects and be certain the hose is not kinked (Figure 4).

30. From the underside of the passenger seat cushion, snap the OCM onto the blade of the mounting bracket beneath the inboard front corner of the seat cushion (Figure 4).

31. Connect the OCM electrical connector (Figure 4).
32. Remove the label from the **NEW** seat cushion foam.
33. **If equipped with a ventilated seat**, remove the adhesive backing strips from the **NEW** seat ventilation mat.

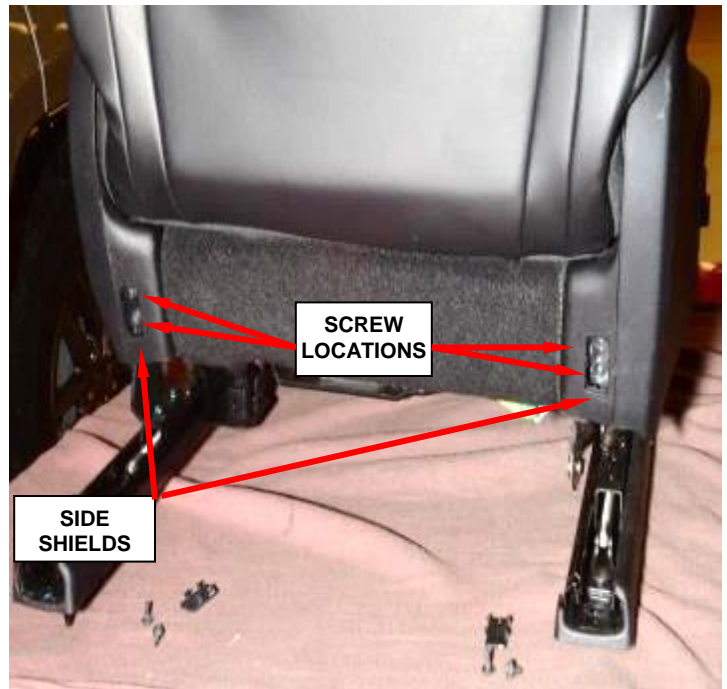
**Figure 5 – Rear Screw Locations**

4. Using a small flat bladed tool or equivalent, remove the lift handle trim cap, if equipped.
5. Remove the screws and the lift handle, if equipped.
6. Using a small hook tool or equivalent, remove the clip and the recliner handle, if equipped.
7. Remove the screw covers and the two screws at the back of the inboard and outboard side shields (Figure 5).
8. Remove the screw securing the inboard side shield (Figure 6).
9. Release the seat belt clip from the inboard passenger seat shield (Figure 6).
10. Pull out at the bottom to release the retaining clips then remove and save the inboard side shield.
11. Lift up at the rear of the outboard side shield slightly to release the retaining hook.
12. Push forward on the outboard side shield and remove from the retaining hook.

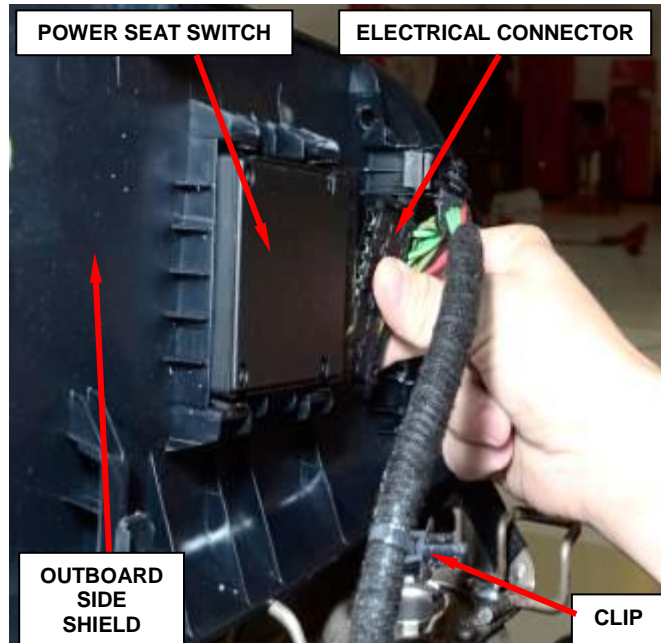
**Figure 7 – Electrical Connector**

13. Disconnect the electrical connector from the outboard side shield, if equipped (Figure 7).
14. Release the power seat harness clip from the outboard side shield, if equipped (Figure 7).
15. Remove and save the outboard side shield.

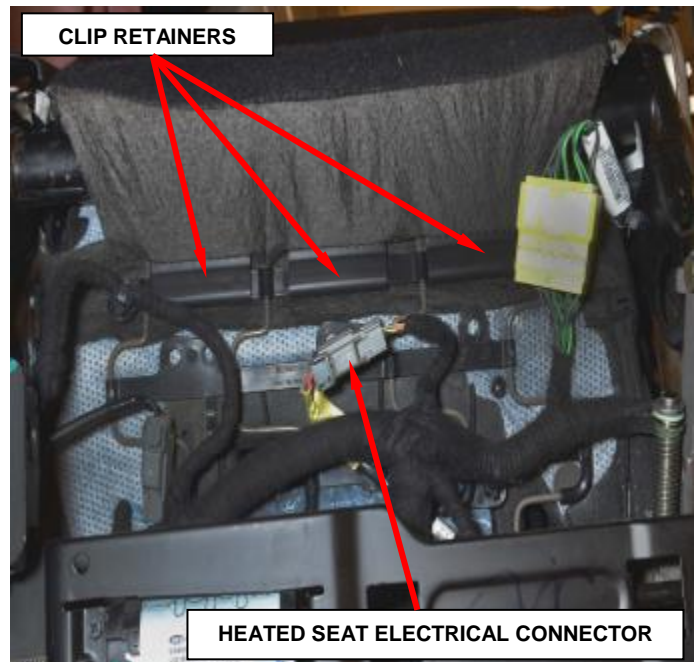
**Figure 8 - Rear Clip Retainers**

16. Release the three clip retainers at the rear of the passenger seat cushion (Figure 8).
17. Disconnect the heated seat electrical connector (Figure 8).
18. Release the heated seat harness retaining clip.

50. Secure the clip retainers at the rear of the passenger seat cushion (Figure 8).
51. Install four edge biter clips to the front outside clip retainers as shown (Figure 20).

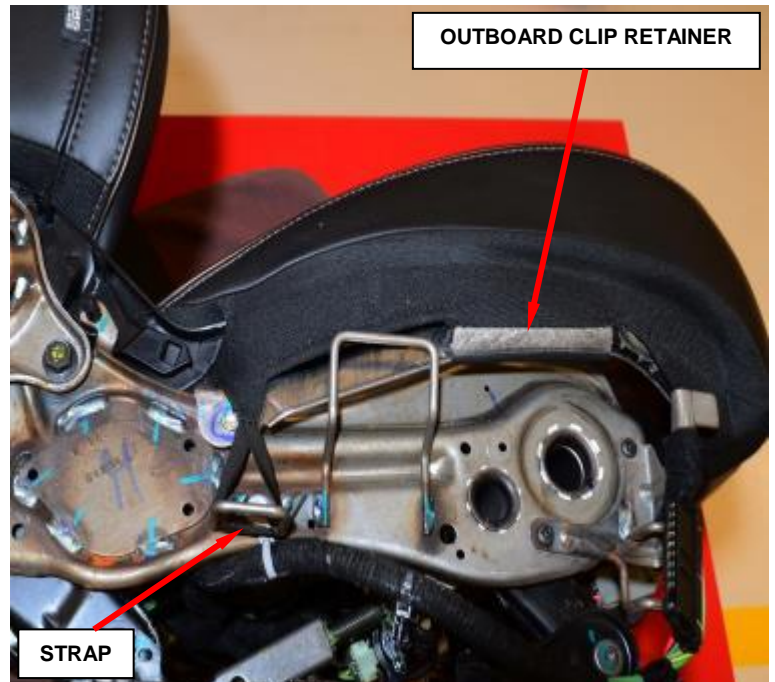
**Figure 9 – Side Clip Retainers  
(Outboard Side Shown)**

19. Release both side clip retainers and the strap (Figure 9).

52. Secure the three clip retainers at the front of the passenger seat cushion (Figure 10).
53. Secure the strap and both side clip retainers (Figure 9).
54. Connect the electrical connector to the outboard side shield, if equipped (Figure 7).
55. Connect the power seat harness retaining clip to the outboard side shield, if equipped (Figure 7).
56. Install the passenger seat side shields.
57. Install the lift handle and recliner handle, if equipped.
58. Position the passenger front seat into the vehicle.

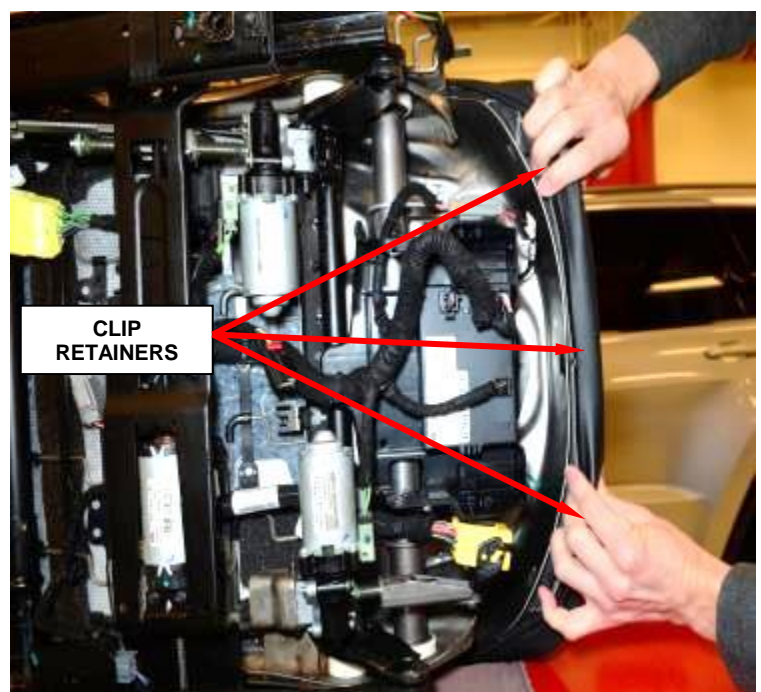
**Figure 10 – Front Clip Retainers**

20. Release the three clip retainers at the front of the seat cushion (Figure 10).

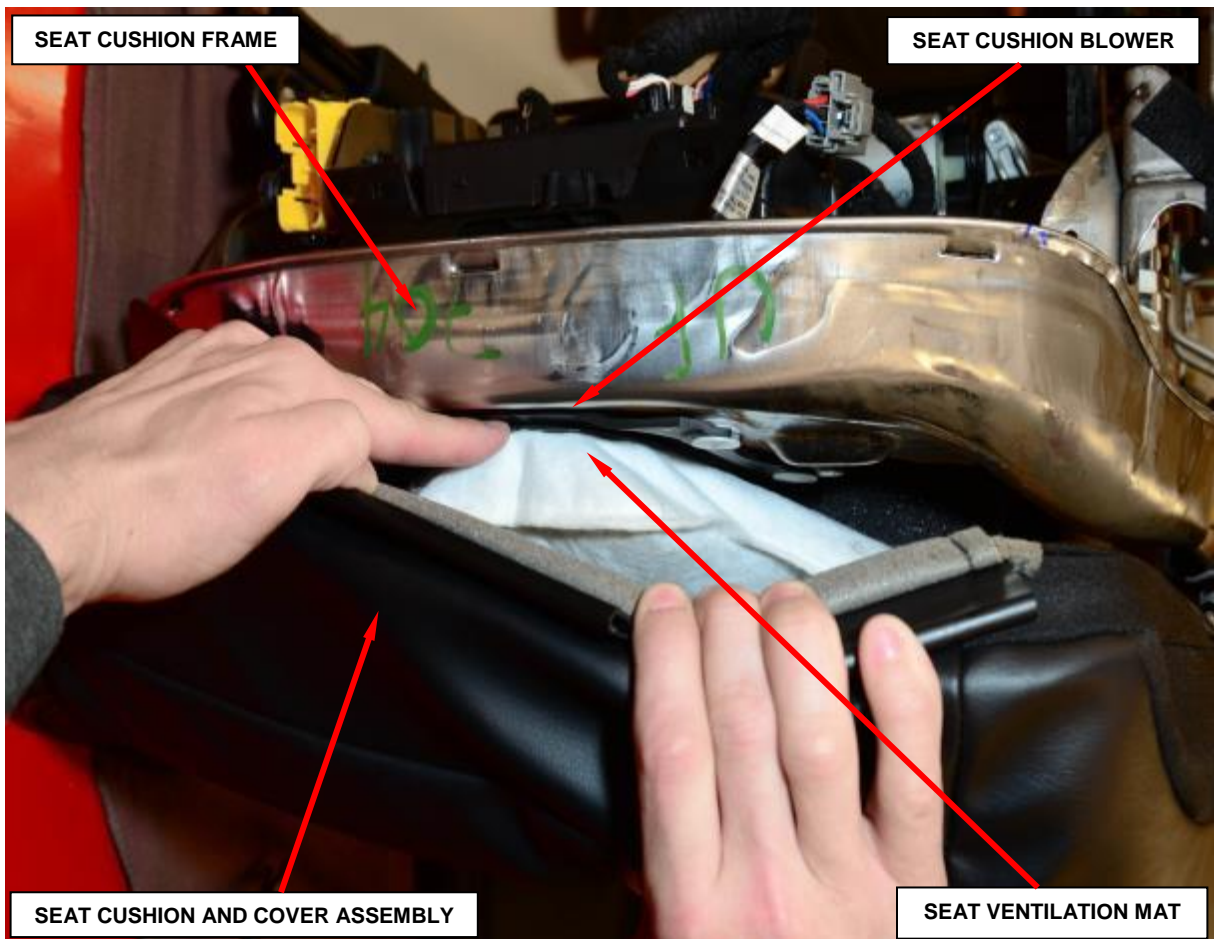
Figure 11 – Seat Cushion Ventilation Mat

21. **If equipped with a ventilated seat**, carefully unwrap the cover and foam at the front of the passenger seat cushion. Using a suitable tool, pry the seat cushion ventilation mat from the seat cushion blower (Figure 11).

46. Position the passenger seat cushion assembly onto the seat cushion frame.
47. **If equipped**, route the heated seat wire harness pigtail and clip to the seat frame bracket.
48. Connect the heated seat electrical connector (Figure 8).
49. **If equipped**, align the seat cushion ventilation mat with the tabs on the seat cushion blower and snap into place, if equipped (Figure 11).

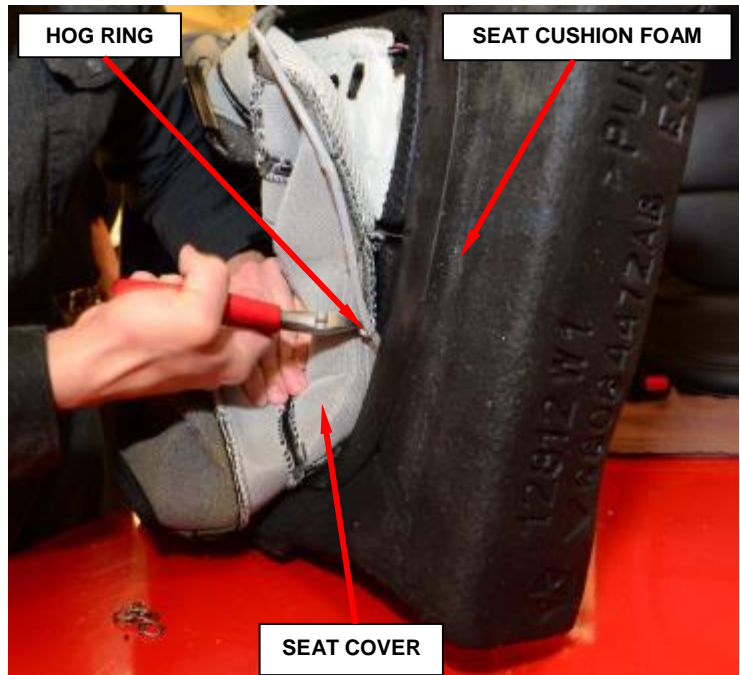
Figure 12 – Hog Rings

23. Cut and remove the hog rings that secure the passenger seat cover to the seat cushion foam, and remove the seat cover (Figure 12).

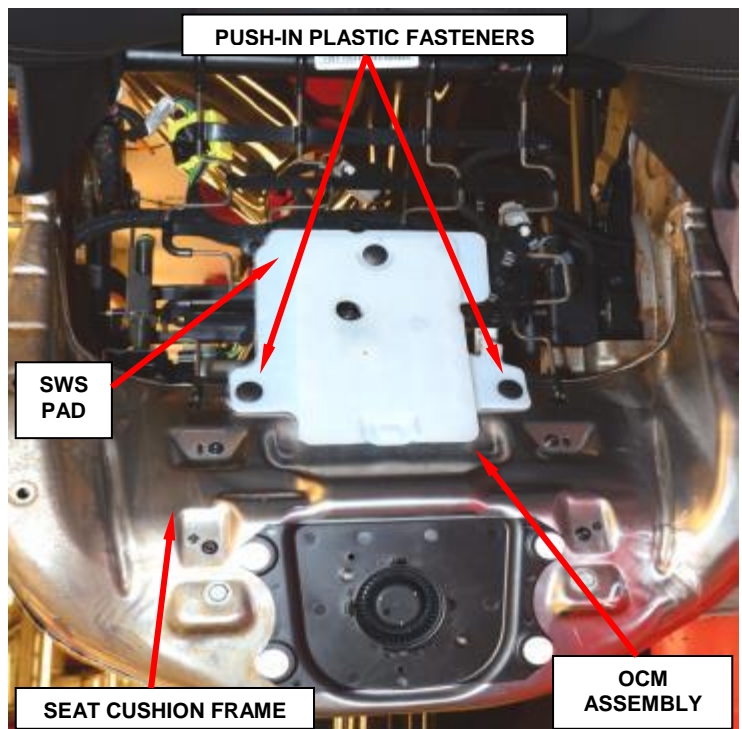
Figure 13 – OCM Assembly

25. Release the two push-in plastic fasteners that secure the Occupant Classification Module (OCM) assembly to the passenger seat cushion frame (Figure 13).

27. Position the **NEW** Occupant Classification Module (OCM) assembly to the top of the passenger seat cushion frame as a unit. Lift the back of the SWS and pad far enough to access and insert the OCM and pressure hose between the seat cushion springs to the underside of the seat cushion frame. Be certain the pressure hose is not pinched or kinked (Figure 13).

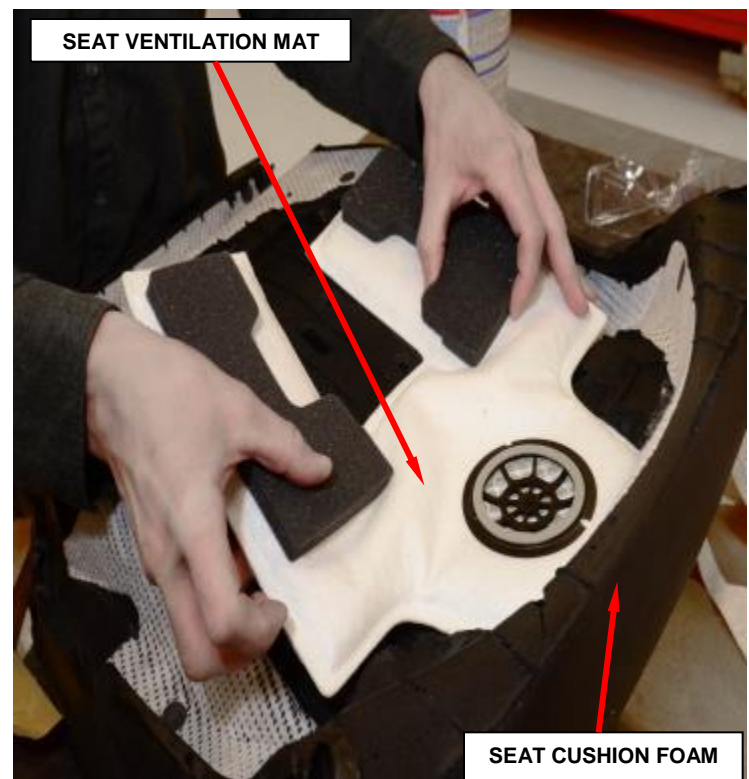
**Figure 14 – Seat Ventilation Mat**

34. Position the passenger seat ventilation mat to the bottom of the seat cushion foam and press the seat ventilation mat into place (Figure 14).

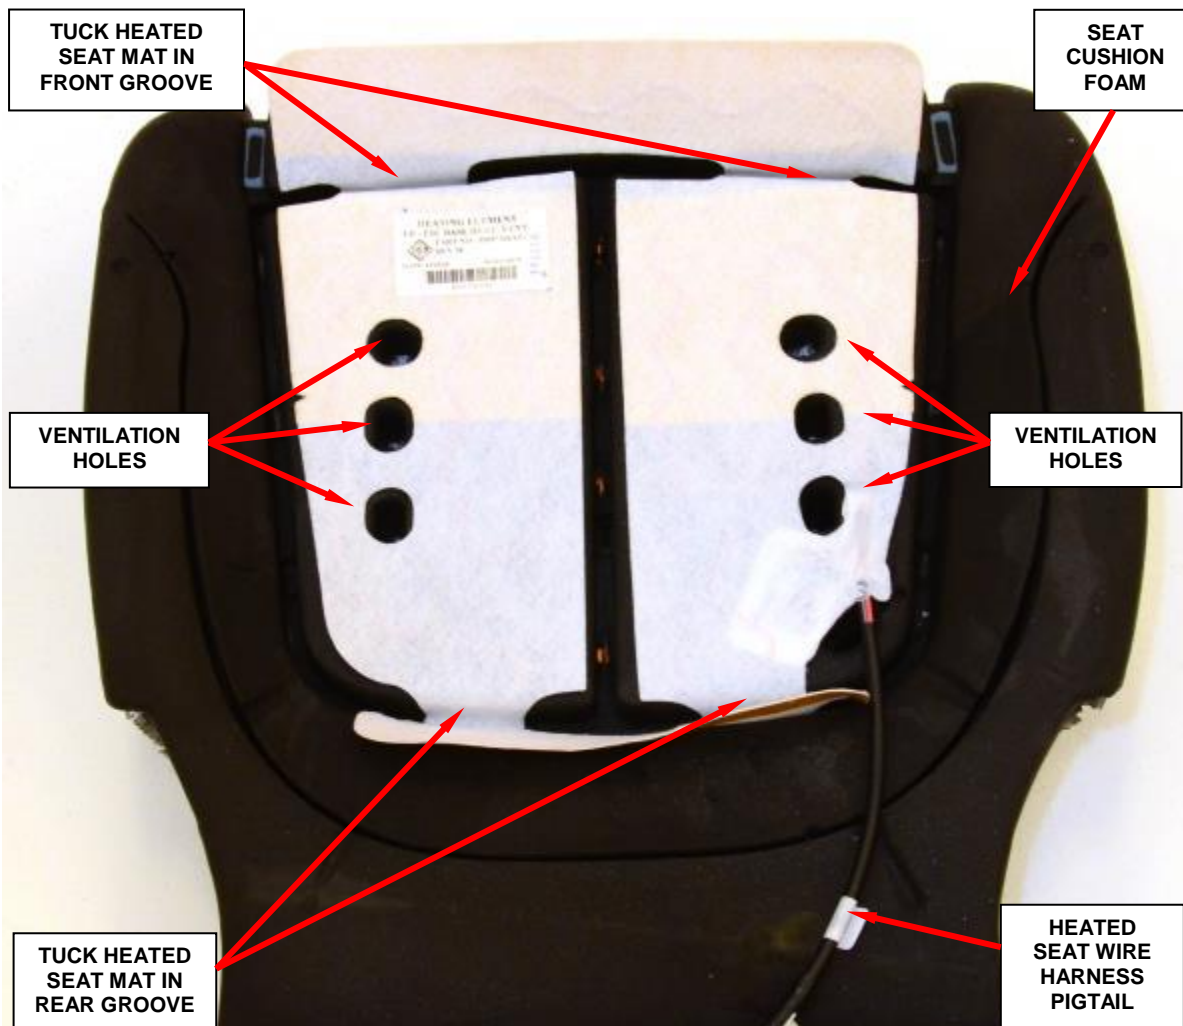
Figure 15 – Heated Seat Mat

35. **If equipped with a heated seat**, remove the right and left side adhesive backing strips from the **NEW** heated passenger seat mat and position the mat to the ventilation holes on the top side of the seat cushion foam. Press firmly to secure the heated seat mat to the seat cushion foam (Figure 15).
36. Tuck the front of the passenger heated seat mat into the groove of the seat cushion as shown (Figure 15).
37. Remove the front side adhesive backing strips from the heated seat mat. Press firmly to secure the passenger heated seat mat to the seat cushion foam (Figure 15).
38. Tuck the rear of the passenger heated seat mat into the groove of the seat cushion as shown (Figure 15).

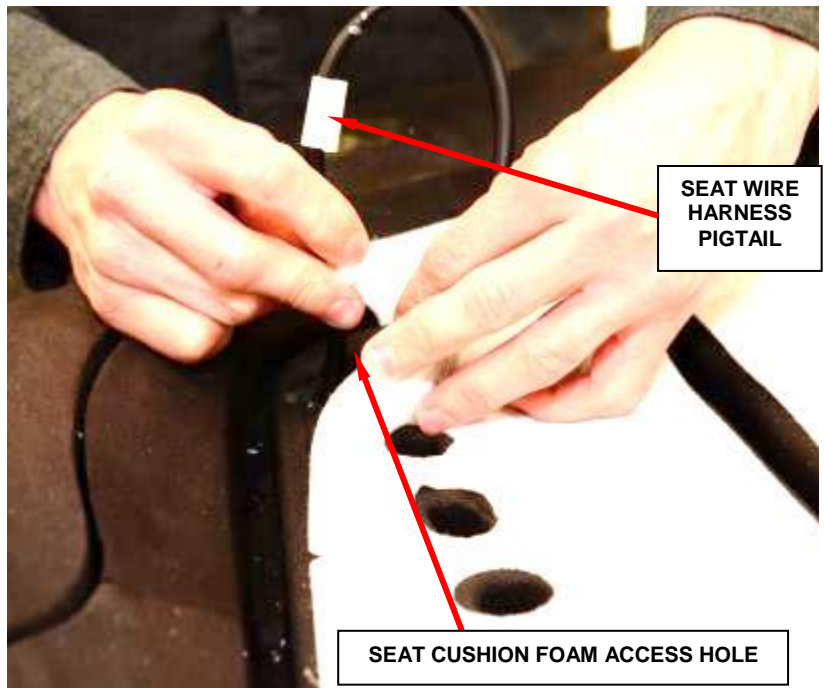
**Figure 16 – Heated Seat Wire Harness Pigtail**

40. Route the heated seat wire harness pigtail through the seat cushion foam (Figure 16).

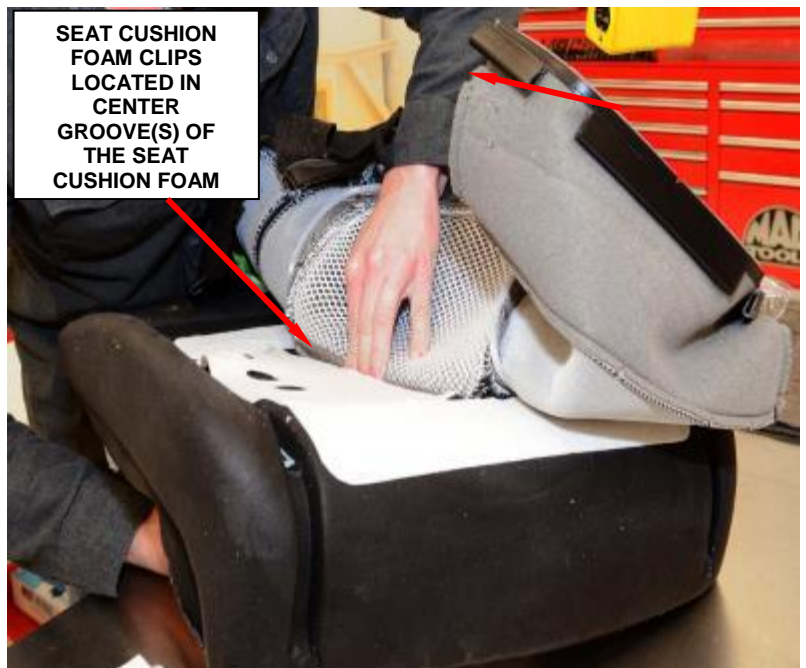
**Figure 17 – Seat Cover Clips**

41. Position the passenger seat cover onto the seat cushion foam and engage the center seat cover clips by snapping them into the seat cushion foam clips (Figure 17).

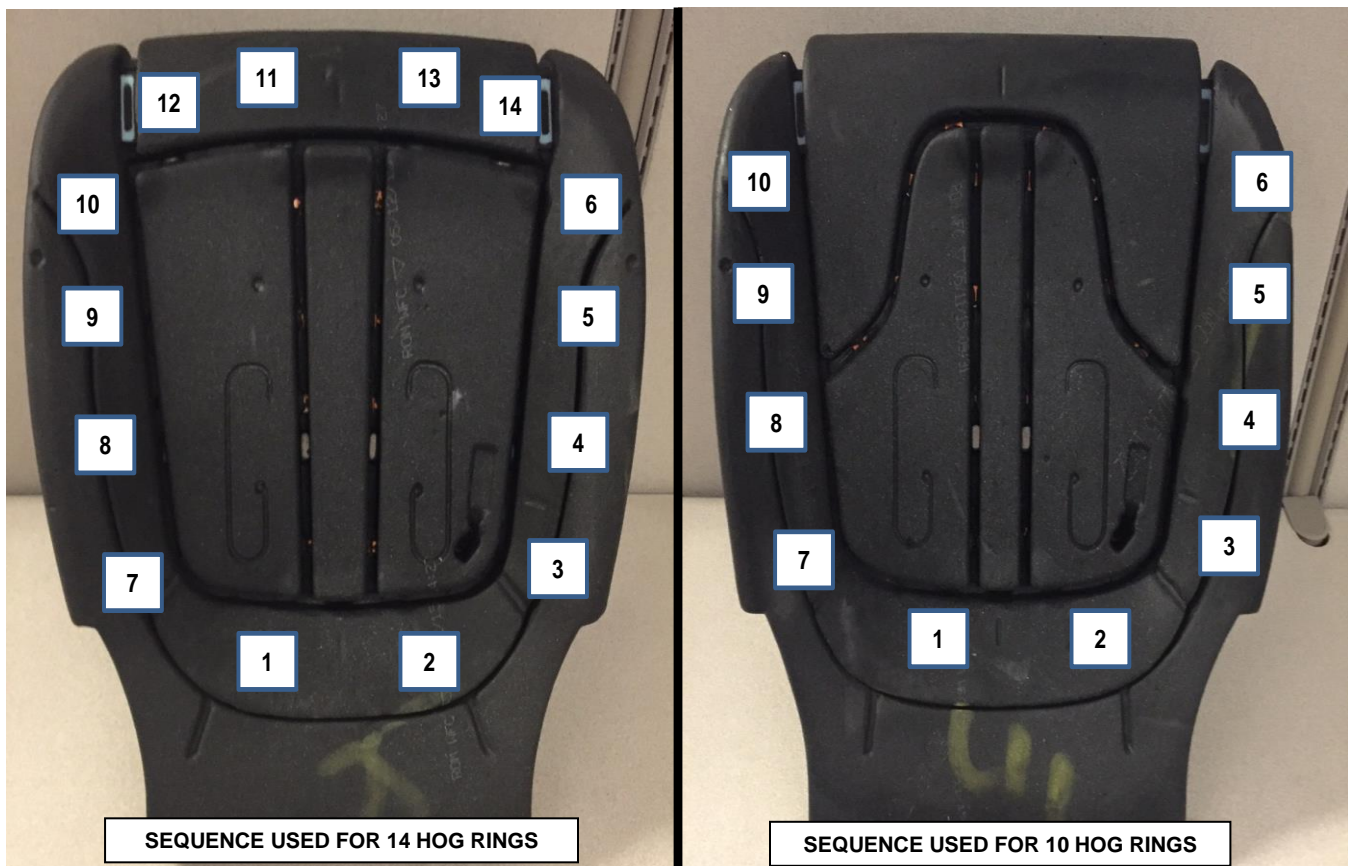
**Figure 18 – Hog Ring Installation Sequence**

**NOTE:** Refer to the hog ring sequence diagram for correct installation sequence. Seat covers may require either ten or fourteen hog rings depending on trim sales code (Figure 18).

42. Secure the passenger seat cover to the seat cushion foam using **NEW** hog rings following the correct hog ring sequence (Figure 18).

**CAUTION:** Verify that no hog rings have punctured or damaged the heated seat mat.

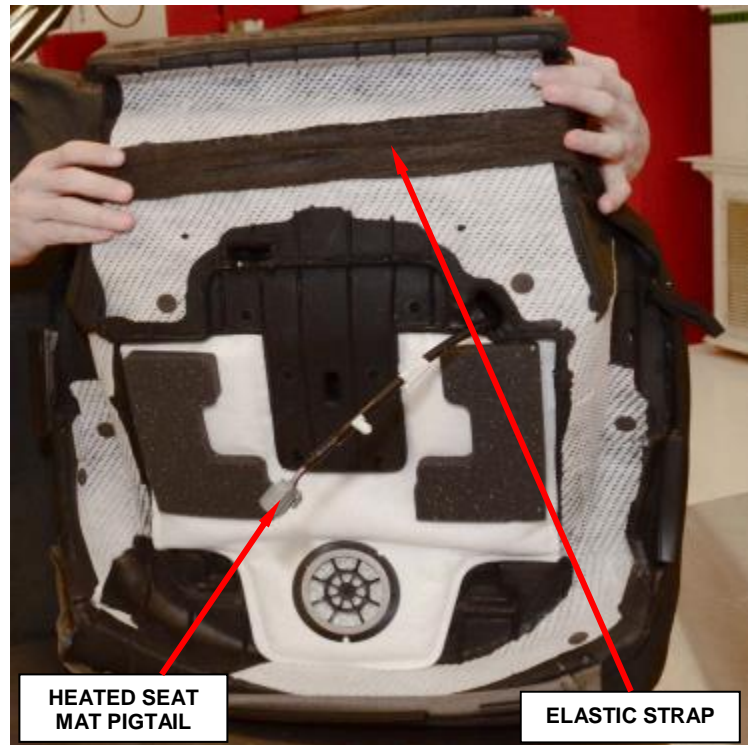
**Figure 19 – Elastic Strap**

43. Roll the passenger seat cover over the seat foam starting at the right front corner and right side of the seat cushion foam.
44. Roll the passenger seat cover over the seat foam at the left front corner and left side of the seat cushion foam.
45. At the rear side of the cushion stretch the elastic strap over the seat cushion foam laying the strap flat on the back side of the foam (Figure 19).

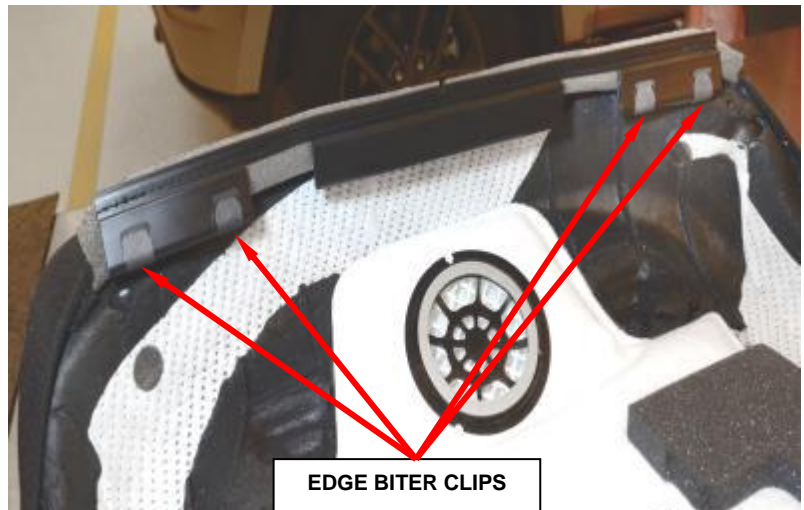
**Figure 20 – Edge Biter Clips**

**NOTE: Edge biter clips may have been installed at the factory and will not require replacement if they are in the position shown in Figure 20.**
