SAFETY RECALL NOTICE

IMPORTANT SAFETY RECALL RVXX1509 NHTSA RECALL # 15V-651

Inspection and Replacement Criteria for Drag Links

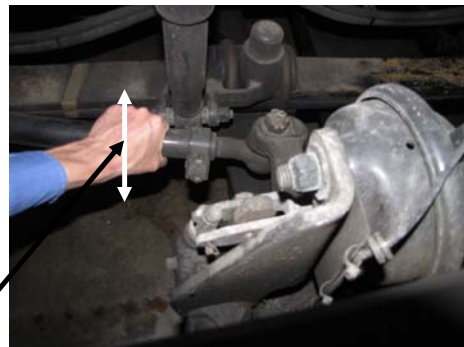
At the steering arm end (i.e., the adjustable end), **push down and pull up** on the drag link in a direction toward the ground by reaching over the driver's side front tire. **Any movement requires placing the vehicle out of service for immediate replacement of the ball socket.**

The adjustable end is the rearmost end and is to be checked by pushing down and pulling up on the drag link.
