June 14, 2016

04134 Version 2

## Safety Recall: Front Passenger's Airbag Inflator Can Be Over-Pressurized (Phase 1)

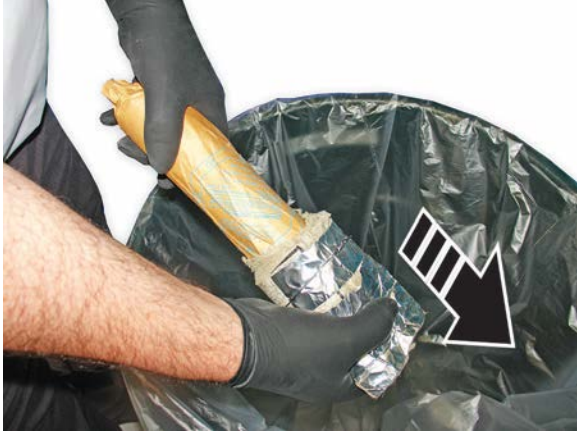
- Hold the paper wrapping the inflator with one hand and slide the insulation off into the trash.  
NOTE: The insulation is securely wrapped around the inflator. You may have to use some force to slide the insulation off. Do not cut the insulation and be careful that you do not move the white or orange plastic ends.

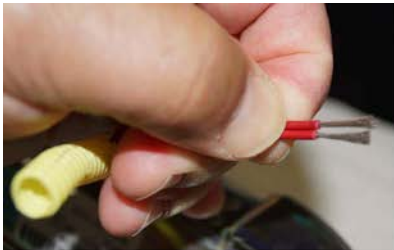
- Strip away about 1 inch of the wire insulation, then twist the wires together.

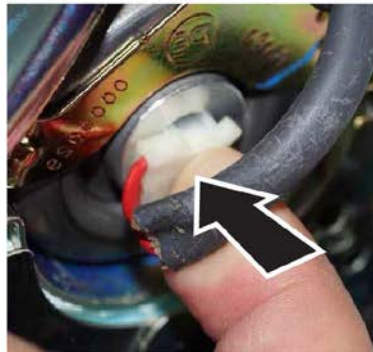
② Press the connector into place until it clicks.
