RECALL 17V-047: DRIVER'S FRONT AIR BAG MODULE – PRIOR PARTS REPLACEMENT

This Service Information bulletin replaces SI B65 02 17 **dated January 2017**

RE: Recall 17V-047: Driver's Front Air Bag Module B65 02 17

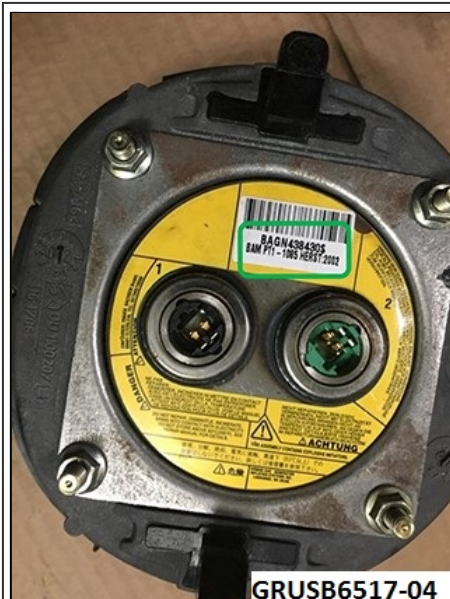
1. Remove the driver's air bag in accordance with repair instructions REP 32 34 020 "Removing and installing/replacing air bag units".
2. Check the label on the back of the driver's air bag.

Is the label yellow with the number BAM XXX - 1085 (as shown below) printed below the bar code?

YES- replace air bag following attached procedure.

NO - the driver's air bag is not affected. Reinstall the driver's air bag.

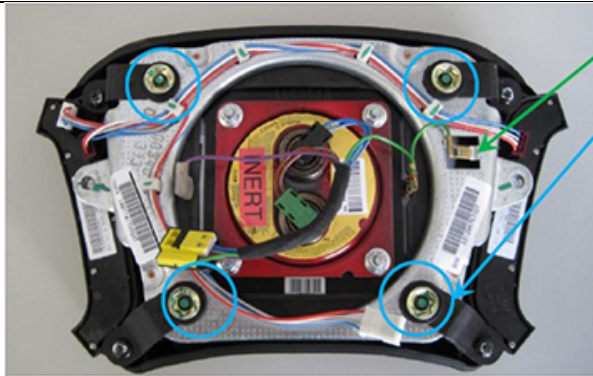
On vehicles with a basic steering wheel, the horn ring must be removed from the new part. To do so, proceed as follows:

<p>1. Remove horn ring.</p> <ul style="list-style-type: none">• Unplug the connector for the grounding cable (see the green arrow in the figure)• Remove the nuts (see the blue mark in the figure, Torx 55).

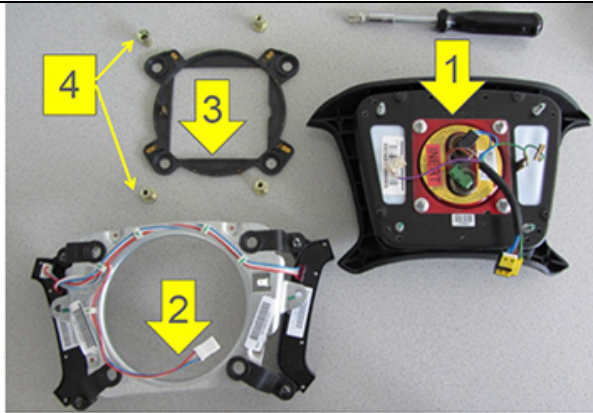
<ul style="list-style-type: none">• Take off the horn ring, making sure that the springs remain in place.• Remove the horn contact plate.• Separate components after disassembly:<ul style="list-style-type: none">1 - Air bag module2 - Horn ring3 - Horn contact plate4 - Torx nuts

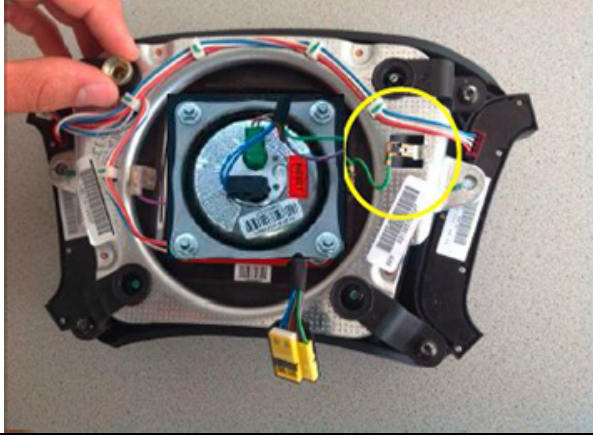
<p>5. Plug in the connector for the grounding cable and secure the horn ring with the four Torx nuts.</p> <p>Tightening torque: 5.0 +/- 0.2 Nm.</p>

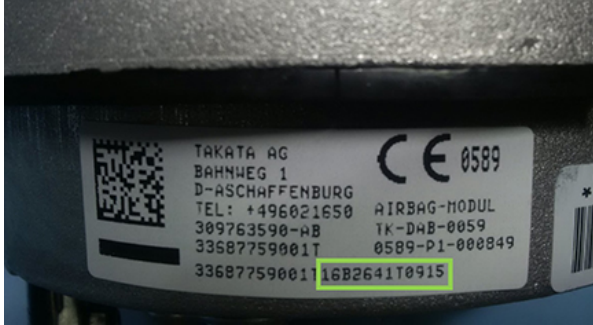
<p>6. Check the horn function at all four corners.</p> <p>7. Document the serial number: For reimbursement under warranty, the serial number for the new driver's air bag module (see marking in the following figure) must be noted on the workshop order and on the warranty application. If the serial number is missing, the warranty application is rejected.</p>

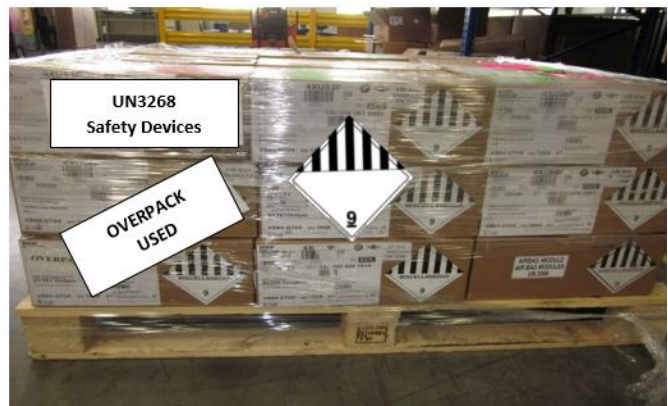
Securely attach the following labels on each side of the shrink-wrapped pallet.

- o Class 9 Label
- o UN3268 Safety Device *
- o OVERPACK USED *
