**NUMBER:** 08-036-15

Front Door Speaker, Audio Distortion or Inoperative

2014 (VF) Ram Pro Master

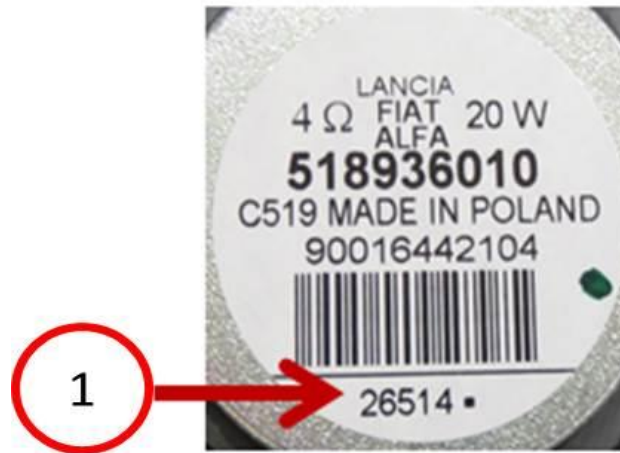
**Fig. 1 Speaker Julian Date**

1. Remove the lower door speakers, following procedure in TechConnect > 08 - Electrical/8A - Audio/Video/Entertainment/Connectivity/SPEAKER/Removal .
2. Check the Julian date on the speakers.

1 - Example: 26514, 265th Day Of The Year / 14 = 2014, September 23, 2014

- 
3. Is the Julian date on or before 19614 (July 18, 2014)?
    - a. Yes >>> Proceed to [Step #4](#)
    - b. No >>> This bulletin does not pertain. Perform normal diagnostics and reinstall the original speakers. Follow procedure in TechConnect > 08 - Electrical/8A - Audio/Video/Entertainment/Connectivity/SPEAKER/Installation.

4. Replace **both** front speakers, follow the procedure in TechConnect > 08 - Electrical/8A - Audio/Video/Entertainment/Connectivity/SPEAKER/Installation.
5. Using a Scan Tool (wiTECH) to clear any DTCs that may have been set.
