To All Lamborghini Dealers and Licensed Service Points
From Customer Service Department
Subject Service Campaign - Gallardo rear fender side air intakes sealing
Group 140.8.21
Date 19.09.2005
Pages 7

Gallardo rear fender side air intakes sealing

Gallardo models until VIN 2785

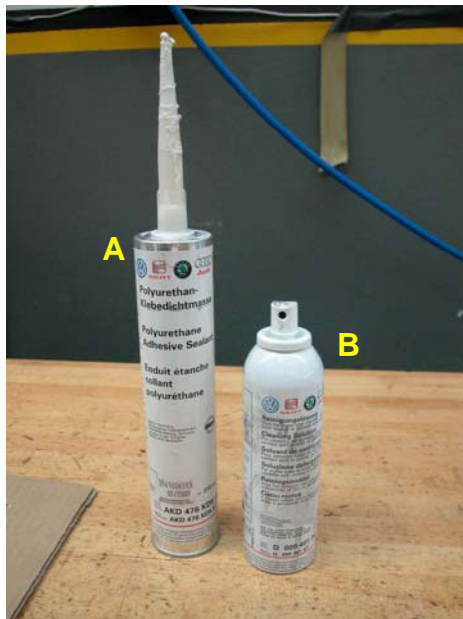
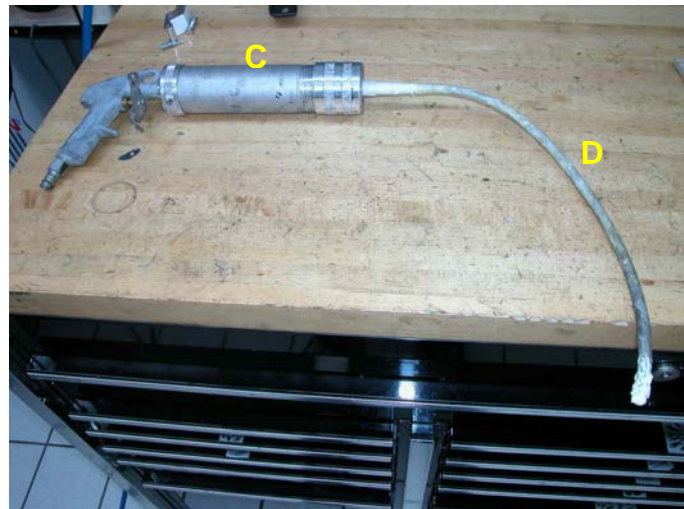
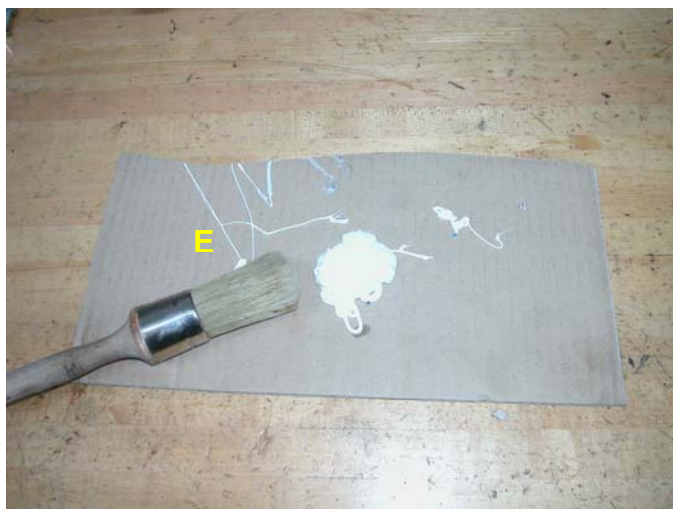
Necessary material

- Polyurethane adhesive sealant (A) (half a cartridge each car), available at the Lamborghini warehouse - p.n. 900000125.
- Cleaning degreasing solution (use a commercial product)
- Gun applicator for the adhesive sealant (C).
- A rubber pipe extension (about 60 cm length) (D) or a paintbrush (E) for sealant application.

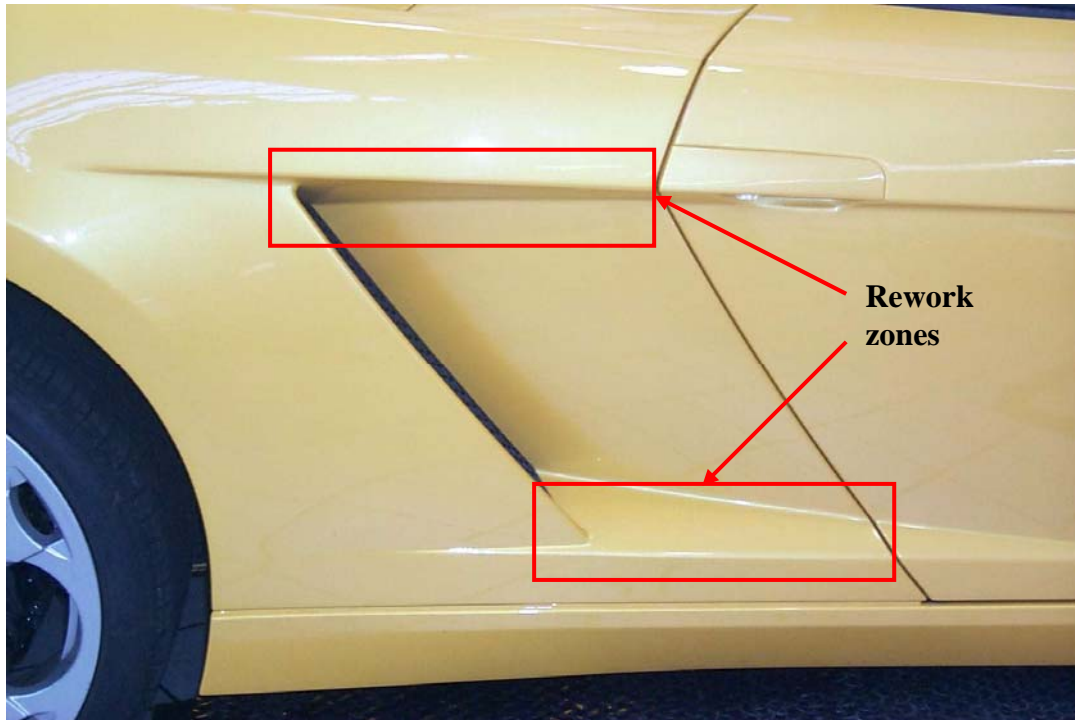
Right side

- 1.3 Remove the rear wheels of the vehicle
- 1.4 Remove the front part of the rock panels of the rear wheelhouses (pictures below)

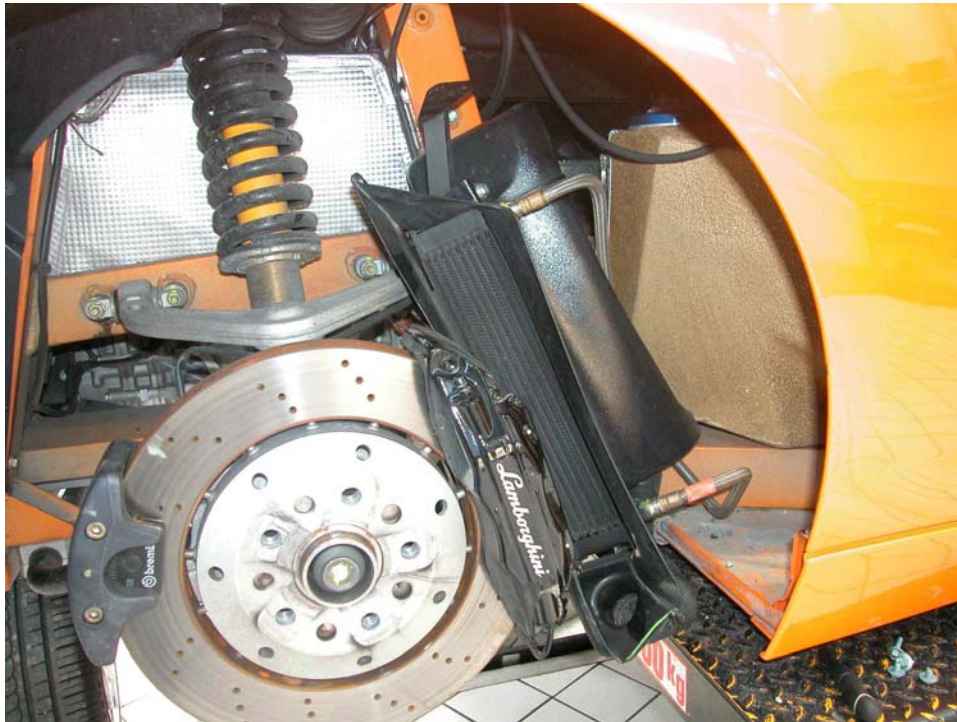
Right wheel

- 1.5 Remove the oil radiator brackets (without removing the radiator pipes) and move the radiator in order to create an access to the rework zone.

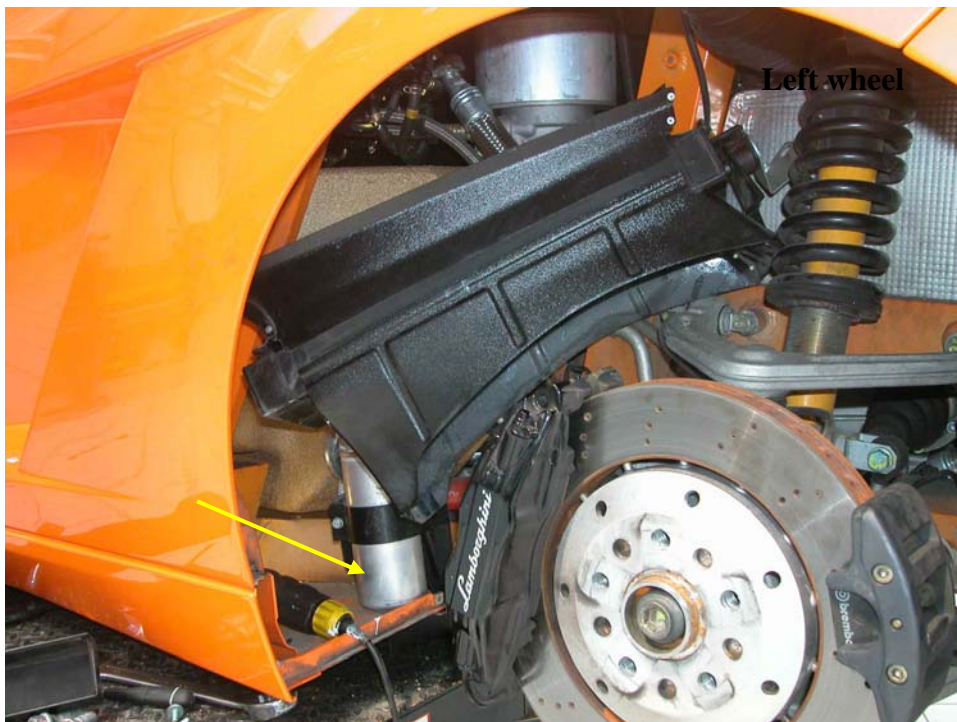
Left wheel

- 1.6 Remove the air intake black grid.
- 1.7 Only for the left side air intake: remove the upper pipe from the engine oil radiator and unscrew the oil filter bracket in order to move better the radiator.

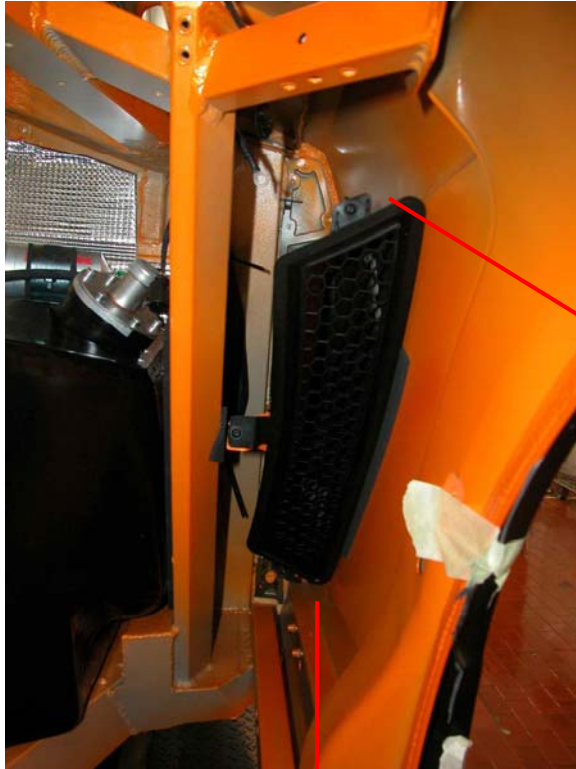
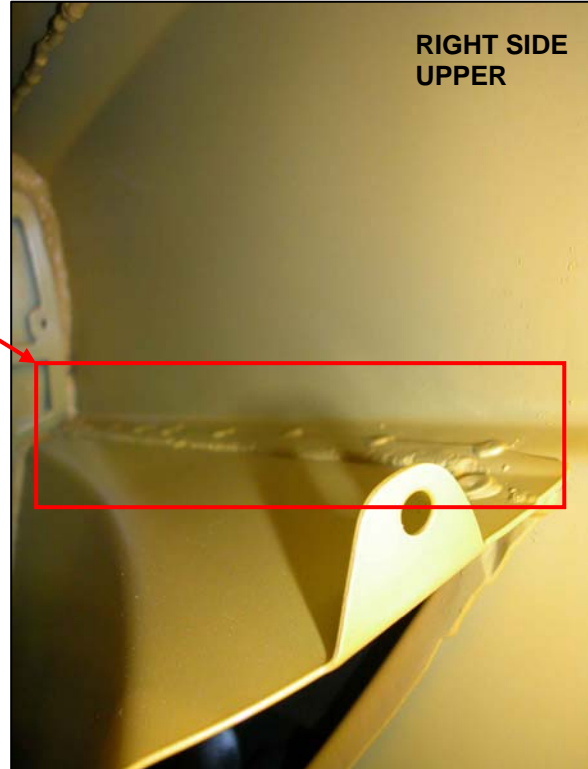
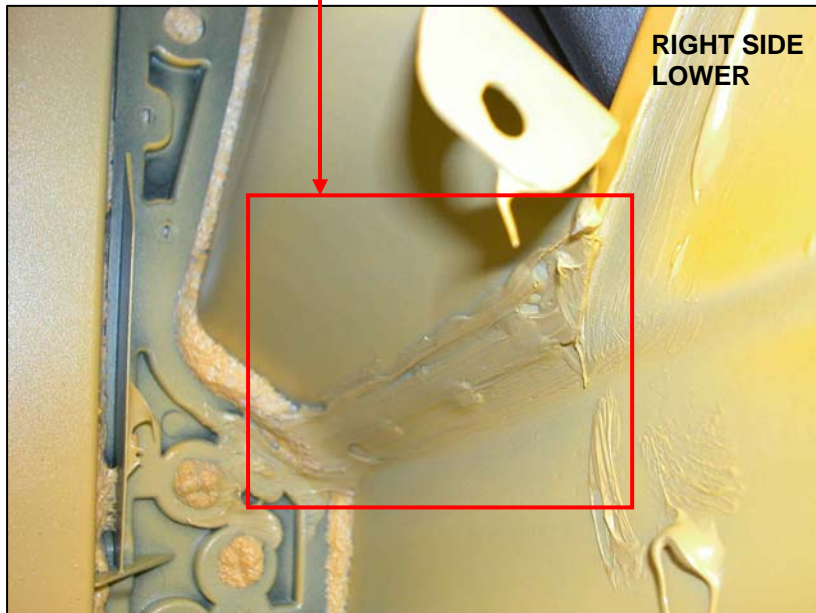
1.8 Identify the upper and lower connecting joints to be sealed (see pictures below – right side of the car).

1.9 Using a cloth, clean the upper and lower connecting joints surfaces with the cleaning solution.

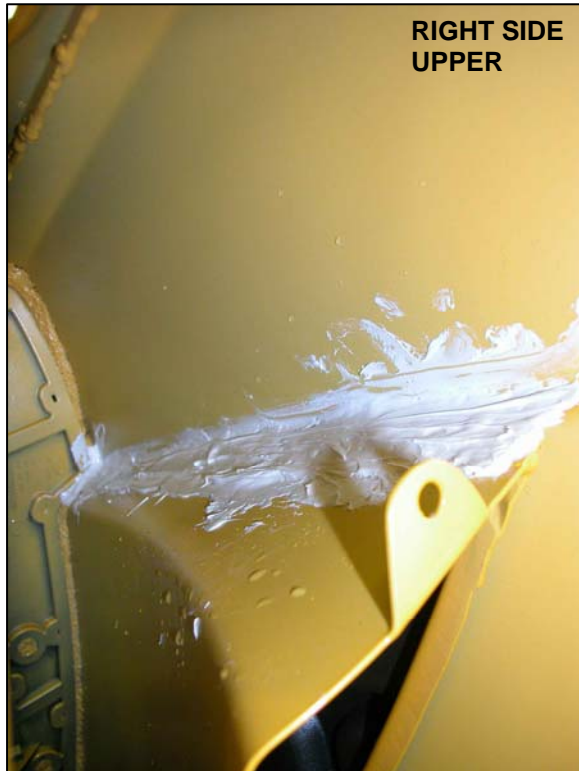
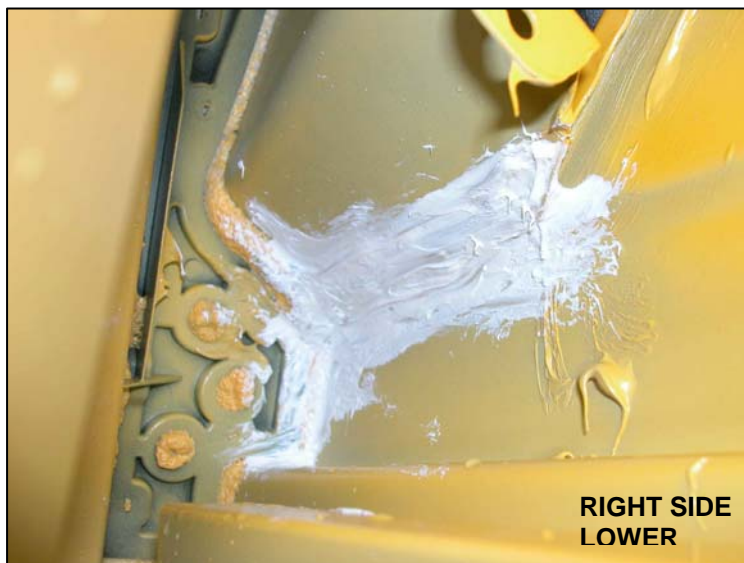
1.10 Apply the sealant on the whole connecting joints using the gun applicator with a rubber pipe extension (suggested solution) or a paintbrush (see pictures below).

1.11 Spread the sealant on the whole jointing surface (see pictures below).
