To All Lamborghini Dealers and Licensed Service Point
From Customer Service Department
Subject Water drain in alternator pipe
Group 140.9.03
Date 30.01.2007
Pages 5

Water drain in alternator pipe

Gallardo (Coupe and Spyder) from VIN G52500 to VIN G74934.

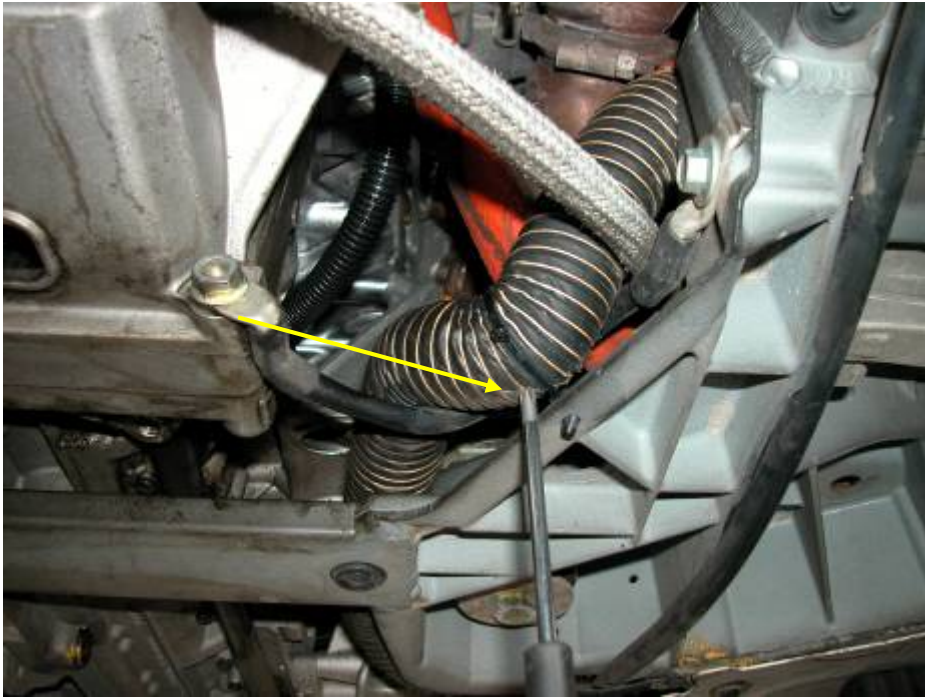
Pic.2

- 1.1 Adopt all precautions to prevent car damages and to work safe.
- 1.2 Raise the car on the lift.
- 1.3 Using a screw driver; create a small hole near the black clamp on the alternator pipe. (See picture 2). Please **BEWARE** when piercing a hole in the pipe because water may be released.

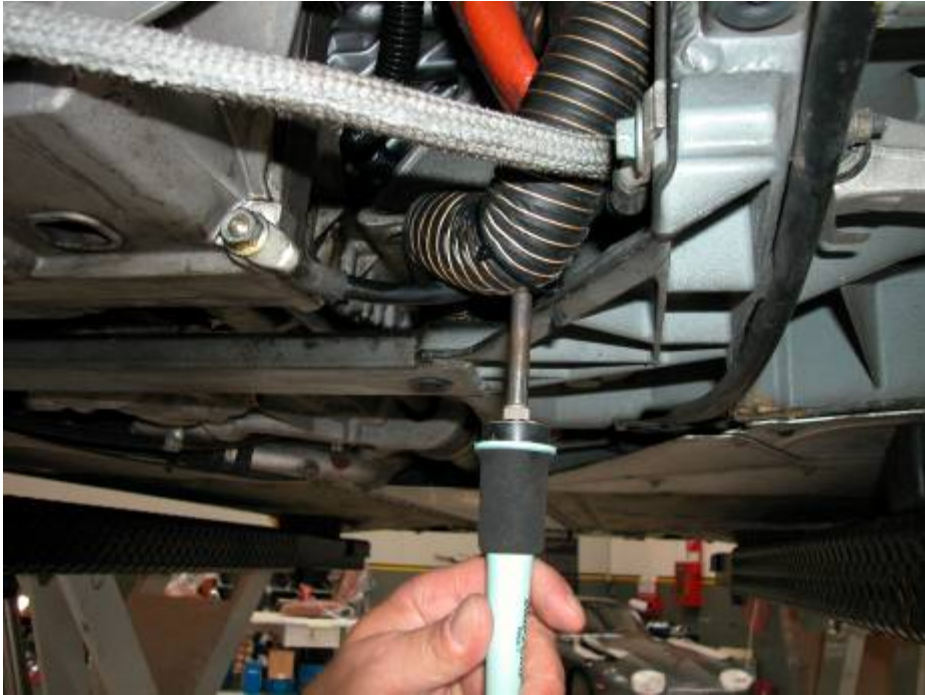
Pic. 3

1.6 Beware that the pipe is void of all water before the melting process.

Now with the soldering station powered, melt a 5mm hole in the pipe.
(Picture 3)
