Subject Interface for K Line Pull Up

Group 140.9.75.00.05.InterfaceLineK.GB

Interface for K Line Pull Up for the radio

All Gallardo Vehicle with Radio System (not suitable for vehicle with Nav/Sat)

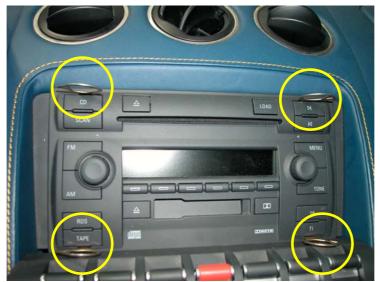
Pic 3

1.1 Insert the four keys into their place on the radio (Pic 3). Please note that each key has written on it where it should be fit. For example the key "TOP L" must be used on the LEFT TOP POSITION.

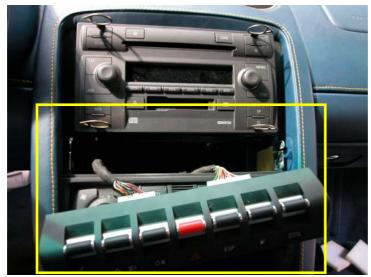
Pic 4

1.2 Now take out the center console part shown on Pic 4.

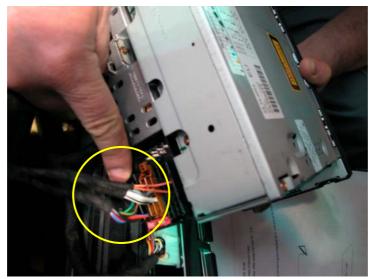
Pic 5

- **1.3** Now take out the radio using the button under it.
- **1.4** Take out the energy black connector (number 271 "cablaggio plancia")
- **1.5** Insert the Interface between the radio and the black connector 271 (Pic 5)

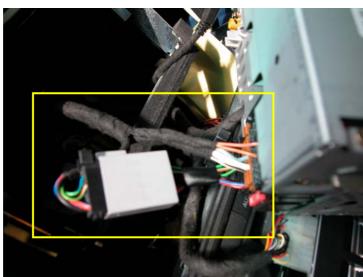
Pic 6

- **1.6** Now that the connector is placed you may return the radio on the correct position.
- **1.7** Remove the keys and return the center console.
