To All Lamborghini Dealers and Licensed Service Point
From Customer Service Department
Subject Cover foils for ECU's and CD changer
Group 148.8.68
Attachments -
Date 25.01.2006
Pages 8

Cover foils for ECU's and CD changer

Murcielago Roadster (L148) until VIN 1528

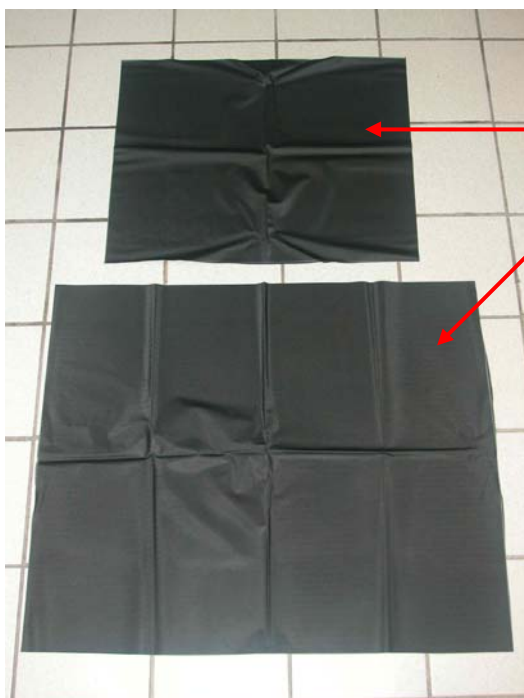
p.n. 417867385 (2x)

- 2 x ECU cover foil p.n. 417867385
- 1 x CD changer cover foil p.n. 417867385A
- 3M Scotch Extruded Sealer EC-5313, 2mm thickness, 7mm width, (please contact the local 3M dealer - www.3m.com - for more information)

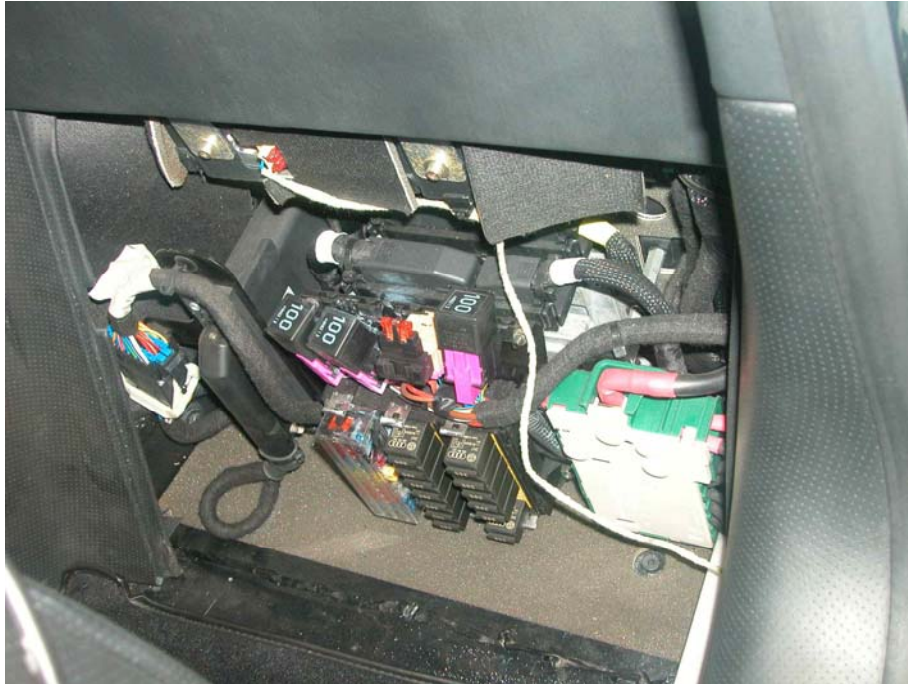
Pic.1

1.2 Remove the ECU's covering behind the left seat.

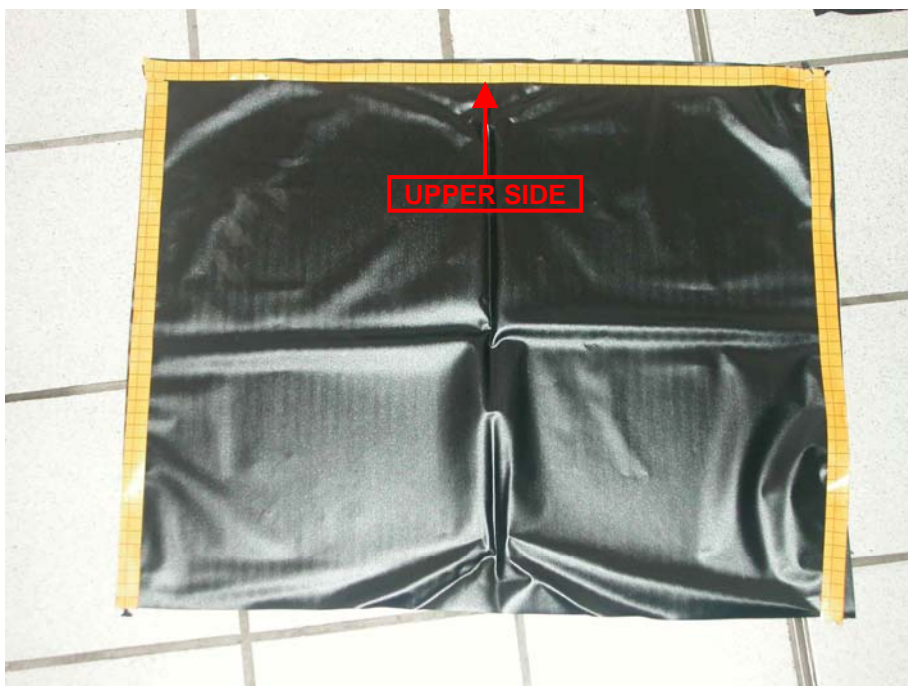
Pic.2

1.3 Apply the sealer on three edges of one cover foil p.n. 417867385, similar to shown in the picture below.

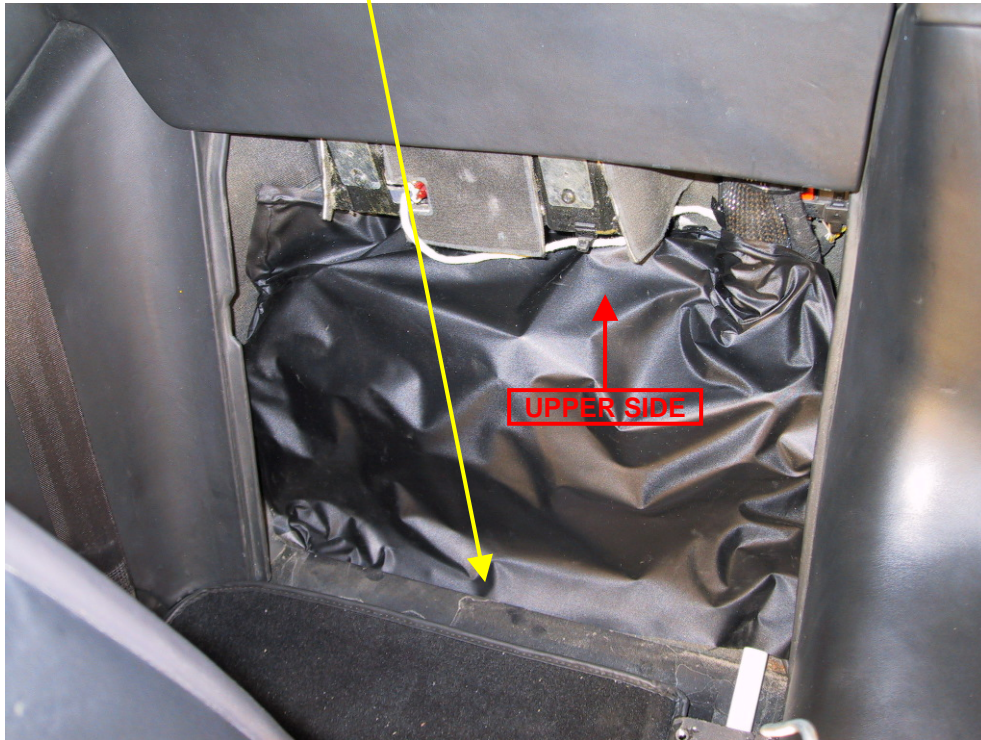
Pic.3

1.4 Fix the cover foil on the ECU's similar to shown in the picture below, fitting the lower side of the foil under the floor panel.

1.5 Reassemble the ECU's covering in its original position.

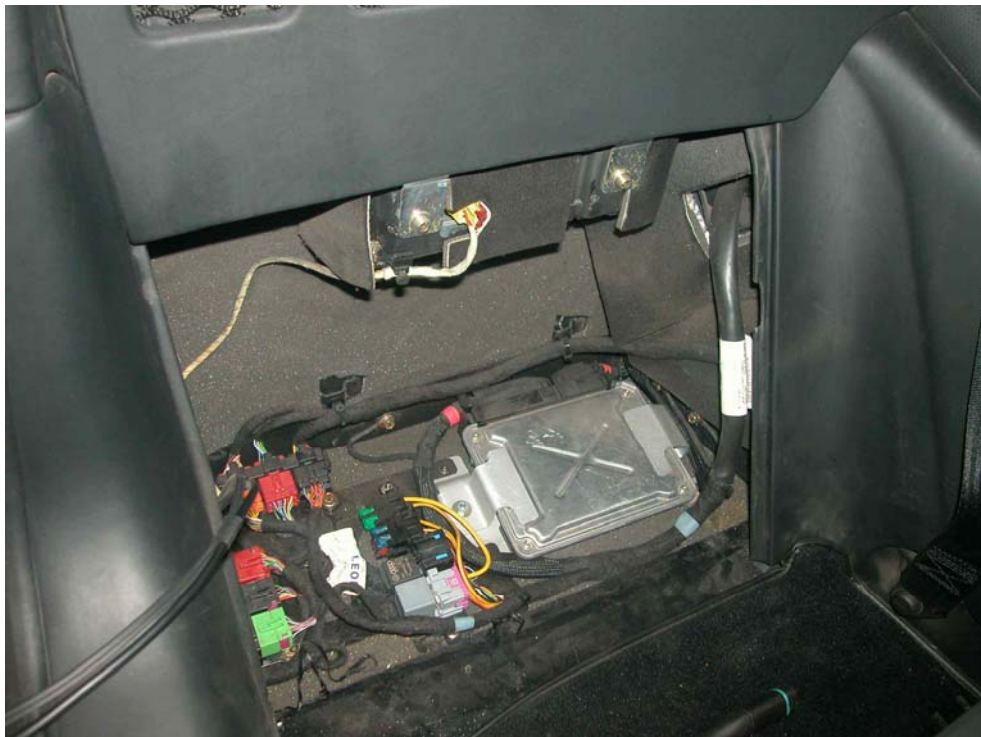
Pic.4

1.6 Repeat the operations 1.2 thru 1.4 on the right side. (see pictures below).

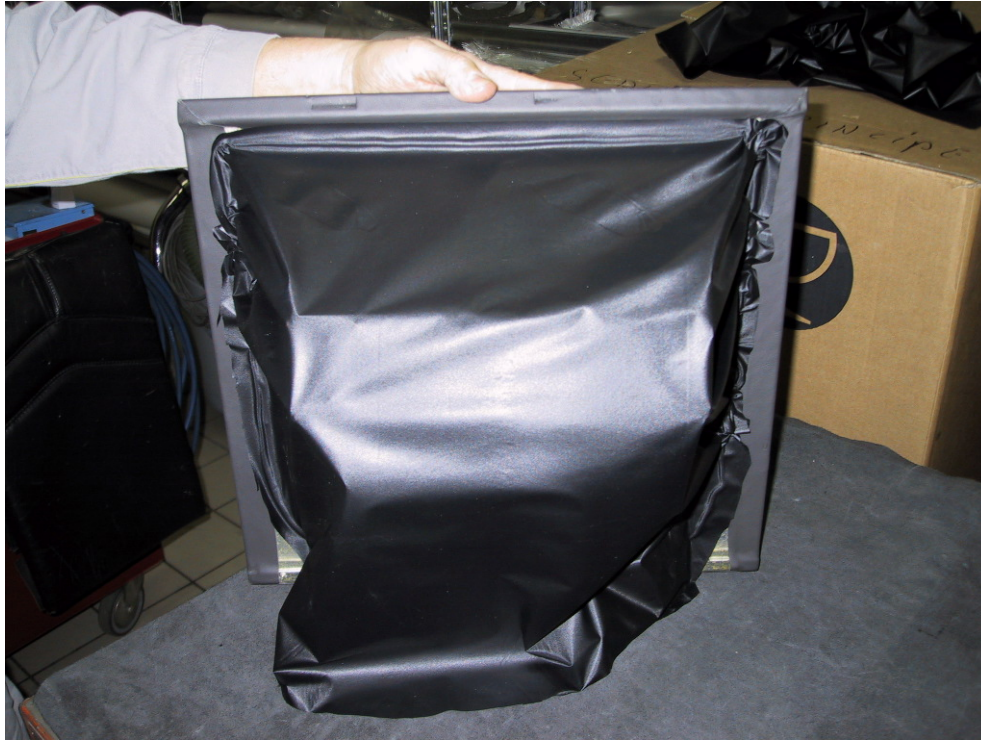
Pic.7

1.8 Fix the foil p.n. 417867385A on the CD changer covering (cut the excess foil if necessary) sealing carefully the three edges (pic.7) and leaving the lower side open to allow the wiring passing (pic.8-9).
