GROUP
VOLUME	Climate Control
2	NUMBER
-	005

MODEL Sportage DATE

Technical Service Bulletin

HVAC Mode Control Switch

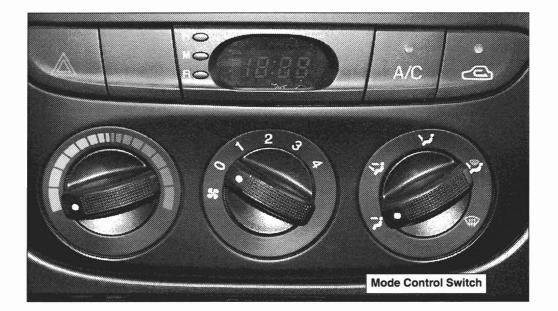
This bulletin provides information related to 2001 MY Sportage HVAC Mode Control Switch. On 2001 MY vehicles produced before 6/29/00, an internal switch contact may break off. When this occurs, air flow selections cannot be made.

To correct this condition, the internal switch contact has been revised to eliminate breakage.

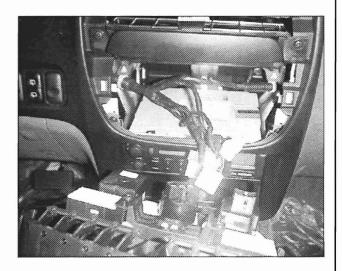
2. Disconnect four (4) HVAC control electrical connectors and remove center panel.

1. Open cup holder, grasp center panel assembly as illustrated in photo, and pull to release panel assembly from retaining clips.

3. Remove mode control switch from center panel by removing two (2) screws, and knob. Discard old switch and knob.

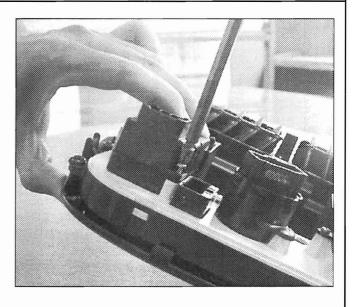
4. Install new mode control switch with the two (2) screws, then install the new knob.

5. Reconnect the four (4) HVAC electrical connectors.

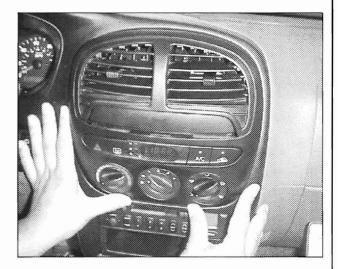
- 6. Reinstall center panel to dash.
- 7. Check and confirm proper HVAC mode control operation.
