ATB 52107 (1409)

Product Update: 2015 Fit Front Bumper Beam

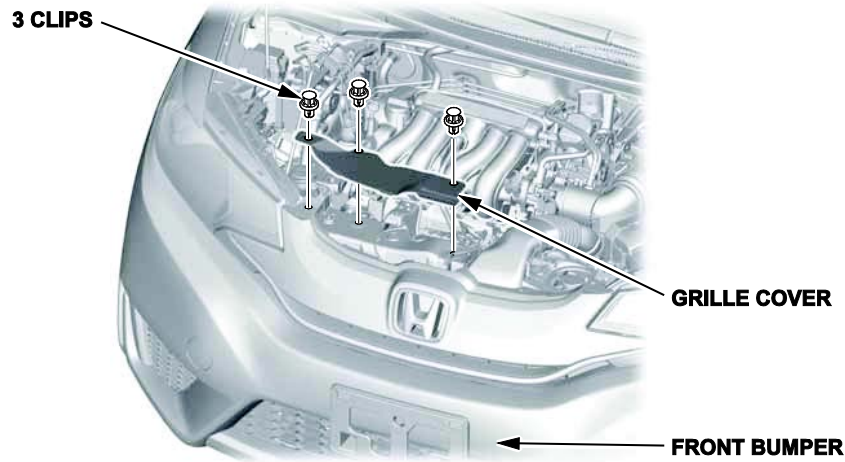
1. Raise and support the vehicle about chest high so you can easily access the front bumper.
2. Remove the front grille cover.

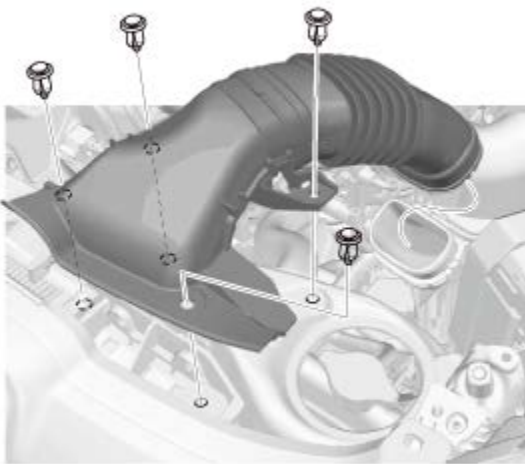
3. Remove the intake air duct.

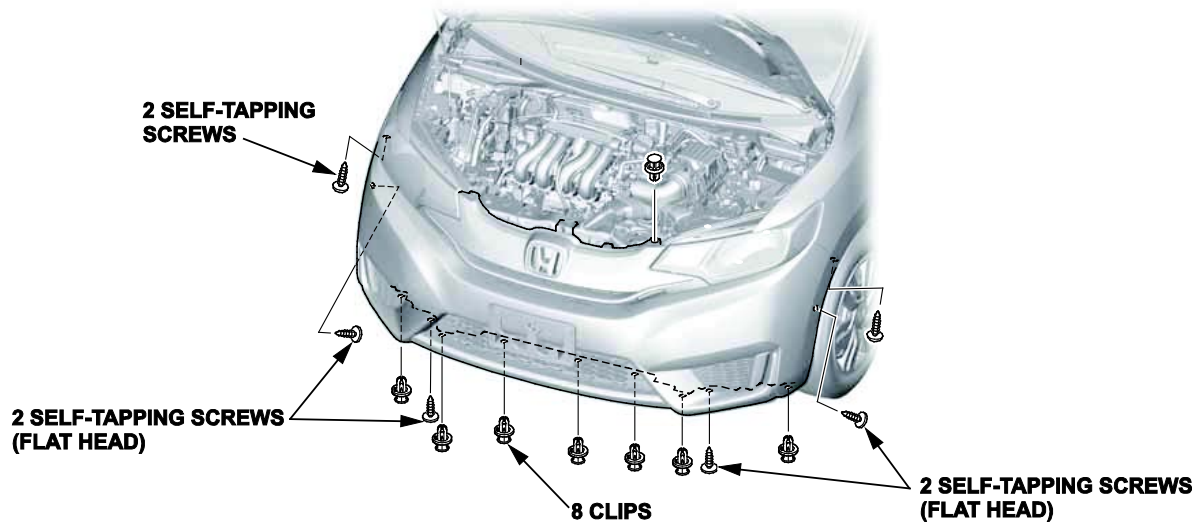
4. Remove front bumper by removing the screws and clips.

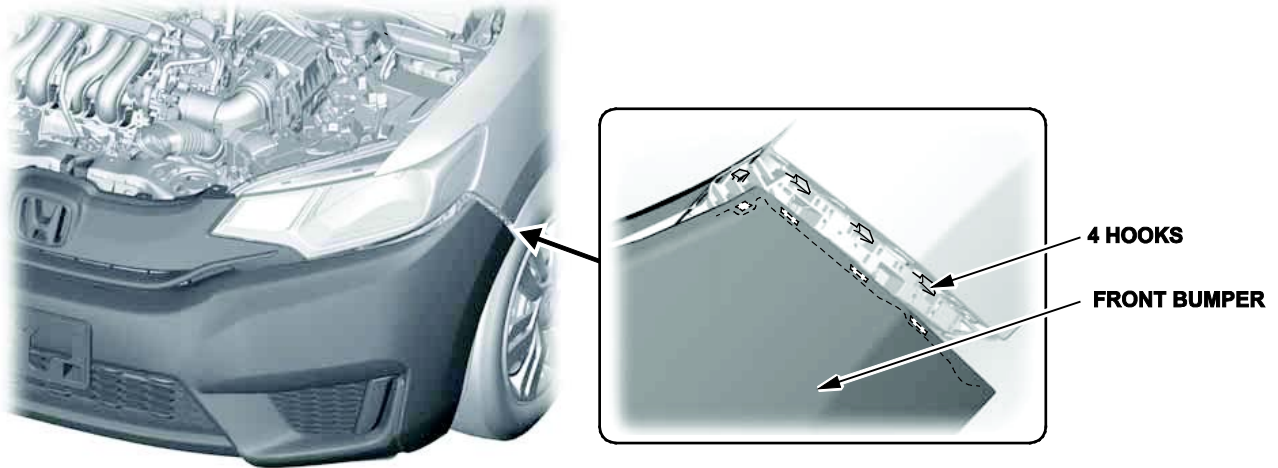
5. Pull out the front bumper at the wheel arch area to release it from the hooks on the side spacer.

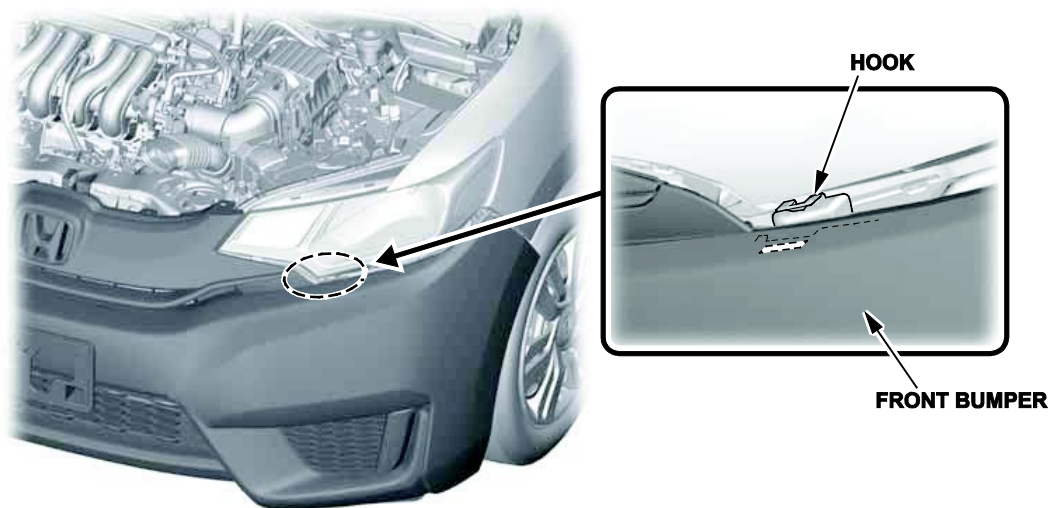
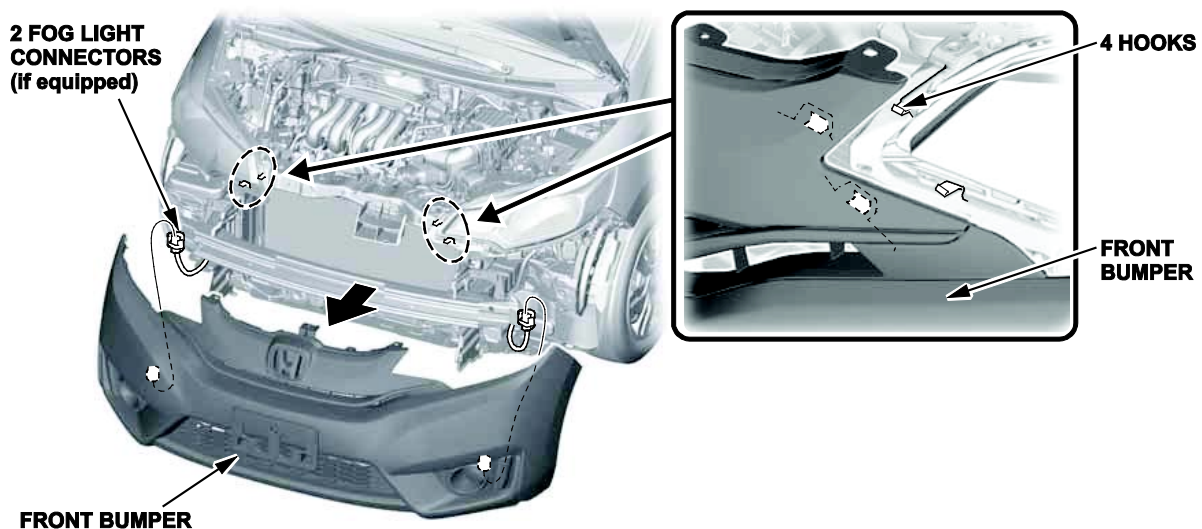
6. With the help of an assistant, gently pull the front bumper away from the side spacer and release the bumper from the hooks on the upper beam, then remove the front bumper.

NOTE: If the vehicle is equipped with fog lights, disconnect the connectors while your assistant holds the front bumper.

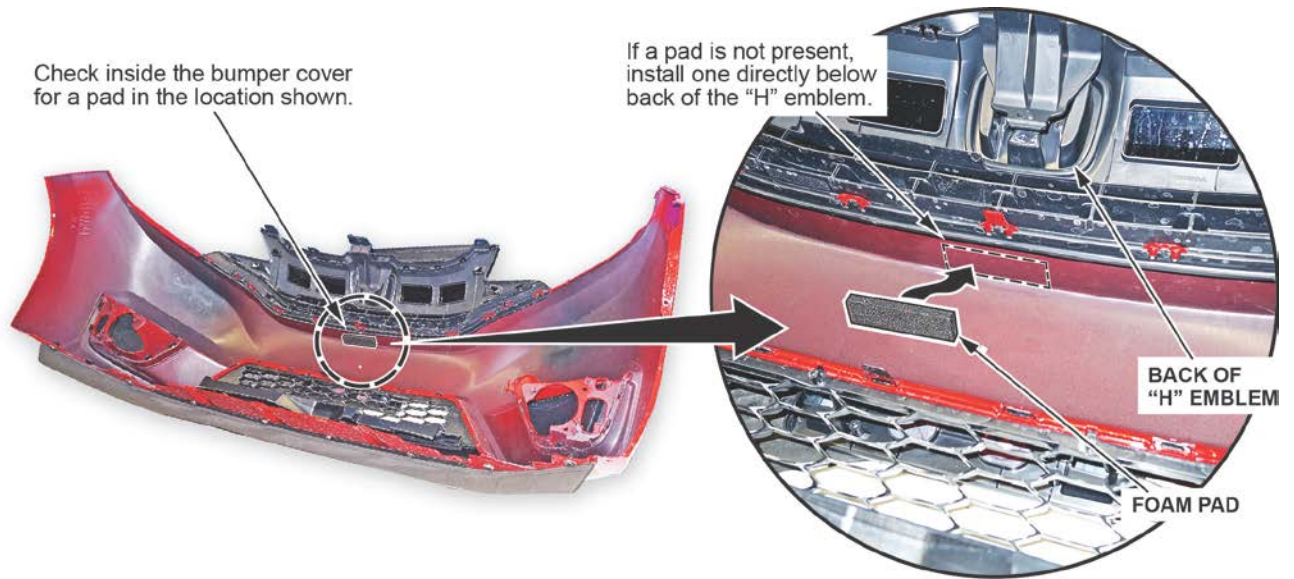
7. Inspect the inside of the bumper cover for a foam pad. If there is no pad present, install one.

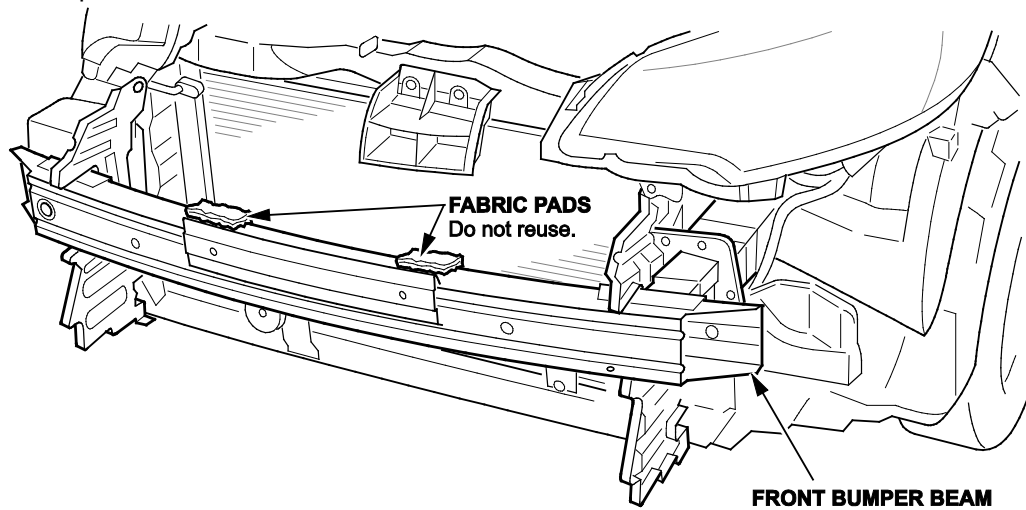
NOTE: There may be two fabric pads located on the front bumper beam. Do not reuse or replace these pads when you replace the bumper beam.

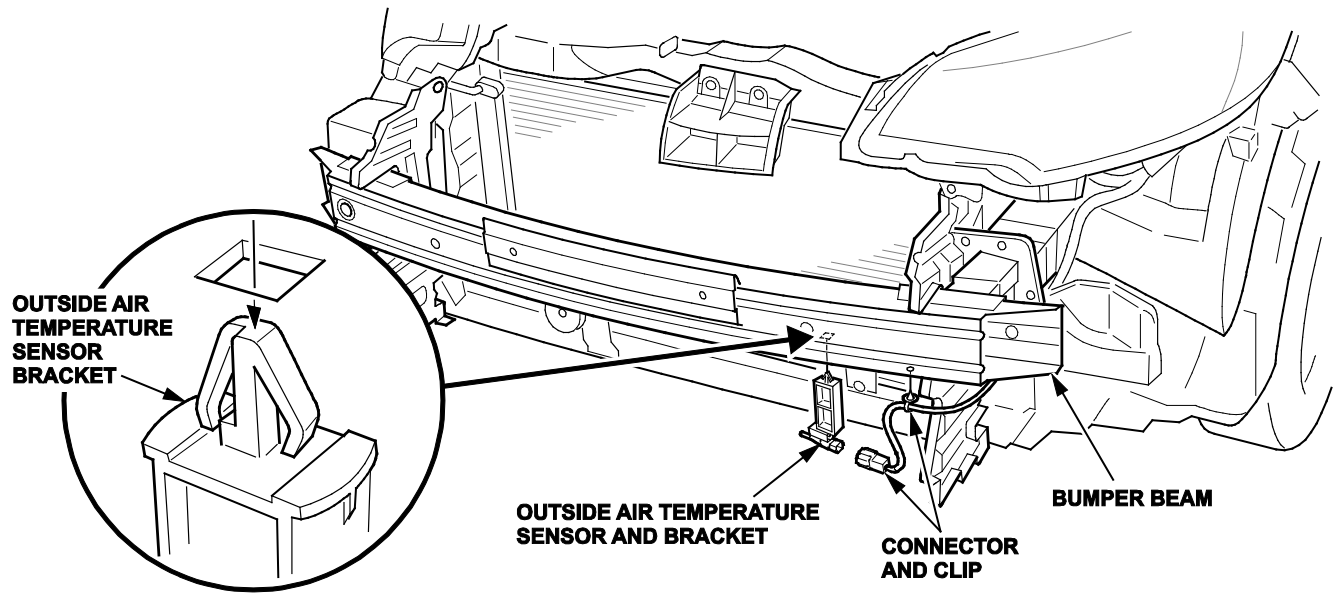
8. Remove the outside air temperature sensor by disconnecting the connector and the harness clip. Squeeze the tabs on the outside air temperature sensor bracket to release the lock and remove it.

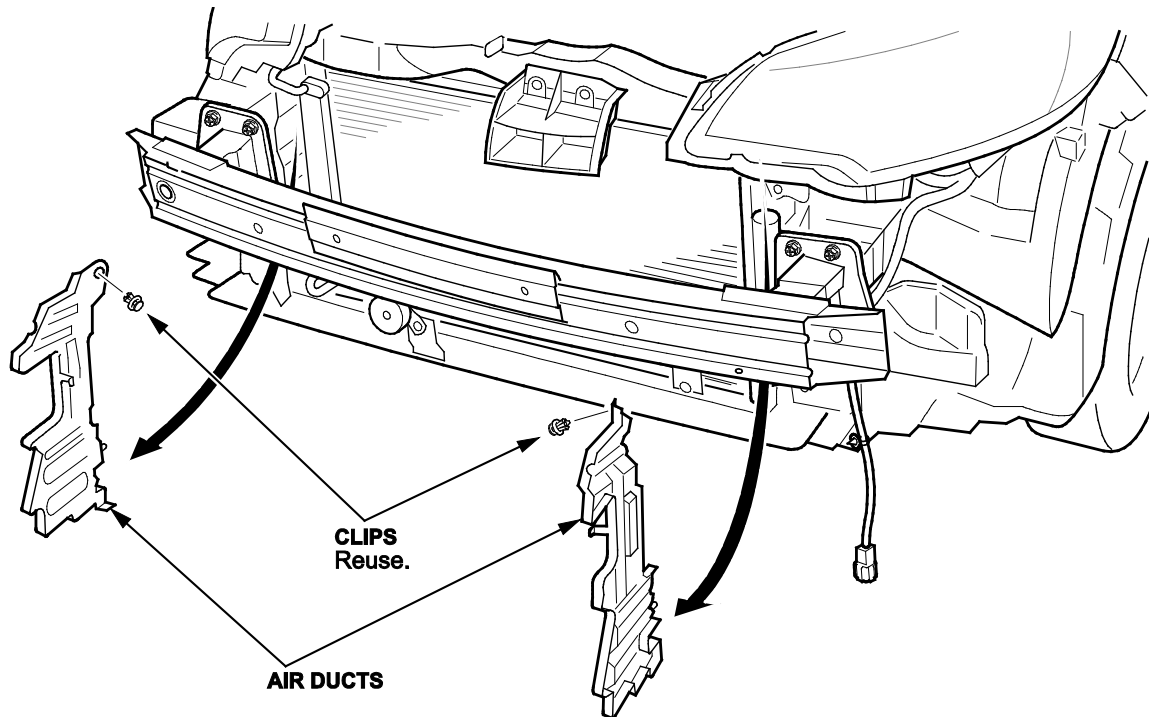
9. Remove the air ducts.

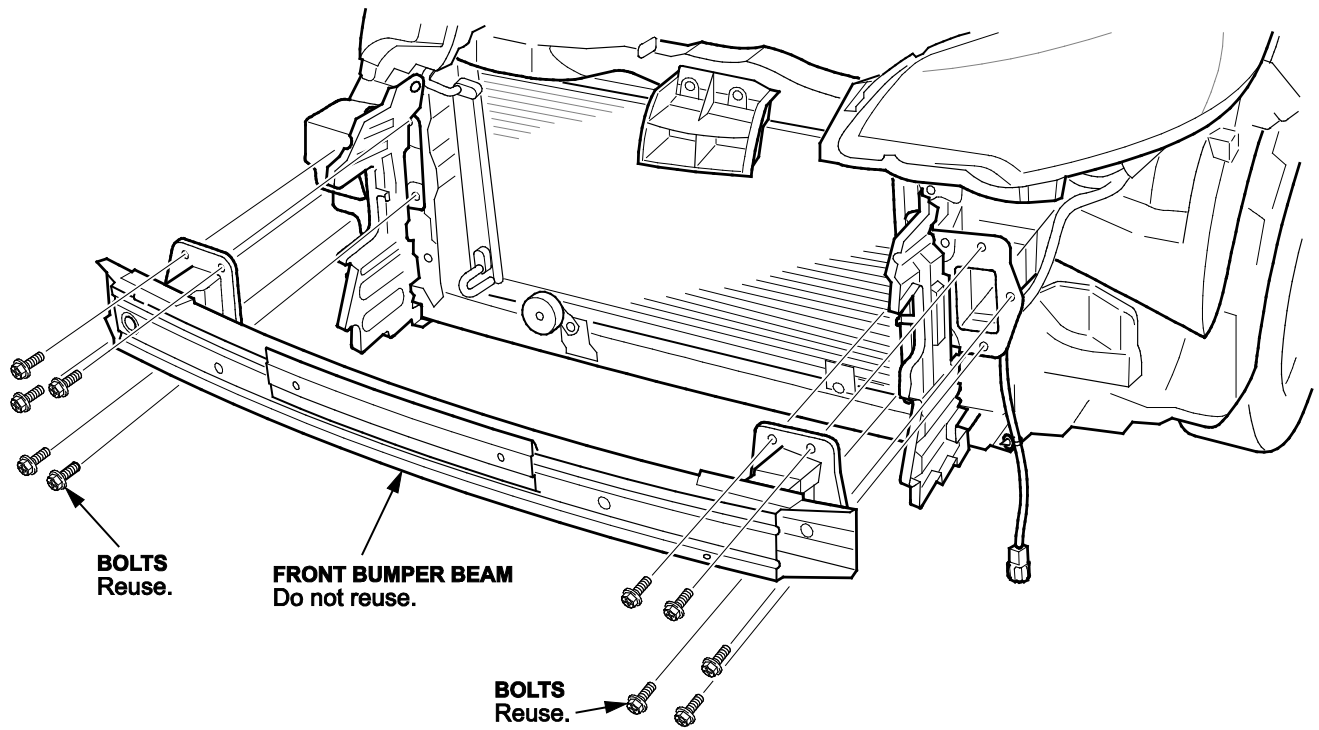
10. Remove the front bumper beam.

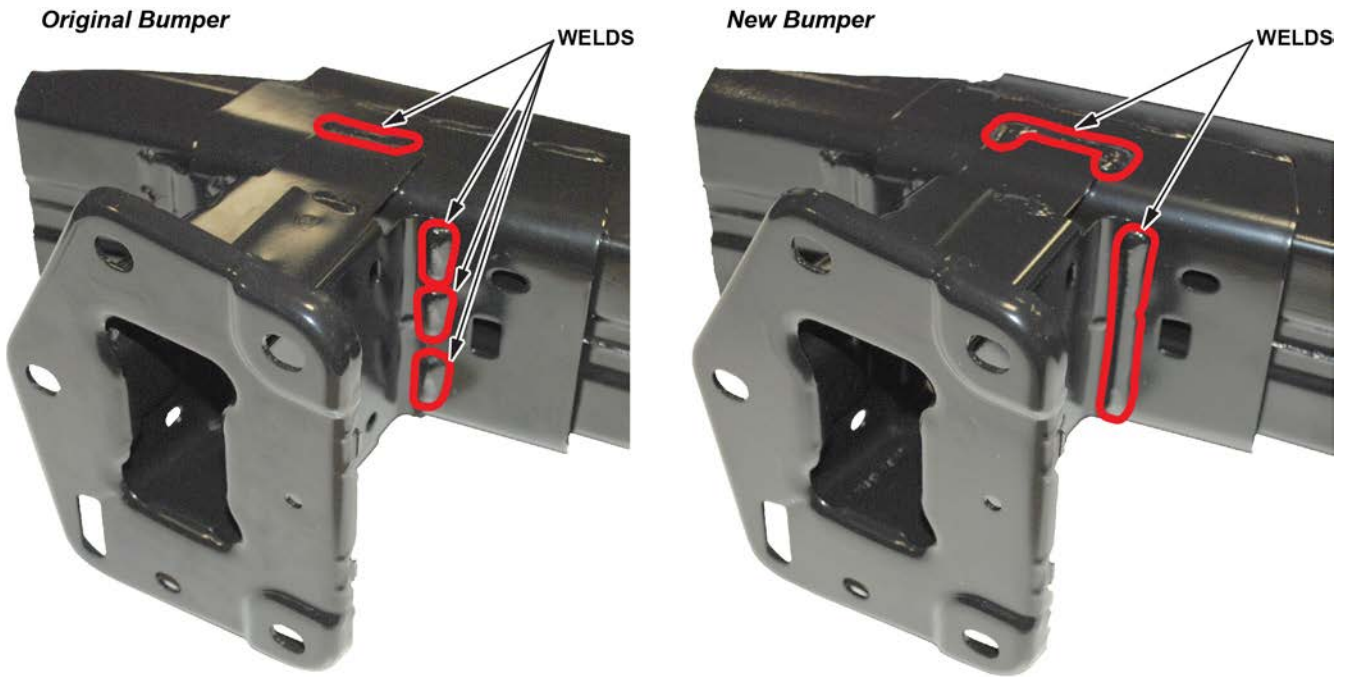
NOTE: Both parts are similar but you can tell the new part from the original part by looking at the weld seams where the bracket connects to the beam as shown.

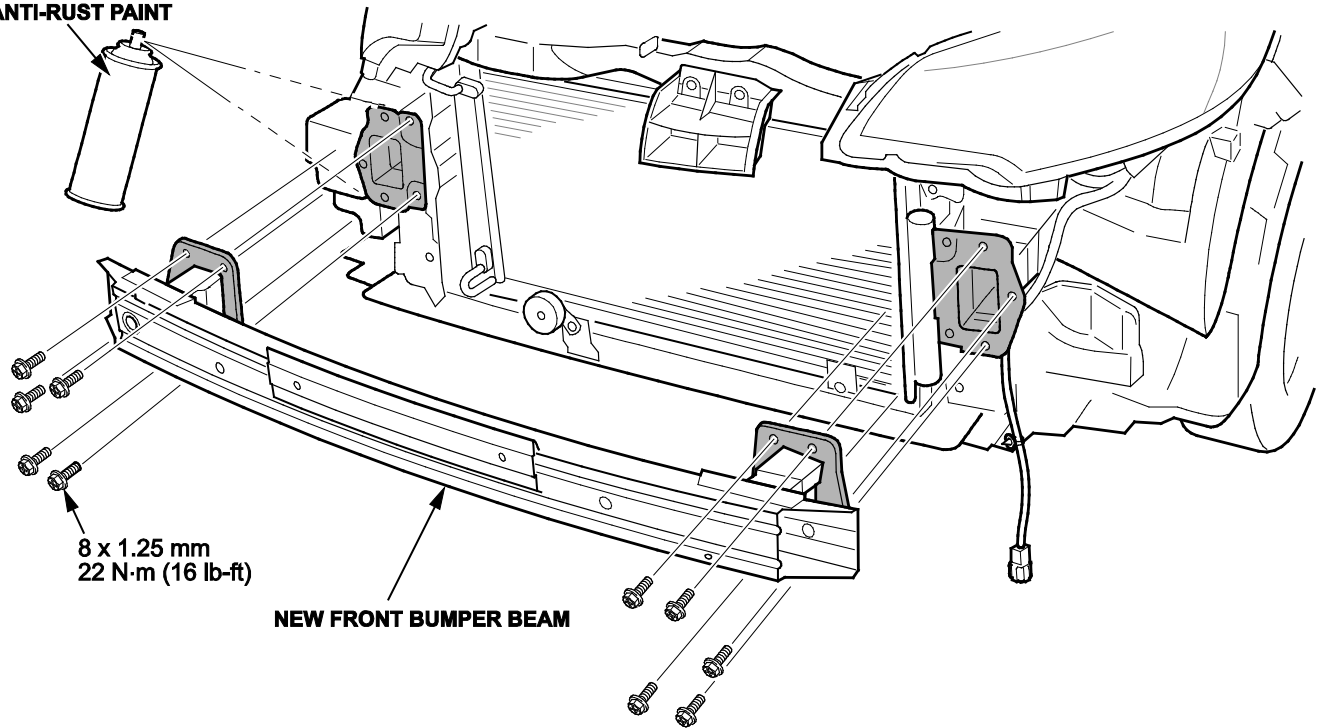
ANTI-RUST PAINT

11. Apply a commercially available anti-rust paint like 3M Rust Fighter anti-rust coating (3M P/N 08892) or equivalent to the areas shown, then install the new front bumper beam and torque the bolts to **22 N·m (16 lb-ft)**.

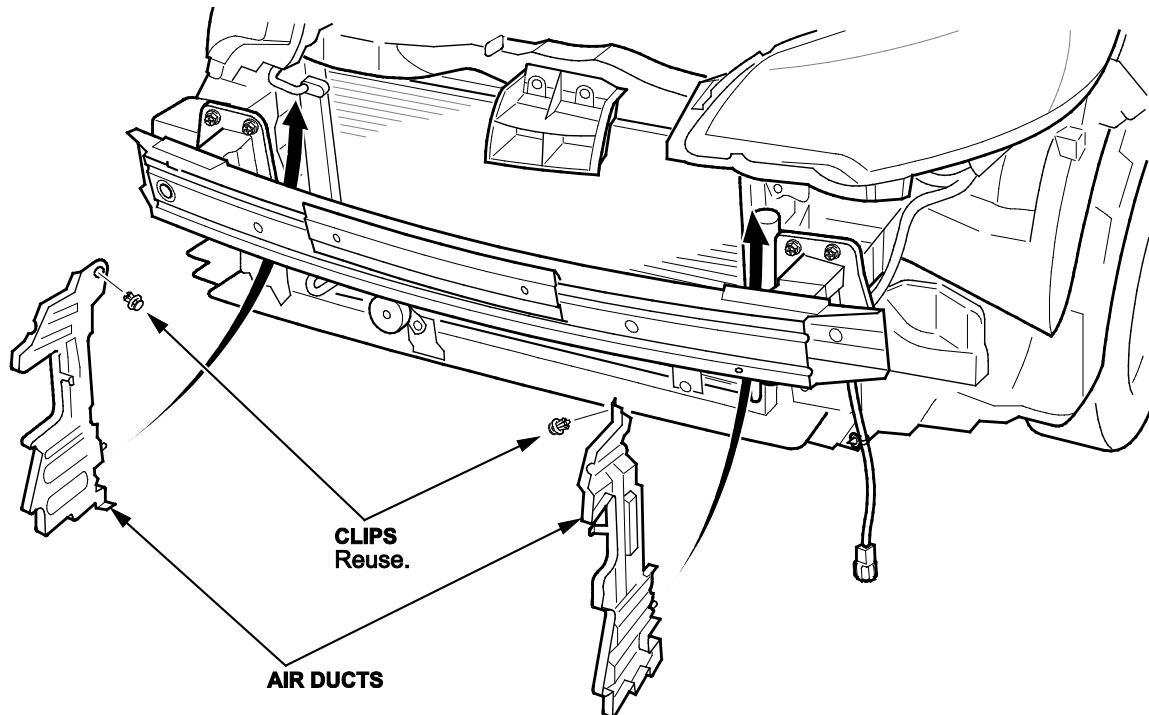
13. Install the air ducts.
