TECHNICAL BULLETIN
JTB00257NAS3
06 MAR 2014

SECTION: 204-04

Wheel/Tire Balancing and Optimization

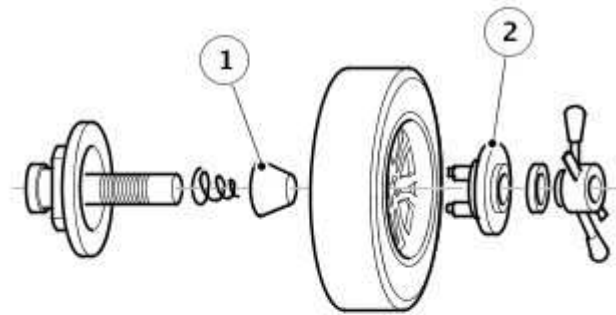
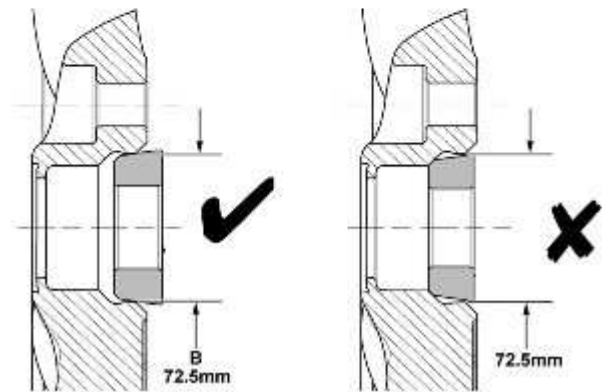
E160494

Mount each wheel/tire assembly (using the correct wheel-fitting attachment) to the balance machine and balance until the residual imbalance dynamic is minimized.

- Target is 0g (zero grams) on each plane; maximum is inner 5g / outer 5g.
- Use the 'bulls-eye' balancing mode to minimize residual imbalance.

4. Remove all four road wheel/tire assemblies.
5. **NOTE: When using adhesive weights, use the attachment arm on the balancing equipment to ensure accurate weight positioning.**

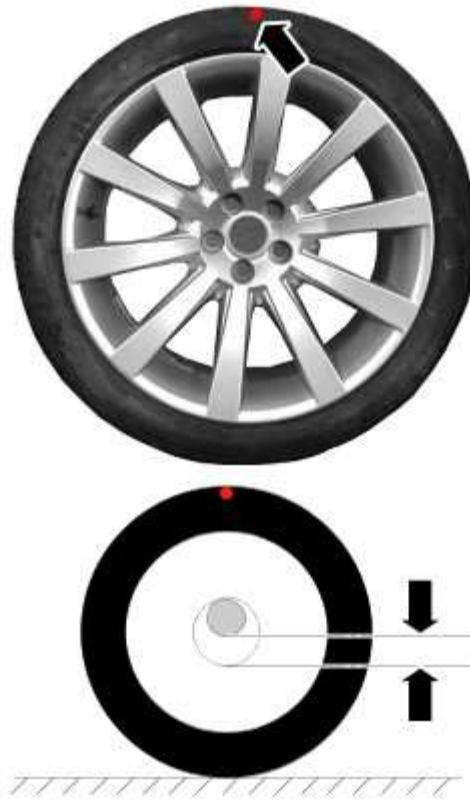
E146997

Prior to tightening the wheel nuts, the marked high point of RFV must be installed to the vehicle with the RFV high point 'up'.

8.   **NOTE: If RFV equipment is not available and the tire has not been removed from the wheel and the RFV spot (red dot) is still visible, install wheel/tire assembly with red dot 'up'.**
