Procedure: L140-03.04

Operation: BJA control unit replacement

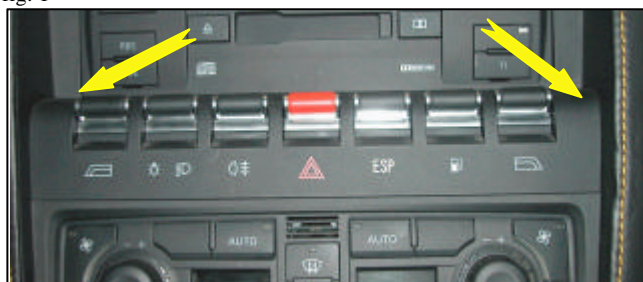
fig. 1

- 1.1 It is recommended to have two rigid plastic (long, flat) blades available.
- 1.2 Insert the two blades in the two sides of the Bja control unit in the car (see yellow arrows in fig.1)
- 1.3 Gently lever the control unit out (be careful not to damage the leather facing).
- 1.4 Position the control unit parallel to the console and press the part right in.
- 1.5 To confirm the part in question has been positioned correctly, make sure the controls work properly (e.g. the window moves).
