Subject Rear Spoiler Tierod Clip

Group 8.27.00 Date 22/12/2011

All Gallardo <u>Coupe</u>, LP 570 version, MY09; MY10 and MY 11 from VIN 9LA06526 to VIN BLA10676.

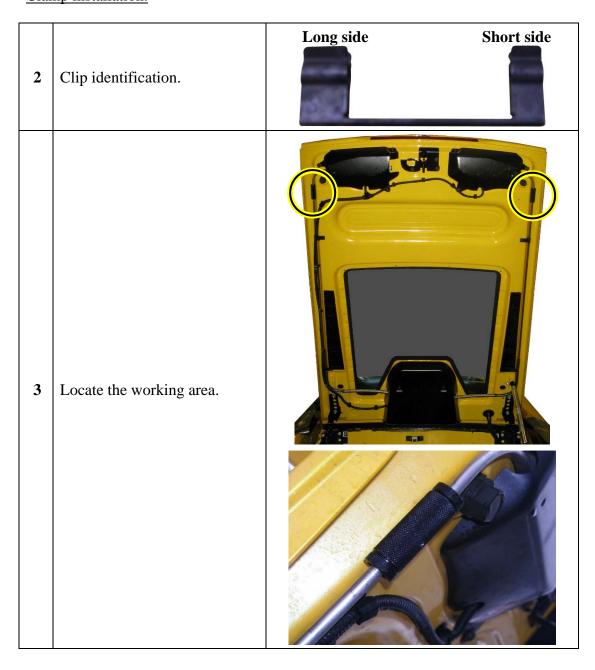
Clamp installation.

As a continuous product monitoring, , Automobili Lamborghini Spa has found that in rare cases the rear spoiler might be stuck in raised position as consequence of the detachment of the tierod which drives it.

4	Fit the clip with the short side placed toward the spoiler lifter mechanism as shown in the beside picture.	Short side
5	Rotate outward the clip until touching the hood plate. Repeat the same operation on both sides.	
6	Close the engine hood
