L834-T.01.14

**To:** Rete di Assistenza ufficiale Lamborghini  
**Subject:** A Pillar Monocoque Sealing  
**Date:** 07<sup>th</sup>/02/14  
**Pages:** 3

Monocoque A pillar sealing.

All Lamborghini Aventador LP 700 Coupe MY 12 and 13 from VIN **CLA00091** to VIN **DLA01695**

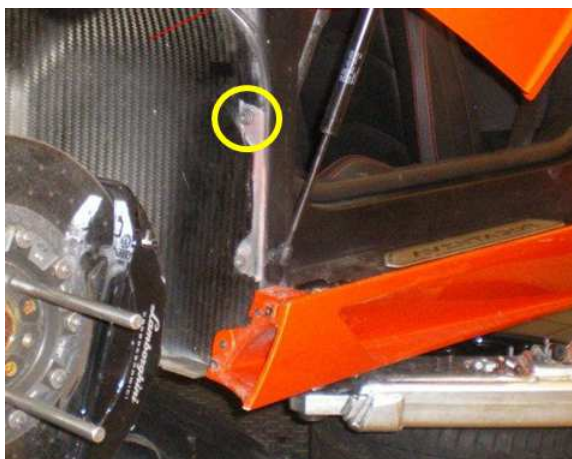
1. Remove the wheel arch undershield: left and right sides (chapter 08 21 – A.).
2. Drain the water from the intermediate hole located in the wheel housing on both sides as shown in picture: holes are symmetrical on the left and right.

(Remark: the picture below shows right sides both sides are symmetrical)

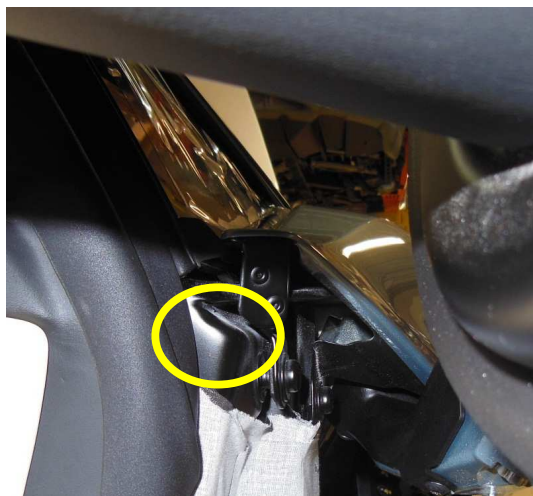
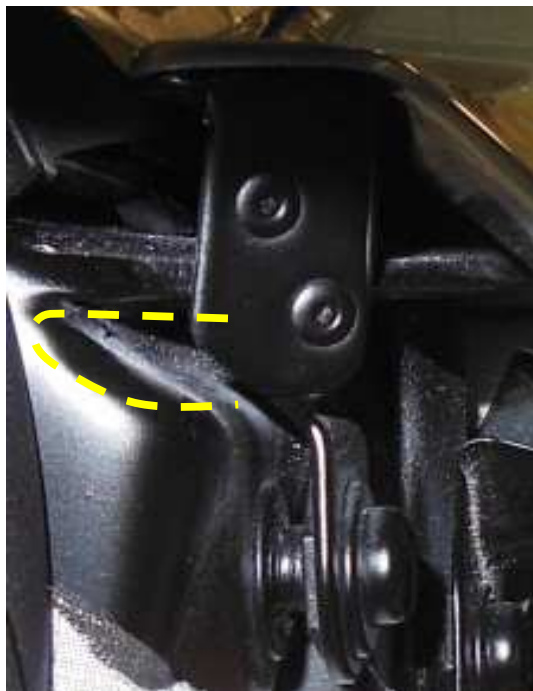
3. Open Both doors.
4. Find the surface to be sealed

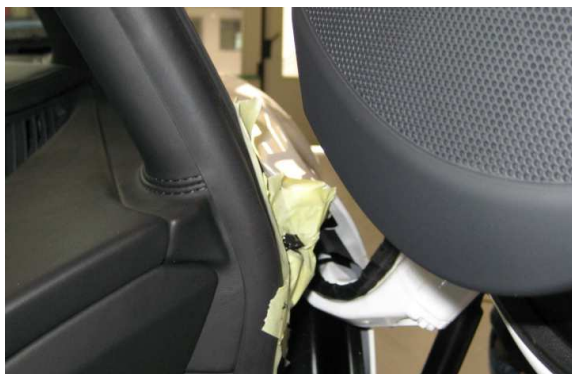
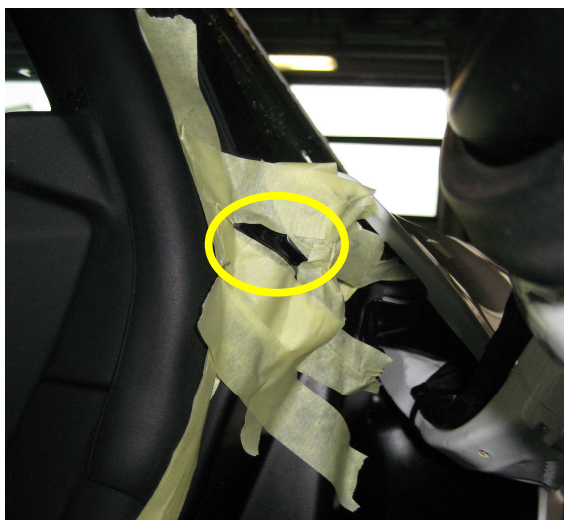
5. Apply the paper tape in order to mask the surrounding surfaces of the Area to be sealed.

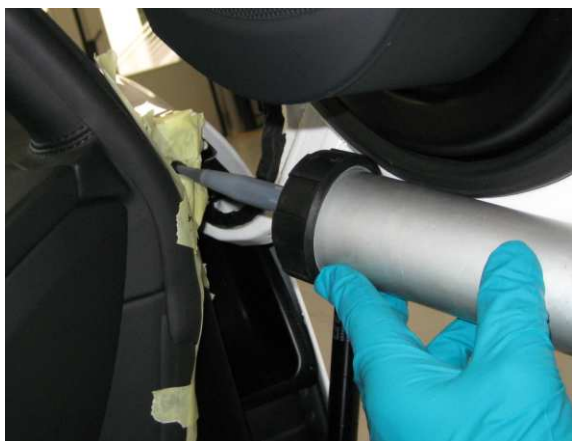
6. Apply the 3M sealant as shown in the picture, with particularly care to not soil the bodywork.

7. Wait not less than 24h so that the sealant is completely dried, leaving the doors open.
