ToAll Lamborghini Dealers and Licensed Service PointFromCustomer Service DepartmentSubjectAnticorrosion screws replacementGroupLB714.8.07Date17.01.2008Pages4

Anticorrosion screws replacement.

All Gallardo (Coupè, Spyder and Superleggera) from VIN G75155 to VIN G86483.

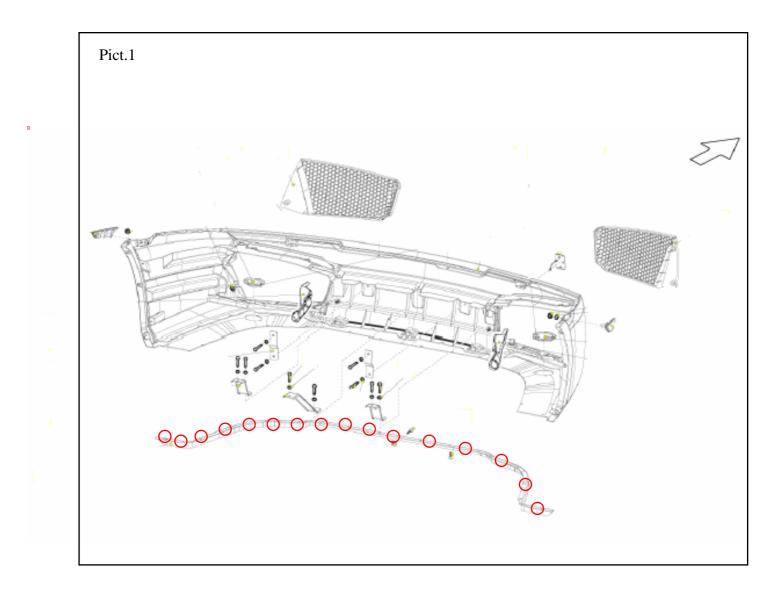
- **1.1** Adopt all precautions to work safe and prevent car damages.
- **1.2** Remove the 17 screws on the front bumper and put the new ones screws (tightening torque 9Nm), as shown in picture 1.
