Service Bulletin

PRELIMINARY INFORMATION

Subject: Duramax Diesel Hard Start No Start P0087 P0088 P0191 P128E Or Injection Pump Replacement

Models: 2010 - 2015 Chevrolet Express and Silverado
2010 - 2015 GMC Savana and Sierra
Equipped with the 6.6L Duramax Diesel RPO codes LGH and LML

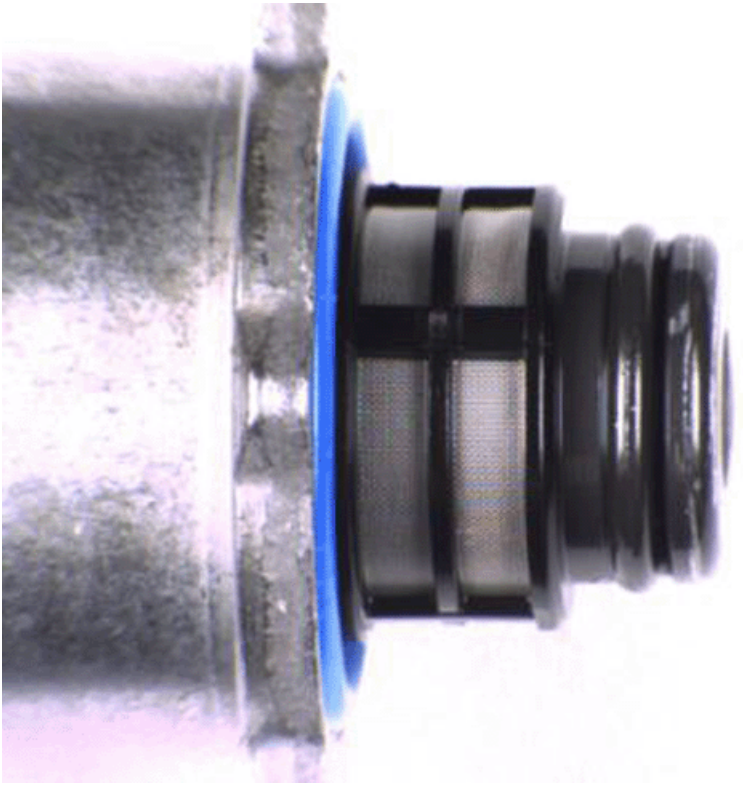
The picture above is an example of a clean Pressure Regulator 1.

If Pressure Regulator 1 is clean and there is no magnetic metal debris found, complete the SI repair procedure and replace the Fuel Injection Pump.

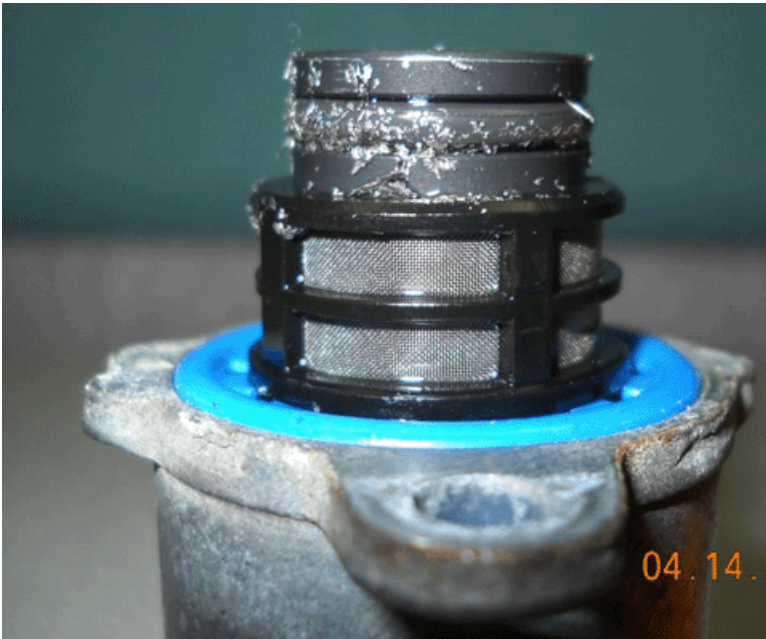
The pictures above are examples of Pressure Regulator 1 with the magnetic debris described

If Pressure Regulator 1 is contaminated with debris as shown above, complete the following repairs:

If working on a C/K Truck, it is strongly recommended to remove the engine from the vehicle and secure it to an engine stand to properly complete the repairs.

1. Replace all of the parts listed under the latest version of PIP4949 found in the Service Forms section of Global Connect.
2. Clean and flush all fuel chassis lines, filter pipes, and other engine mounted fuel system pipes not replaced.
3. The fuel filter housing should be cleaned with a new fuel filter installed.
4. The fuel tank and fuel sender should be cleaned and flushed.
