Service Bulletin

PRELIMINARY INFORMATION

Subject: Ignition Key Cannot Be Turned

Models: 2014 Chevrolet Silverado 1500
2014 GMC Sierra 1500

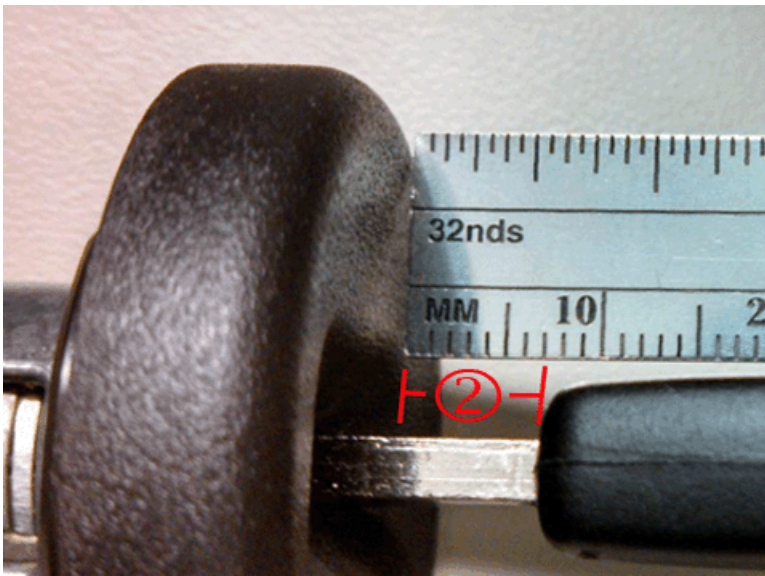
1. Insert key into ignition and confirm key will not turn.
2. With key inserted, measure the key to the cylinder, shown below is the correct (1) and incorrect (2) insertion measurements.

Important: If the insertion distance is correct, do not perform the following procedure and proceed to Condition #2.

3. The ignition lock cylinder will need to be replaced to correct this issue, if the key is not going in fully. To remove and replace the ignition lock cylinder, it must be rotated to the start position so the ignition cylinder retaining tab can be pressed down. Since the lock cylinder will not rotate continue with the following steps.
4. Obtain a new key that is cut to the vehicle. Reference the latest version of TSB 09-00-89-029: Key Cutting Procedure for Obtaining Replacement Key. The purpose of ordering a new key is so that the original customer's keys are left intact.
5. Shorten the key shank by grinding or cutting 6-7mm (1/4 inch) off the tip of the key.

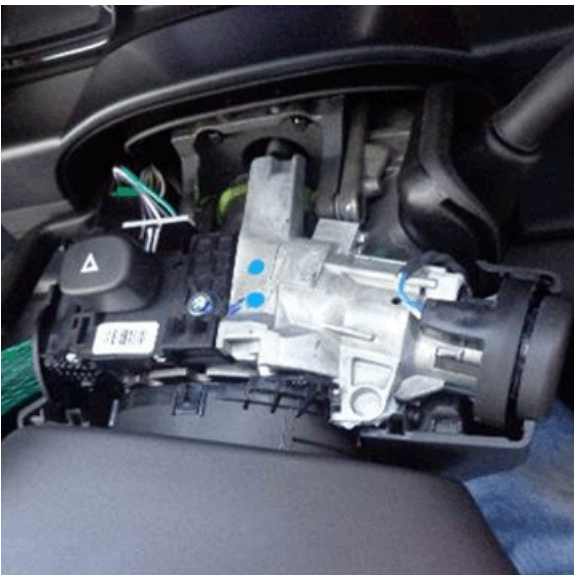
7. Remove steering column upper cover.

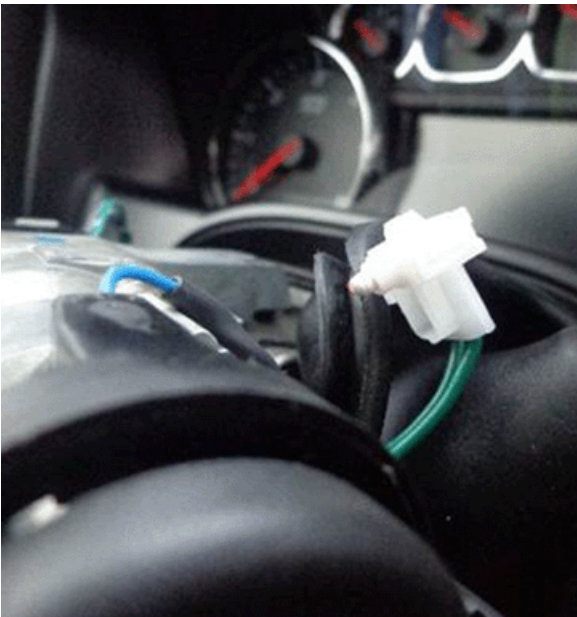
8. Remove the key reminder chime sensor.

Important: If you don't remove the sensor, you will shear the sensor off during removal.
