# Service Bulletin

## PRELIMINARY INFORMATION

**Subject:** Liftgate Rattles Over Rough Roads

**Models:** 2010 - 2014 Chevrolet Equinox  
2010 - 2014 GMC Terrain

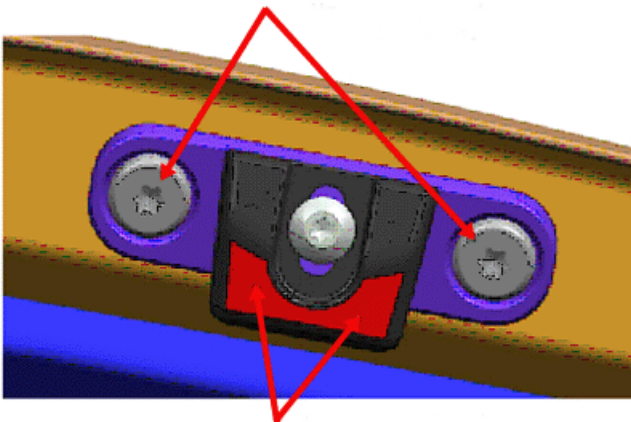
#### To Reset Liftgate Wedges:

Some customers may complain of a rattle noise from the rear lift gate on rough roads.

1. Insufficient contact between lift gate wedges.
2. Latch contacting striker

Open the lift gate, insert paper between the Body Side & Liftgate Side Wedges, then close the lift gate. If the paper cannot be removed, grease Liftgate Side Wedge with 12345579 (in Canada, use 10953481). If the paper can be removed, reset the Wedges using the following procedure.

1. Loosen Liftgate Side Wedge center screw to allow center portion to "ratchet" along internal detents freely.
2. Pull center adjustment portion of Liftgate Side Wedges to full downward position.
3. Close Liftgate to full latch engagement. Use power to close w/ Power Liftgate system (if available), close manually on non-power lift gates (do not slam) Open Lift gate.

4. Pull center adjustment portion down one additional detent & torque screw 5.0NM. Note: If Wedge adjustment does not have enough travel for the one additional detent- Add washer GM#11562459 under the two Liftgate Side Wedge attachments to shim as required.
5. Recheck engagement with paper test procedure above, repeat step #4 until paper cannot be removed.
6. Grease Liftgate Side with GM# 12345579 Dielectric Silicone Grease. (In Canada, use 10953481 Dielectric Silicone Grease) See the picture above.
