Service Bulletin

PRELIMINARY INFORMATION

Subject: DTC P0014 or P0024 Light With No Drivability Concerns

Models: 2012-2014 Buick Lacrosse
2012-2014 Cadillac SRX
2012-2014 Chevrolet Captiva Sport
2012-2014 Chevrolet Impala Classic
with 3.0L LFW and 3.6L LFX engines

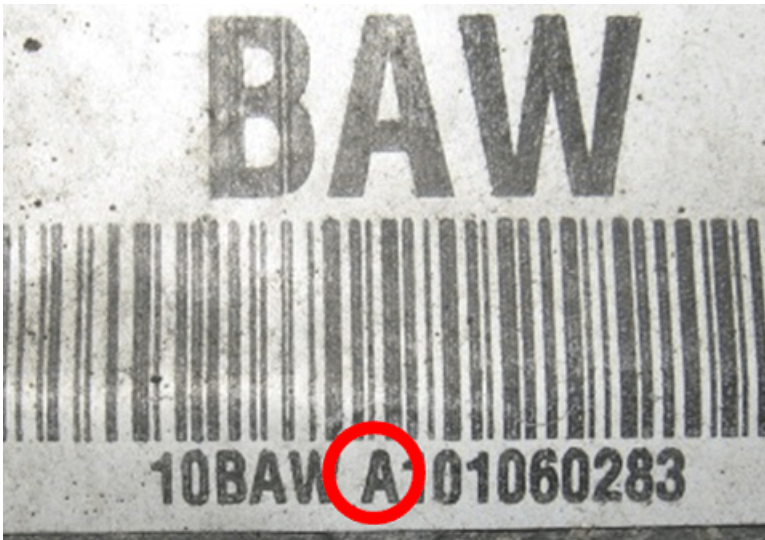
If you get a vehicle with one of these codes, and no other drivability concerns, inspect the engine EUN sticker for an A before the sequence number; before replacing the actuator.

The engine EUN sticker should be located on the engine left side below the left head or on the back of the right head. (See the example below)

If there is an "A" before the sequence number then replace the OCV/Cam Actuator Solenoid Valve with a replacement "service" valve.

"DO NOT JUST SWAP FROM ANOTHER LOCATION."

The service OCV is from a different supplier and can make up the difference in the clearance that causes this concern.
