Service Bulletin

Subject: Revised Front License Plate Bracket Installation Instructions

Models: 2014 - 2015 Cadillac CTS Sedan (VIN A)
with Front License Plate Mounting Package (RPO VK3)

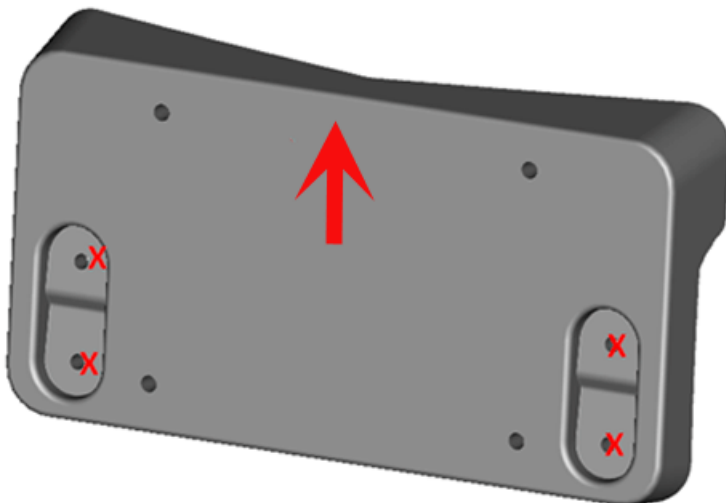
1. Drill 5.0 mm holes in all 4 location holes in bracket marked "X."

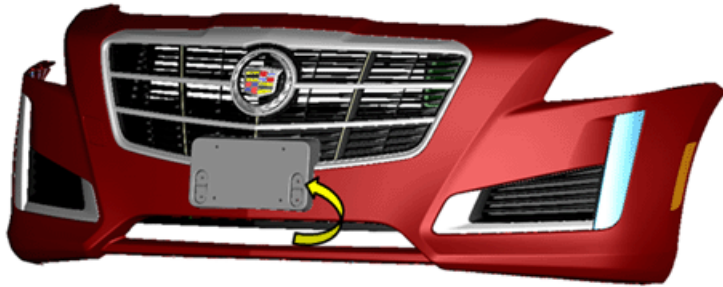
2. Install bolts through the license plate bracket and fascia holes.

3. Reach inside and behind the fascia (through the lower fascia opening) and install u-nuts on the backside. The u-nut is being used only as a nut, it does not clip on to any body parts.
4. Tighten bolts into u-nuts with a torque of (22 in lbs.) or (2.5 nm.).

Note: The license plate bracket **MUST** be mounted as shown above so that airflow through the fascia is not restricted and proper engine cooling occurs.
