09028 Version 14

Warranty Extension: MIL Comes On With DTCs P0301 thru P0304

Year	Model	Trim	VIN Range
2011–13	Odyssey	ALL	Check the iN VIN Status for Eligibility

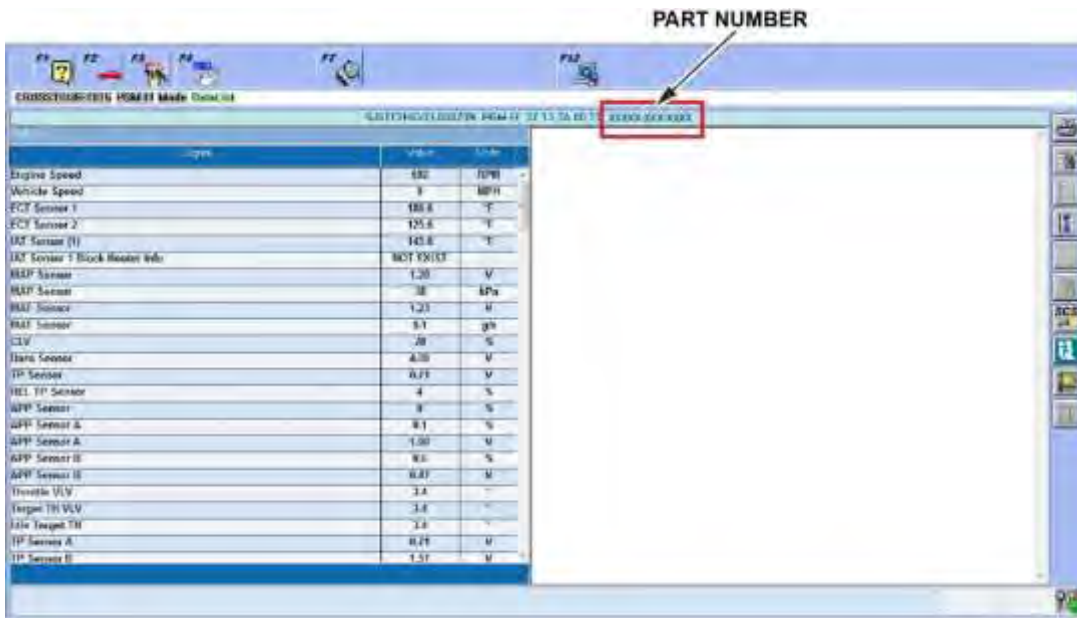
3. For 2011 Odyssey only: Check the PCM software version P/N located above the **PGM FI Data List**.

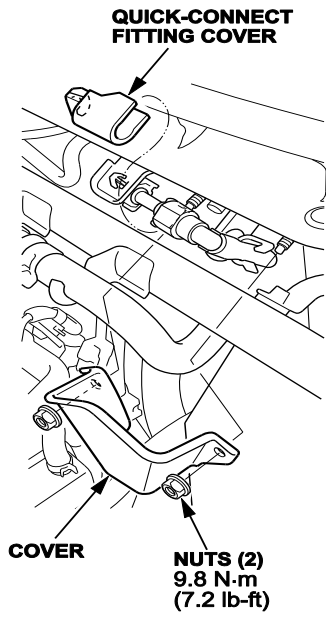
4. Disconnect the fuel feed hose line at the bulkhead.

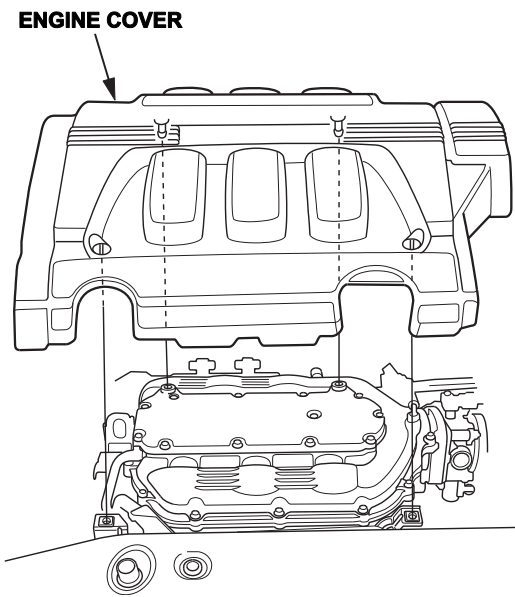
5. Remove the engine cover.

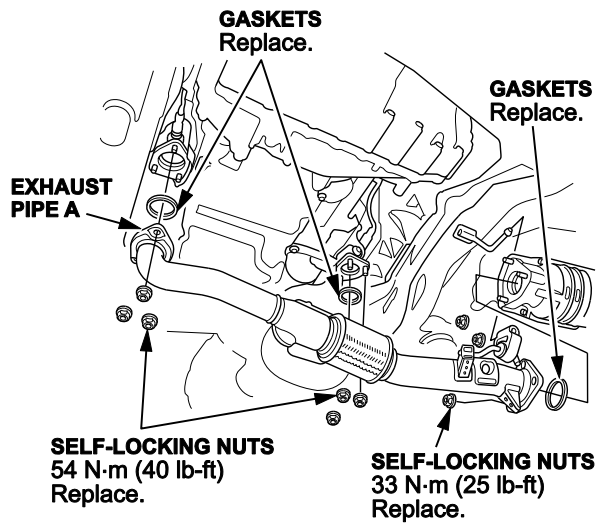
12. Remove exhaust pipe A.

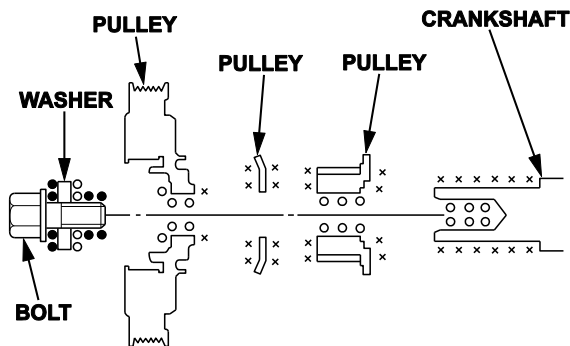
13. Depending on the diagnosis, remove the appropriate WU-TWC support bracket bolts.
14. Remove the EGR lower pipe nuts.
15. Remove the crankshaft pulley bolt but not the pulley.

NOTE: Make sure to apply new oil to the bolt flange and threads before reinstallation.

- X : Remove any oil
- O : Clean
- : Lubricate with new engine oil

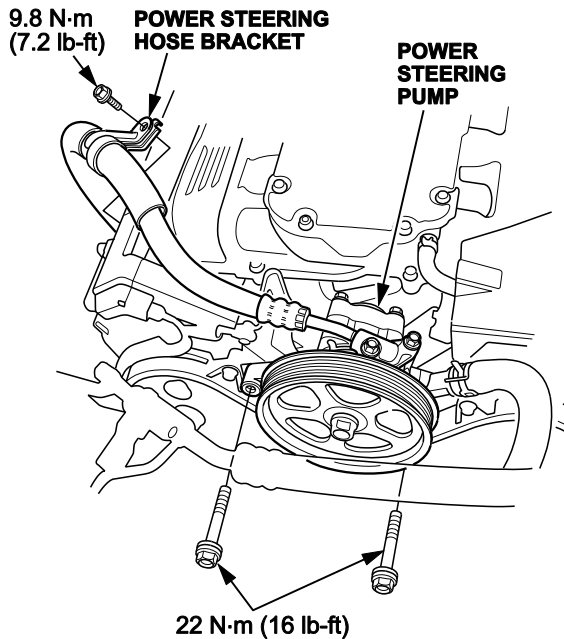
20. Remove the drive belt.
21. Remove the drive belt auto-tensioner.
22. Remove the power steering pump bolts, the power steering bracket then secure the power steering pump out of the way.

NOTE: Do not remove any of the hoses.

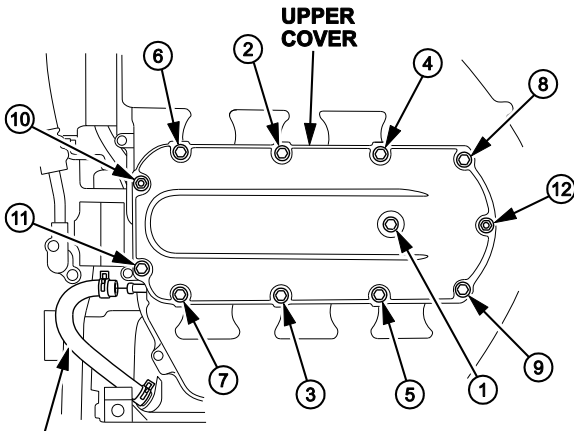
PCV HOSE

28. Remove the engine intake upper cover and PCV hose.

SPECIFIED TORQUE
6 x 1.0 mm
12 N·m (8.7 lb-ft)

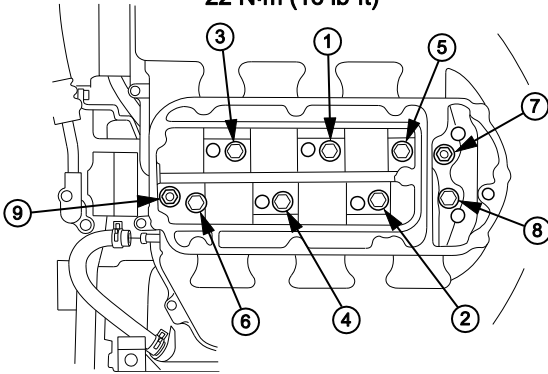
29. Remove the intake manifold bolts and nuts in three steps, then remove the intake manifold.

SPECIFIED TORQUE
22 N·m (16 lb-ft)

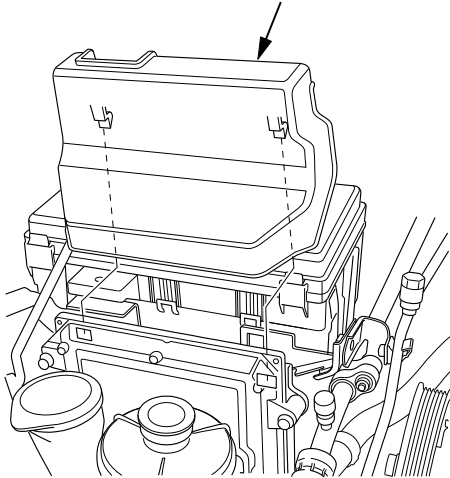
PCM COVER

30. Remove the PCM cover.

KEIHIN SHOWN:

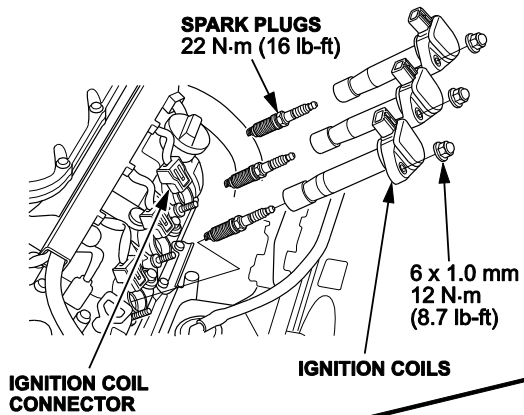
FRONT

32. Remove the appropriate Ignition coils based on the diagnosis.

NOTE: Depending on the diagnosis, you will either have to remove the rear bank ignition coils or both ignition coil banks.

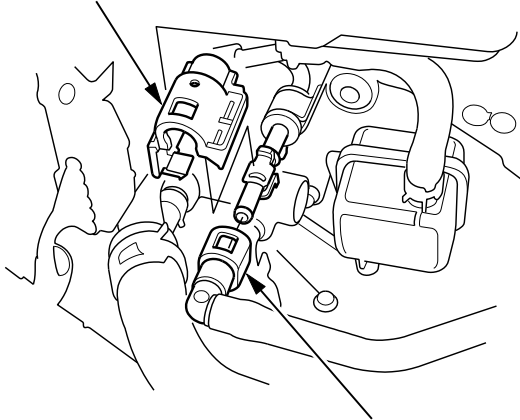
**QUICK-CONNECT
FITTING COVER**

34. Remove the quick-connect fitting cover, then disconnect the fuel feed hose.

FUEL FEED HOSE

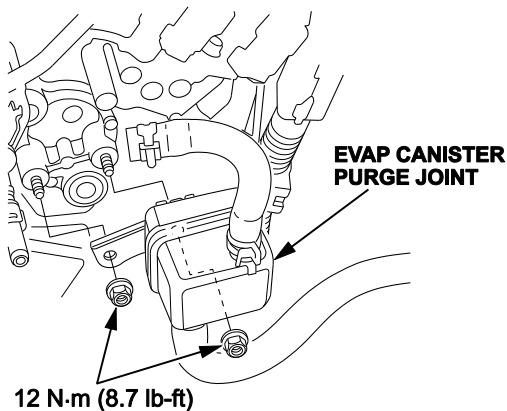
35. Remove the EVAP canister purge joint with the bracket.

12 N·m (8.7 lb-ft)

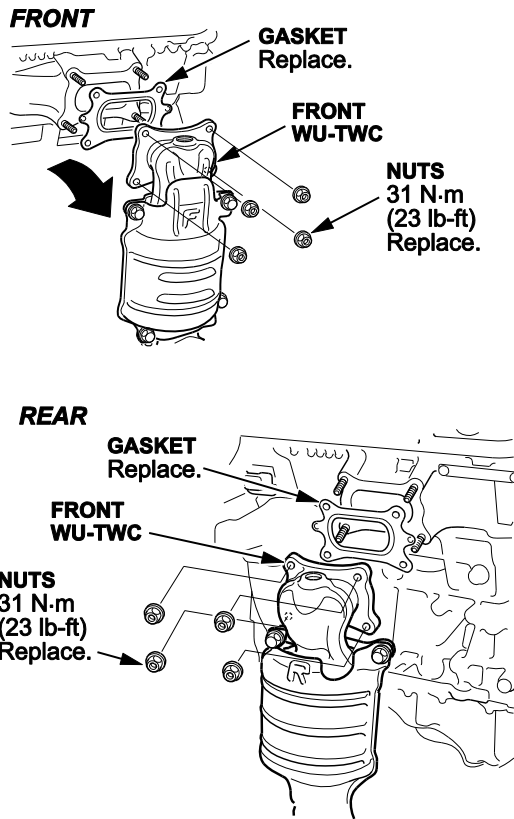
39. Remove the appropriate WU-TWC depending on diagnosis.

NOTE: Set the WU-TWC aside and cover the opening with shop towels to prevent coolant from entering.

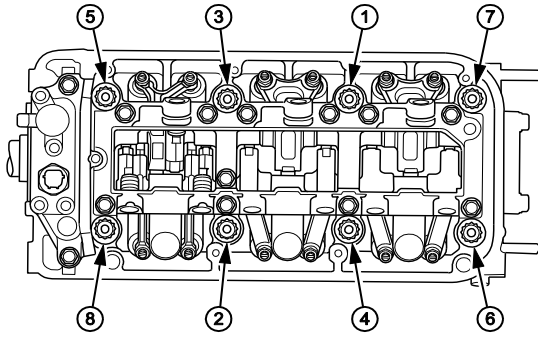
FRONT

40. Remove the appropriate head with the injector base attached.

NOTE: Depending on diagnosis, you will remove the rear bank head or both heads.

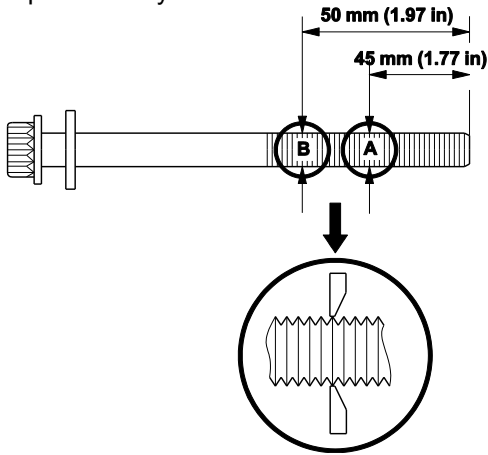
41. Measure the head bolts to determine if they need replacement. If either diameter is less than **11.3 mm (0.445 in)**, replace the cylinder head bolt.

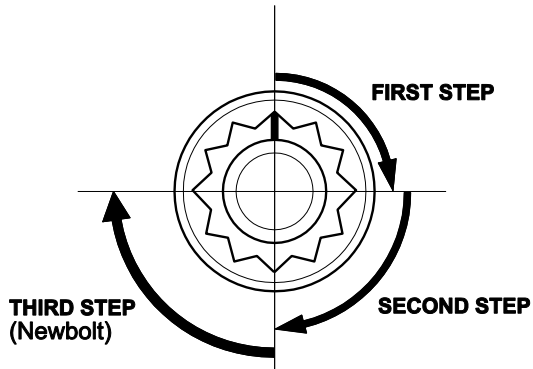
NOTE: Below are the head bolt torque specifications for reinstallation.

- First step: torque the cylinder bolts in sequence to **29 N•m (22 lb-ft)**.
- Second step: tighten in sequence an additional **90 degrees**.
- Third step: tighten in sequence an additional **90 degrees**.
- If the bolts are new, tighten an additional **90 degrees**.

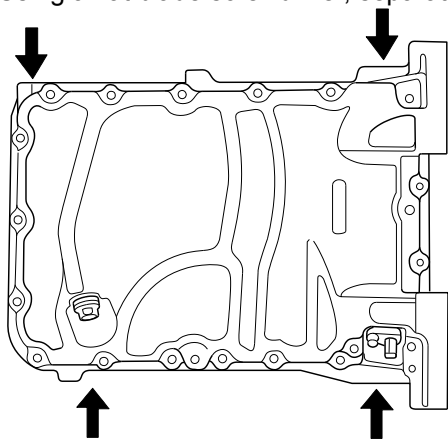
46. Using a flat blade screwdriver, separate the oil pan from the engine block in the areas shown.

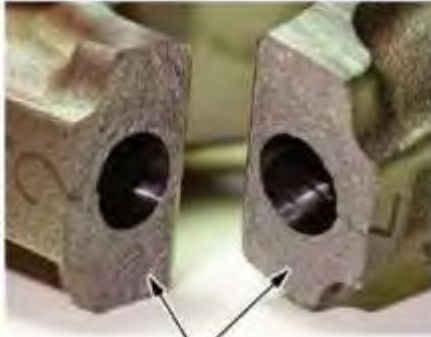
The uneven mating surfaces are uniquely matched and not interchangeable.

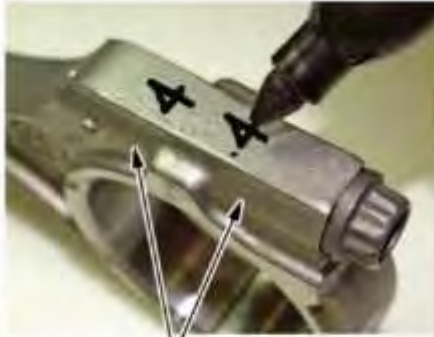
Mark the connecting rod and rod cap with the cylinder number.

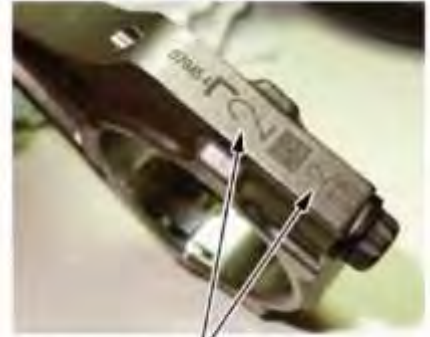
These are manufacturing marks, and do not indicate the cylinder number.

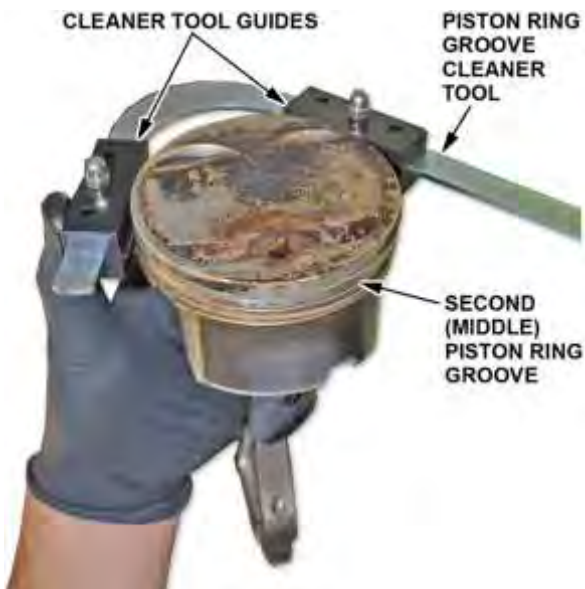
3. While holding the piston upright in your left hand, take the piston ring groove cleaner tool in your right hand and line up the cleaner tool guides with the second (middle) piston ring groove.

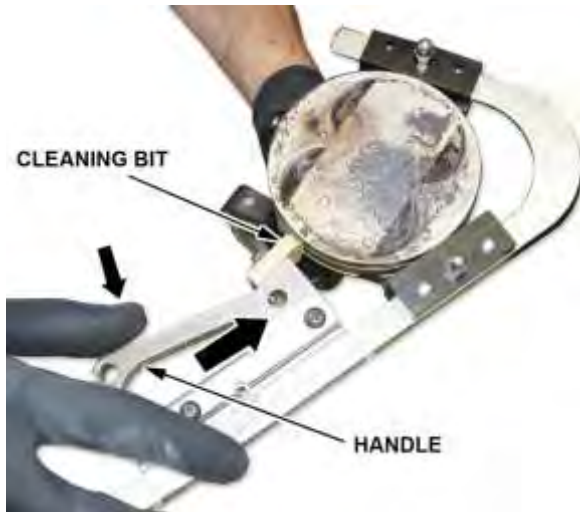
4. Press the handle on the piston ring groove cleaner tool and slide the cleaning bit onto the appropriate piston ring grooves.

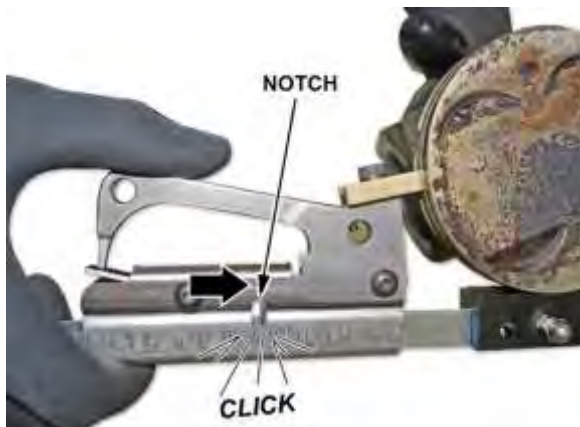
5. Once the cleaning bit is in the appropriate ring grooves of the piston, make sure the tool handle clicks in to place.
NOTE: There is only one notch on the tool for the handle to engage.

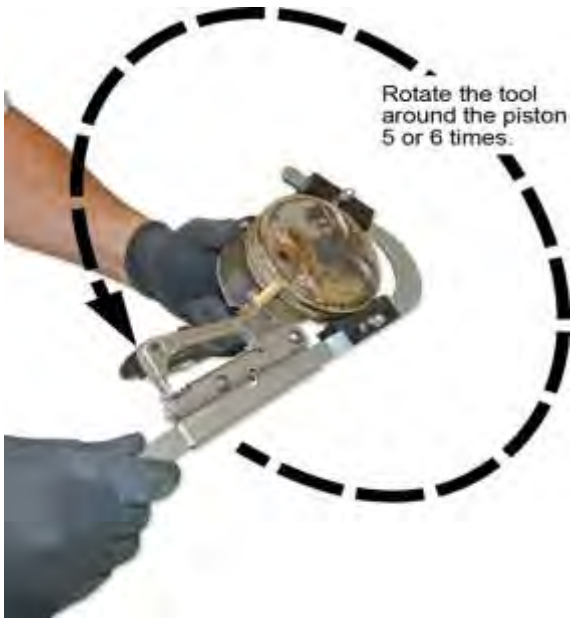
6. Hold the piston steady and rotate the tool counter-clockwise five to six times to remove any carbon deposits in the piston ring grooves. **Do not** rotate the tool clockwise.

NOTE: You can watch this procedure in the *Tech2Tech* segment "How to Clean Piston Ring Grooves".

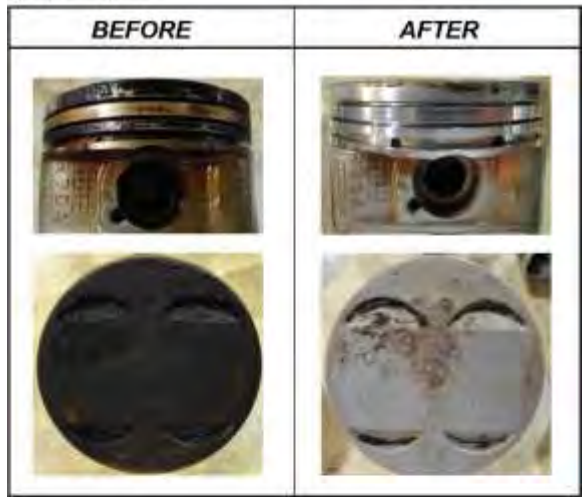
54K PISTON

NOTE: Below are some examples of before and after pictures. Depending on mileage and running conditions, the pistons will achieve different levels of cleanliness.

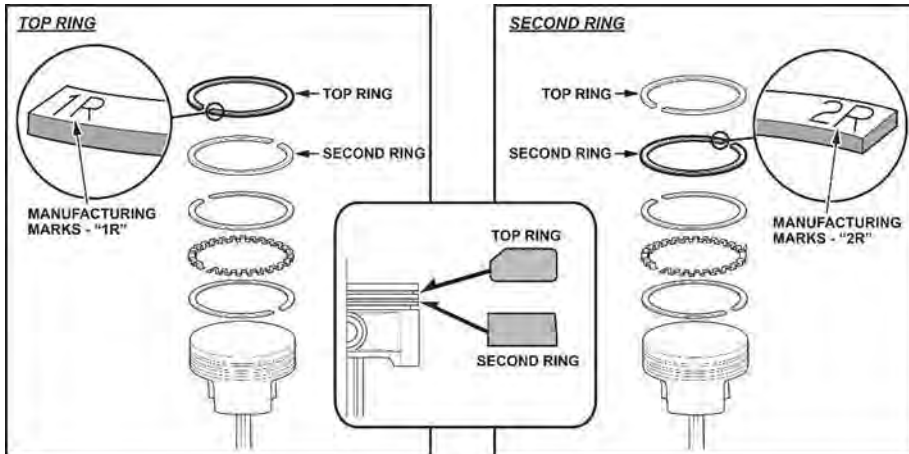
9. Install the piston rings as shown.

NOTE: The first (top) ring has a **1R** manufacturing mark and the second (middle) ring has an **2R** manufacturing mark. The manufacturing marks must be facing upward.

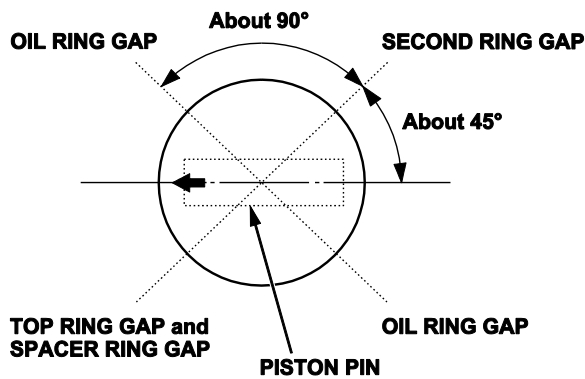
10. Position the ring end gaps as shown.

NOTE: If the ring gaps are not positioned correctly, excessive blowby may occur.

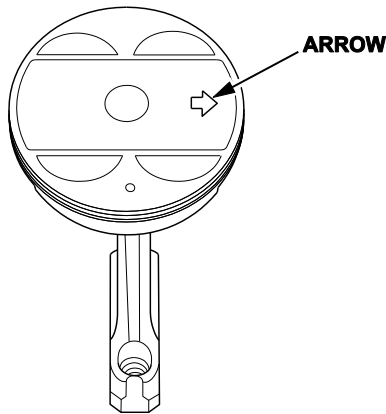
12. Install the piston/connecting rod assembly into the cylinder bore with the arrow on top of the piston facing the timing belt side of the engine.

NOTE: Be careful not to damage the cylinder wall when installing the piston.

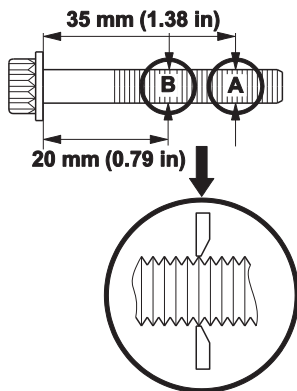
13. Measure the diameter of the connecting rod bolts to determine if they need replacement. Calculate the difference in diameter between point A and point B. It should not be more than **0–0.1 mm (0–0.004 in)**.

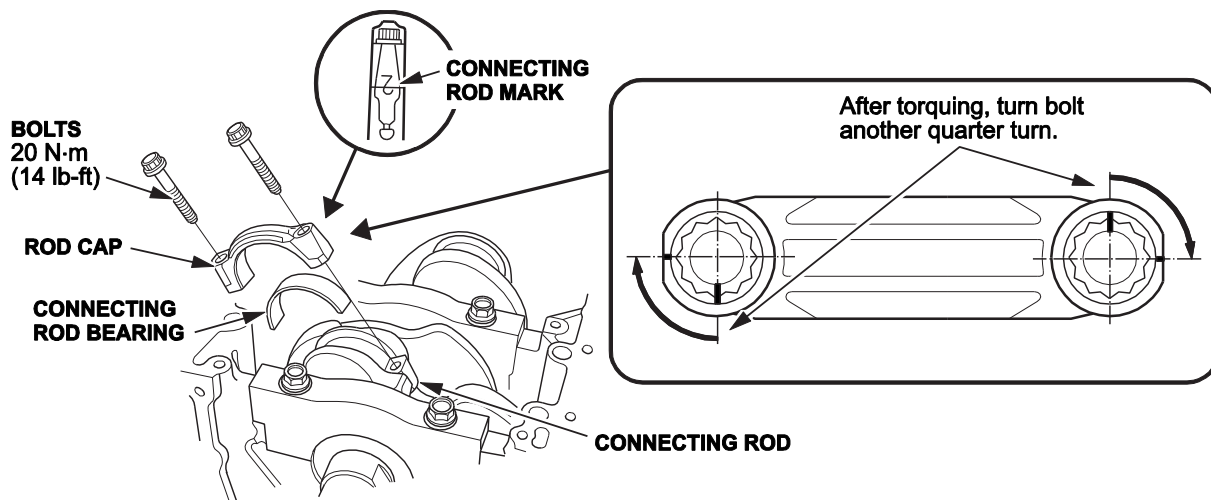
14. Apply new oil to the connecting rod bolt threads and flanges. Torque the bolts to **20 N•m (14 lb-ft)** then tighten the connecting rod bolts an additional **90 degrees**.
