# Service Bulletin

**Subject:** Spray-in Bed Liner General Information and Repair Procedures

**Models:** 2013-2014 Chevrolet Silverado HD 2500/3500 Series  
2015-2016 Chevrolet Colorado, Silverado  
2013-2014 GMC Sierra HD 2500/3500 Series  
2015-2016 GMC Canyon, Sierra  
Equipped with Spray-in Bed Liner (RPO CGN)

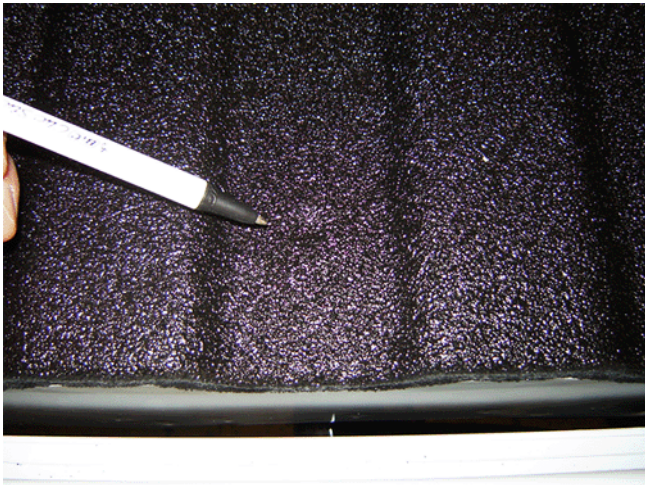
Because the bed liner material is sprayed on evenly, any variation in the bed such as seam sealer or spot welds in the sheet metal will show underneath the spray on coating. This is an expected condition. The coating does not completely fill in these variations.

**Spot weld under bed liner example**
