Preliminary Information

PIC6254C Information On Servicing The 1LE Vinyl Hood Wrap

Models

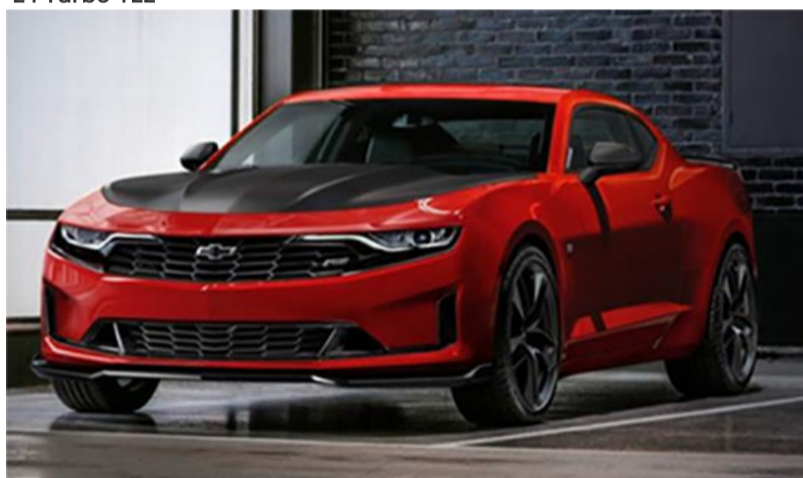
L4 Turbo 1LE

Involved Region or Country	North America
Additional Options (RPO)	Equipped with the 1LE track package, RPOs A1X, A1Y, or A1Z
Condition	All 2017 - 2019 Camaro 1LE cars come equipped with a vinyl hood wrap that is applied before the cars arrive at the dealership. Some dealerships may be looking for additional information on this wrap when it comes to care, cleaning, or in some situations, replacement of the entire hood wrap.
Cause	These hood wraps are all made of a matte finished vinyl material and all of them are black in color. They can be damaged if they are not cared for properly. The most common complaints are smudges or stains that are usually the result of fingerprints, improper cleaning practices, and/or products or leaves that remain on the car and create an outline on the vinyl. In some situations, the customer may even comment about small rips / other physical damage to the wrap itself.

If any suspect damage is found on one of these hood wraps, dealerships are to first attempt to clean the hood before taking any other action.

Hand washing is recommended using a mild detergent and water. Immediately rinse the vehicle and dry the graphic with a soft squeegee and/or soft cloth to help restore the graphic's luster.

- Touchless car washing systems may be used. To avoid water spotting on graphic, always go through the drying cycle.
- To remove tar and bugs from the graphic, use a commercial cleaner designed for such use, but do not rub vigorously. Immediately wash with a mild detergent / water solution, rinse with water, and dry.

If the concern remains and it's determined a new hood wrap is needed, the 1LE hood wrap (Hood Wrap Decal) can be obtained thru GM Service Parts. All 1LE's use the same part number hood wrap. It will be necessary to cut the holes in the hood wrap to accommodate any hood vents or heat extractors however. The 1LE hood wrap must be installed by a certified "wrap" technician. If your dealership/body shop does not have a certified installer, contact Ryan Scislowicz at Kay Automotive Graphics. His phone number is 248-377-4999, extension 3640. He will be able to direct the dealership to the local certified installer.
