## Preliminary Information

### PIP5159C Engine Misfire May Be Due To Loose Spark Plug Wires Models

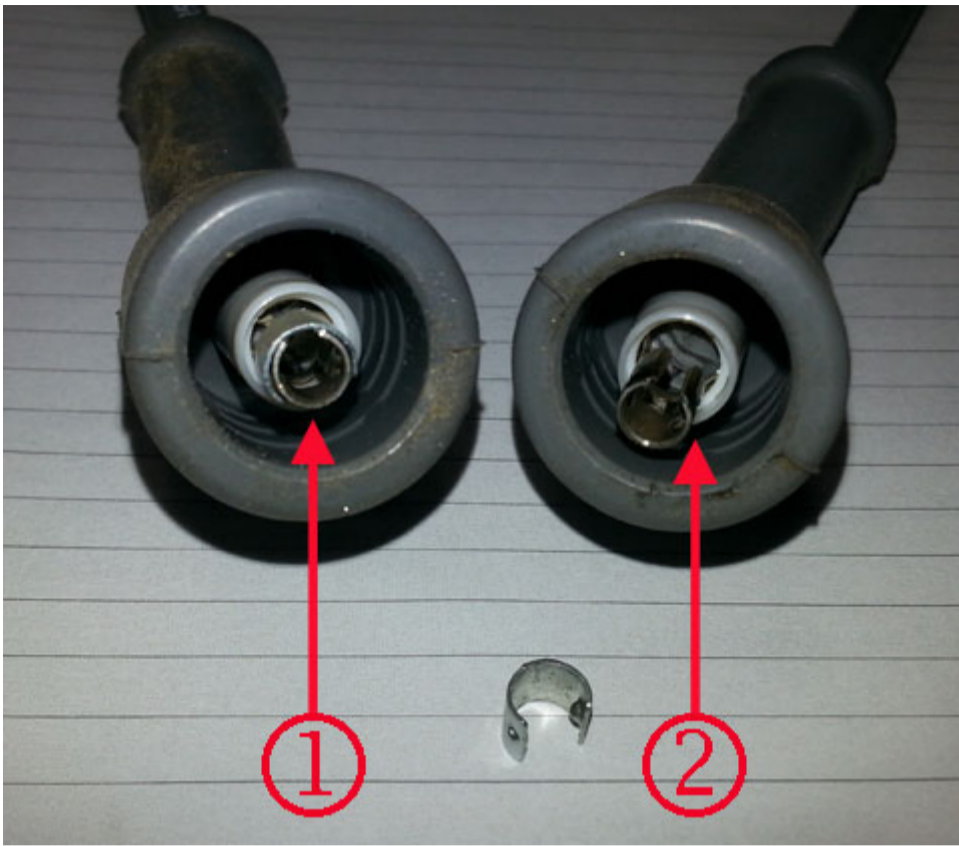
**SES lamp on, DTC P0300 - P0308 may set, inspect for a possible loose sparkplug wire at the ignition coil.**

**1. Shows a good sparkplug wire.**

**2. Shows the wire with the C clip missing.**

**If a loose sparkplug wire is found, inspect for missing "C" clip on wire end that connects to the ignition coil.**

**Replace the sparkplug wire if you find the "C" clip missing or damaged.**

**If this concern is not found reconnect the sparkplug wire to the ignition coil.**
