**December 20, 2018**

**Warranty Extension: MIL Comes On With DTCs P0301 thru P0304**Supersedes 13-081, dated June 13, 2018, to revise the information highlighted in **yellow**.**AFFECTED VEHICLES**

Year	Model	Trim	VIN Range
2011-13	Odyssey	ALL	Check the iN VIN status for eligibility.

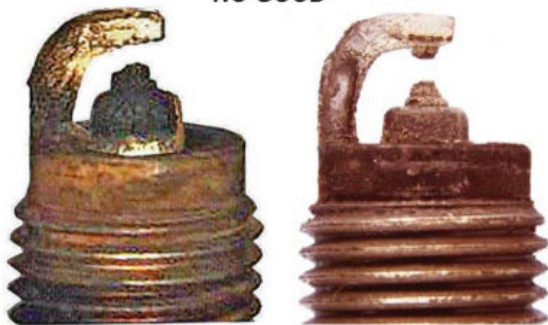
2. Remove and check the spark plug(s) on the affected cylinders (example: if P0301 is stored, check the spark plug on cylinder No. 1).

*Are the spark plug(s) fouled?*

**GOOD**

**NO GOOD**

The piston rings on certain cylinders may rotate and align, which can lead to spark plug fouling. This can set DTCs P0301 No. 1 cylinder misfire detected, P0302 No. 2 cylinder misfire detected, P0303 No. 3 cylinder misfire detected, P0304 No. 4 cylinder misfire detected, and cause the MIL to come on.

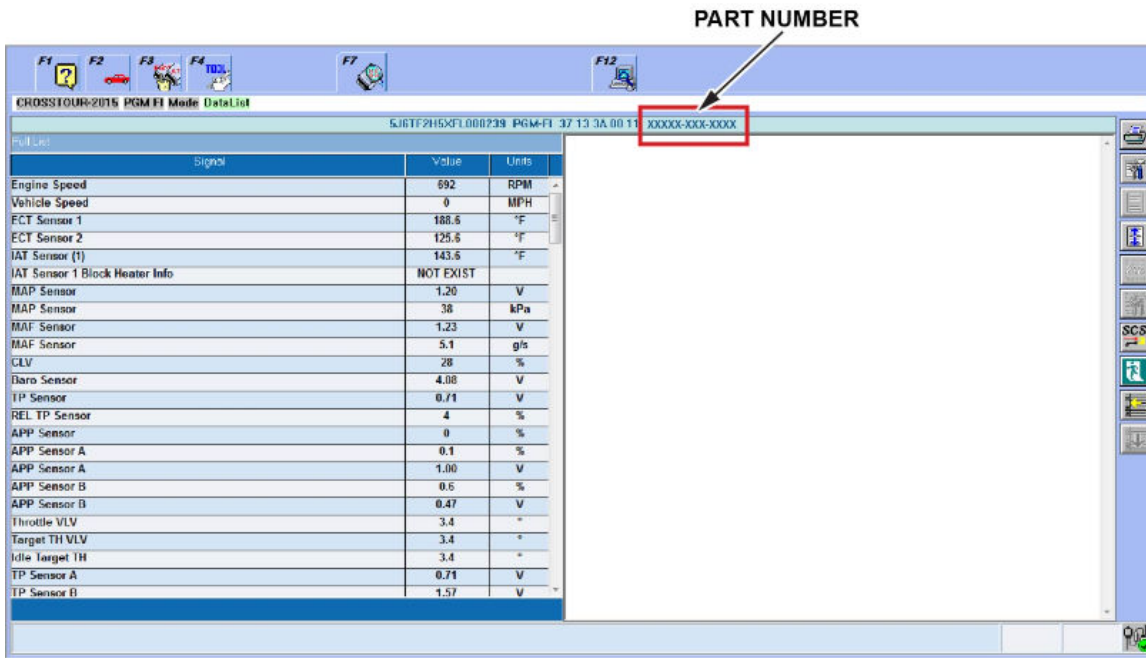
3. For 2011 Odyssey only: Check the PCM software version P/N located above the PGM FI Data List.

Year/Model	Program ID (or later)	Program P/N (or later)
2011 Odyssey (5-speed A/T)*	V0A560	37805-RV0-A56
2011 Odyssey (5-speed A/T)**	V0A240	37805-RV0-A24
2011 Odyssey (6-speed A/T)*	V0A760	37805-RV0-A76
2011 Odyssey (6-speed A/T)** (VIN before 5FNRL5...CB056992)	V04250	37805-RV0-425
2011 Odyssey (6-speed A/T)** (VIN including 5FNRL5...CB056992 and after)	V0A360	37805-RV0-A36
2012–13 Odyssey (ALL)	Software Updated from Factory

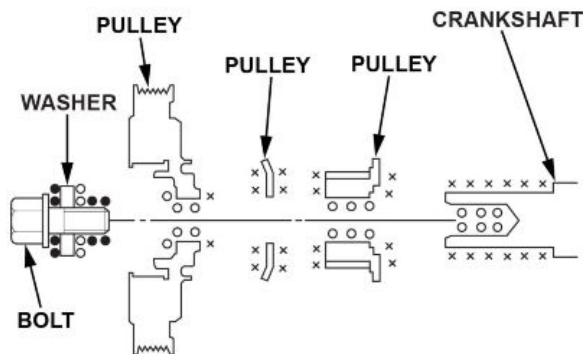
15. Remove the crankshaft pulley bolt but not the pulley.

Make sure to apply new oil to the bolt flange and threads before reinstallation.

X : Remove any oil

O : Clean

● : Lubricate with new engine oil

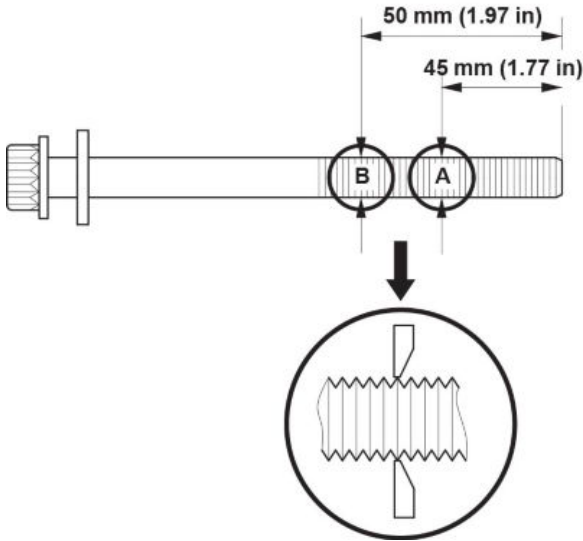
41. Measure the head bolts to determine if they need replacement. If either diameter is less than **11.3 mm (0.445 in.)**, replace the cylinder head bolt.

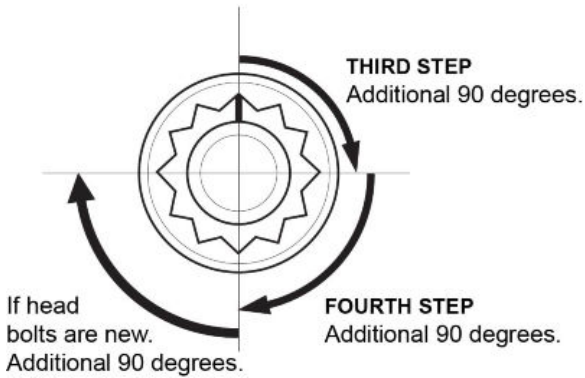
Below are the head bolt torque specifications for reinstallation.

- 41.1. Apply new engine oil to the threads and under the bolt heads.
- 41.2. Torque the cylinder bolts in sequence to **29 N•m (22 lb-ft)**.
- 41.3. Tighten in sequence an additional **90 degrees** (third step).
- 41.4. Tighten in sequence an additional **90 degrees** (fourth step).
- 41.5. If the bolts are new, tighten an additional **90 degrees**.

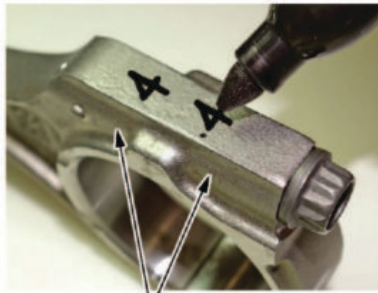
Mark the connecting rod and rod cap with the cylinder number.

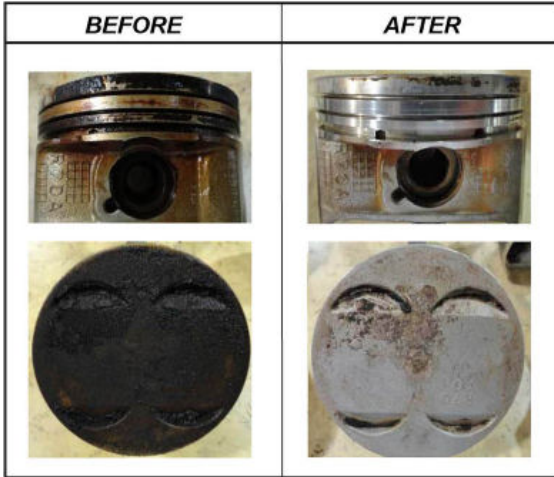
**54K PISTON**

Below are some examples of before and after pictures. Depending on mileage and running conditions, the pistons will achieve different levels of cleanliness.

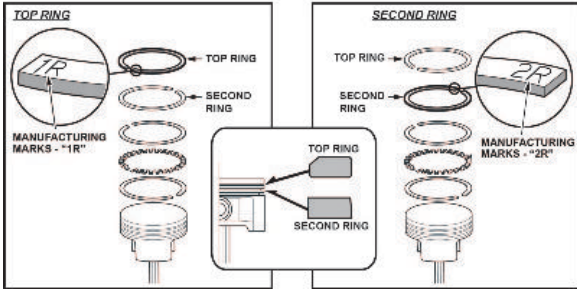
9. Install the piston rings as shown.

The first (top) ring has a 1R manufacturing mark and the second (middle) ring has an 2R manufacturing mark. The manufacturing marks must be facing upward.

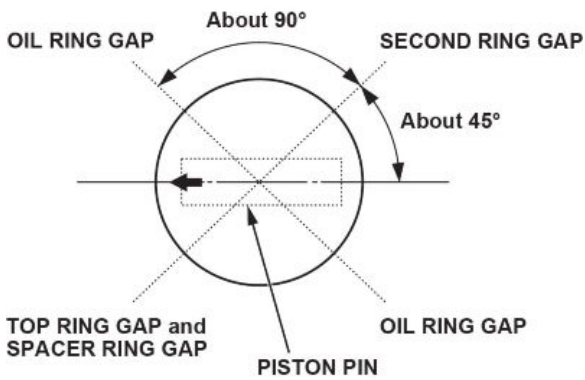
11. Position the ring end gaps as shown.

If the ring gaps are not positioned correctly, excessive blowby may occur.

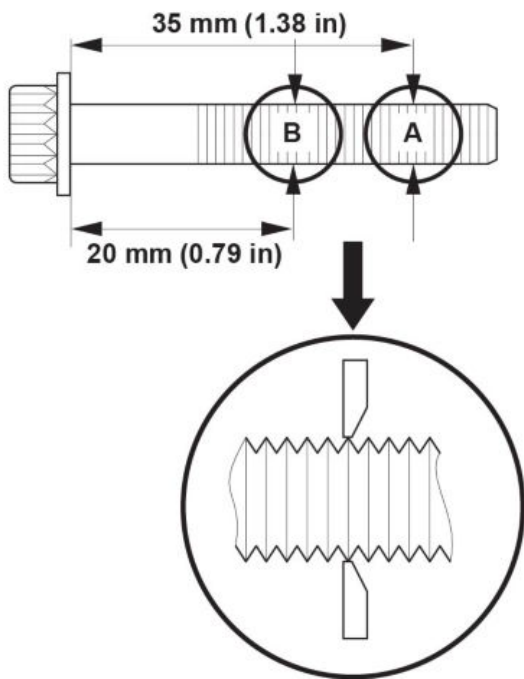
17. Measure the diameter of the connecting rod bolts to determine if they need replacement. Calculate the difference in diameter between point A and point B. It should not be more than **0–0.1 mm (0–0.004 in)**.

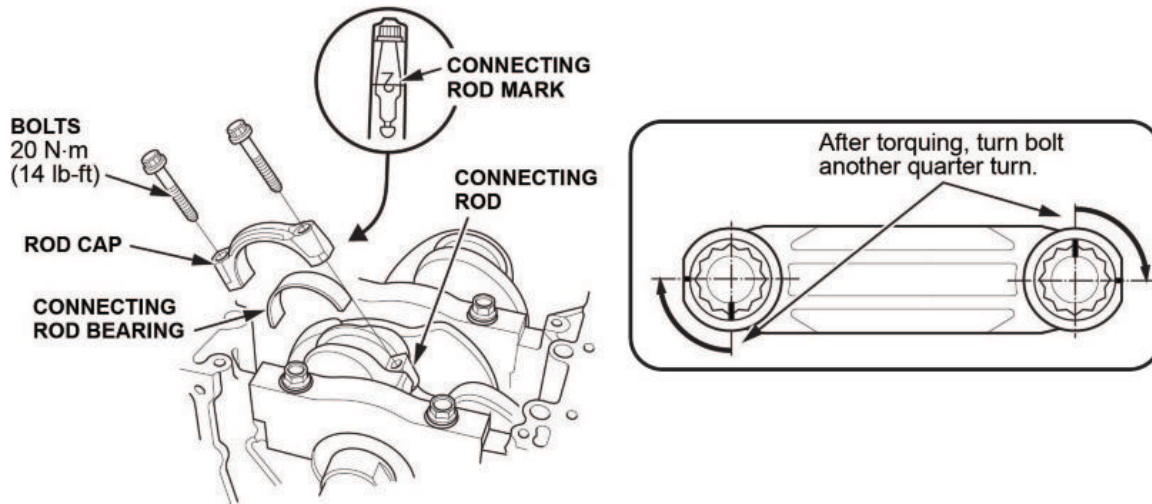
18. Apply new oil to the connecting rod bolt threads and flanges. Torque the bolts to **20 N•m (14 lb-ft)** then tighten the connecting rod bolts an additional **90 degrees**.
