# **Preliminary Information**

## PIP5654 10L90 10L80 10 Speed Automatic Transmission Valve Body Part Unique Number PUN May Contain the Letter O Or The Number 0

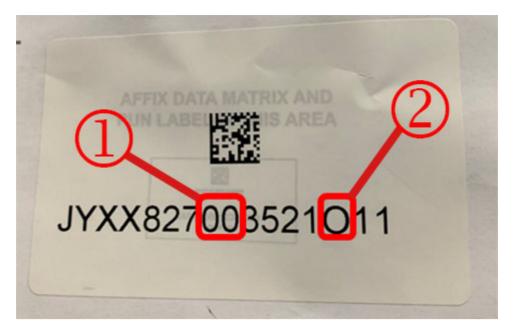
Please be aware that the PUN may contain the letter O or the number 0 as shown in the picture below.

Call Out 1

The number 0.

Call out 2

The letter O.

If the valve body is replaced the dealer technician may find that software may not accept the Part Unique Number (PUN) during the characterization procedure.
