Service Bulletin

Bulletin No.: 19-NA-137

Subject: Squeak Noise From the Vehicle Underbody

Brand:	Model:	Model Year:		VIN:		Engine:	Transmission:
		from	to	from	to		
Cadillac	Escalade	2015	2019				
Chevrolet	Suburban						
	Tahoe						
GMC	Yukon

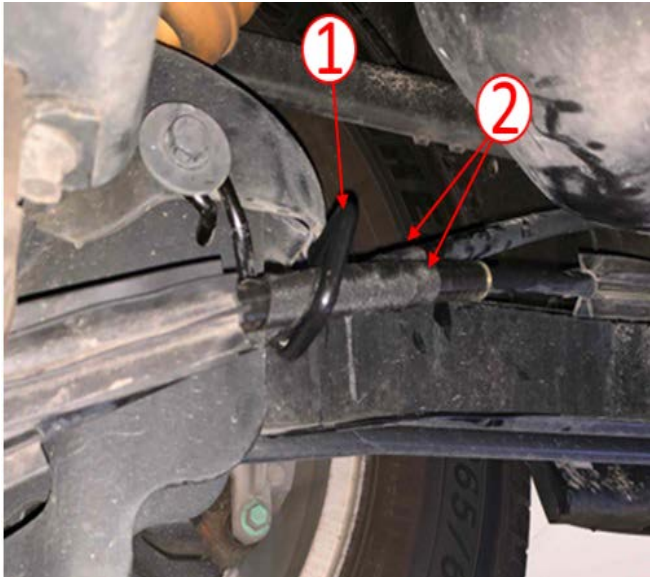
Involved Region or Country	North America, Russia, Europe, Middle East, Israel, South America, Japan, South Korea and Thailand.
Condition	Some customers may comment that a squeak noise can be heard from under the vehicle while driving at slow speeds.
Cause	This condition may be caused by the parking brake cables rubbing against each other.
Correction

<p style="text-align: right; font-size: small;">5360283</p> <p>Note: Ensure that the tape extends at least 25 mm (1 in) above and below the rubbing point at the parking cable bracket.</p> <p>Using Woven Polyester Electrical Tape (PET), locate both of the brake cables near the parking brake cable bracket (1) and apply tape (2) to the cables ensuring that the tape is applied in a double layer extending along the cable as shown above.</p>
