## Service Bulletin

Bulletin No.: 09-06-04-026Q

Subject: Identifying Non-GM (Aftermarket) Engine Calibrations for Gasoline Engines Using

Tech 2® or GDS 2 (U.S. and Canada)

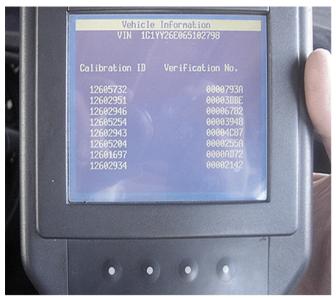
2278650

Calibration ID	Verification No.
Engine 12653674	9000C51F
Engine 12647447	00005530
Engine 12647433	00006C37
Engine 12625892	000036F2
Engine 12647443	00005C9A
Engine 12647455	000051FD
Engine 12647464	00000335 0000EE49
Engine 12647459	0000CC43

- Two examples of the Tech 2® Vehicle Information - (Engine) Calibration ID and Verification No. screens are shown.
- The Tech 2® Vehicle Information -Calibration ID and Verification No. screen will differ slightly depending on vehicle and model year.
- 8. Take a CLEAR digital picture(s) of the Tech 2® Vehicle Information screen showing the entire VIN, (Engine) Calibration ID and Verification No. (Number/CVN) and save it in .jpg format.

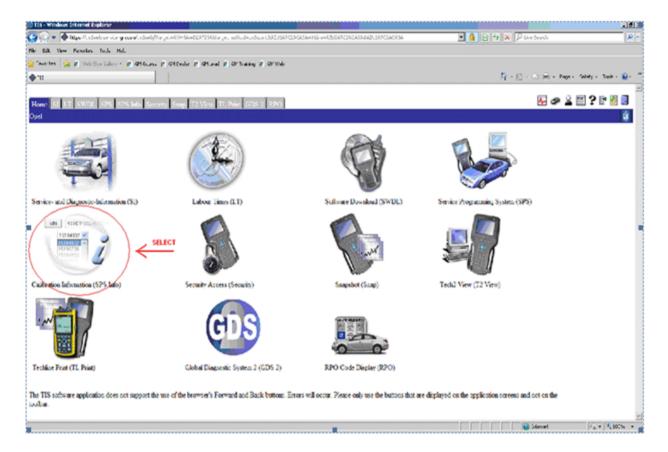
3340046

1. Go to: TIS2WEB Home Page.
