# SERVICE BULLETIN

APPLICABILITY: 2019-20MY Ascent NUMBER: 05-71-19F

Front Coil Spring Inspection Procedure for

Knock / Rattle Sound

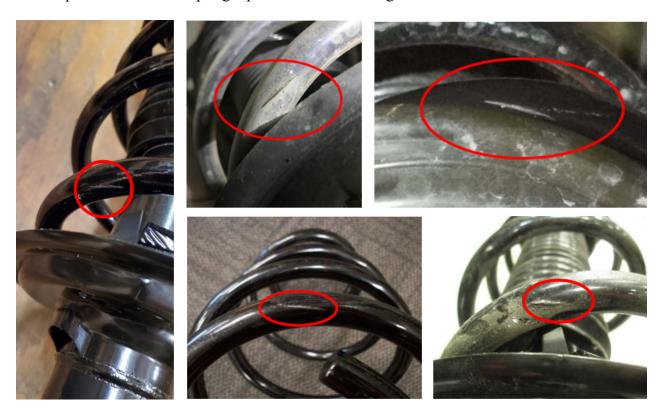
After verifying the customer concern, inspect the front coil springs **closely** for any contact (witness) marks as shown in the example photos supplied below. If any contact marks are confirmed, replace the affected coil spring closely following the procedure in the applicable Service Manual. The current procedures for coil spring replacement are unchanged.
