Service Bulletin

Bulletin No.: 20-NA-122

Subject: Information on Proper Liftgate Adjustment

Brand:	Model:	Model Year:		VIN:		Engine:	Transmission:
		from	to	from	to		
Buick	Encore GX	2020	2021	—		All	All
Chevrolet	Trailblazer	2021	2021	—		All	All

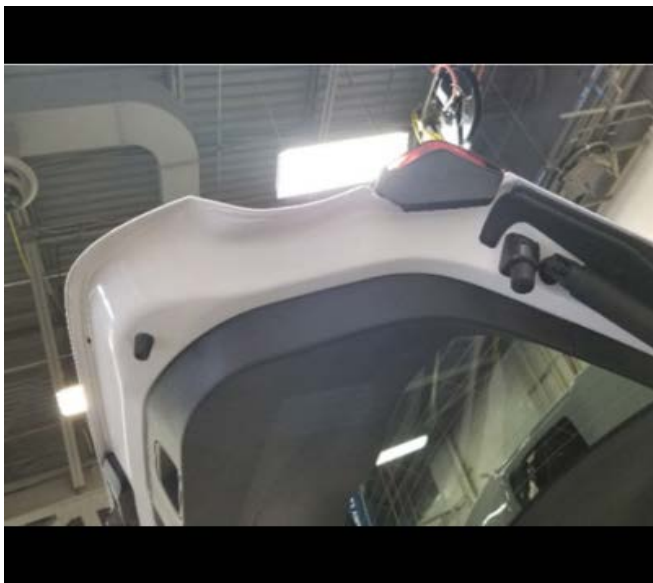
5613599

2. Close the liftgate with a piece of paper between the bumpers of the liftgate and the vehicle itself.
⇒ The paper should not be able to be pulled out, and the bumpers should be firmly seated.
3. Repeat and verify as necessary.

An improper liftgate adjustment may cause unwanted noises, so proper adjustment is important.

1. Open the liftgate.
