Service Bulletin

Bulletin No.: 15-06-01-002K

Subject: Engine Misfire/Tick Noise, Malfunction Indicator Lamp (MIL) Illuminated - DTC P0300 Set

Models: 2015-2019 Cadillac Escalade
2016-2019 Cadillac CTS-V
2014 Chevrolet Silverado 1500
2014-2019 Chevrolet Corvette
2015-2018 Chevrolet Silverado
2015-2019 Chevrolet Suburban, Tahoe
2016-2019 Chevrolet Camaro
2019 Chevrolet Silverado LD
2014 GMC Sierra 1500
2015-2018 GMC Sierra
2015-2019 GMC Yukon, Yukon XL
2019 GMC Sierra Limited
Equipped with 5.3L Engine (RPOs L83, L8B) or 6.2L Engine (RPOs L86, LT1, LT4)

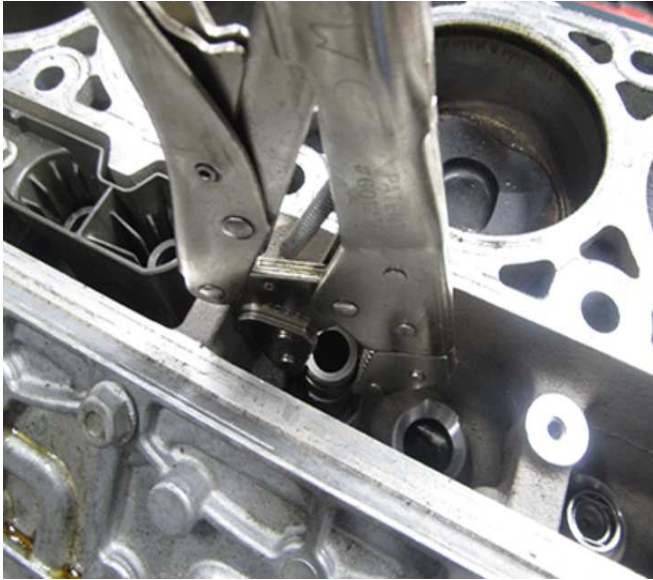
4250109

1. Use vice grips with a slide hammer.

There are two approved processes for removing the lifter when stuck in the bore.
