06/21/18 CAL FTL 60-001

Subject: Adding HVAC Ducting and Vent for the Upper Bunk

Models Affected: New Cascadia vehicles with a 72-inch raised roof sleeper

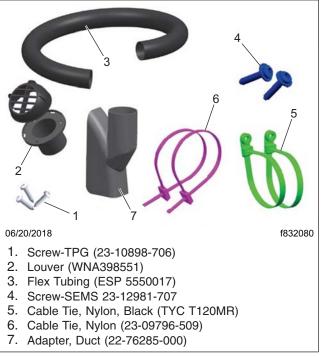
Fig. 1, Parts Required

See Fig. 1 for a list of parts in this bulletin.
