SERVICE BULLETIN

NUMBER: 09-74-21R

SUBJECT: Cleaning Procedure for Carbon Deposit Removal to Address Engine Misfire DTCs, Black Smoke from the Exhaust, Lack of Power, Knocking (Ping) and / or Rough Idle Concerns

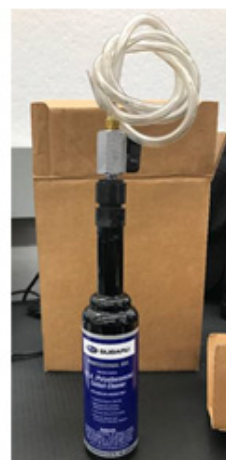
- **STEP 3 (all models):** Pour ONE full bottle of P.E.A. carbon cleaner into the vehicle's FULL fuel tank. **REMINDER:** The fuel tank **MUST** be FULL.
- **STEP 4:** With the valve CLOSED as shown below, remove the cap and thread the applicator tool onto the P.E.A. bottle. During use, try to keep the bottle vertical to insure all the contents are consumed.

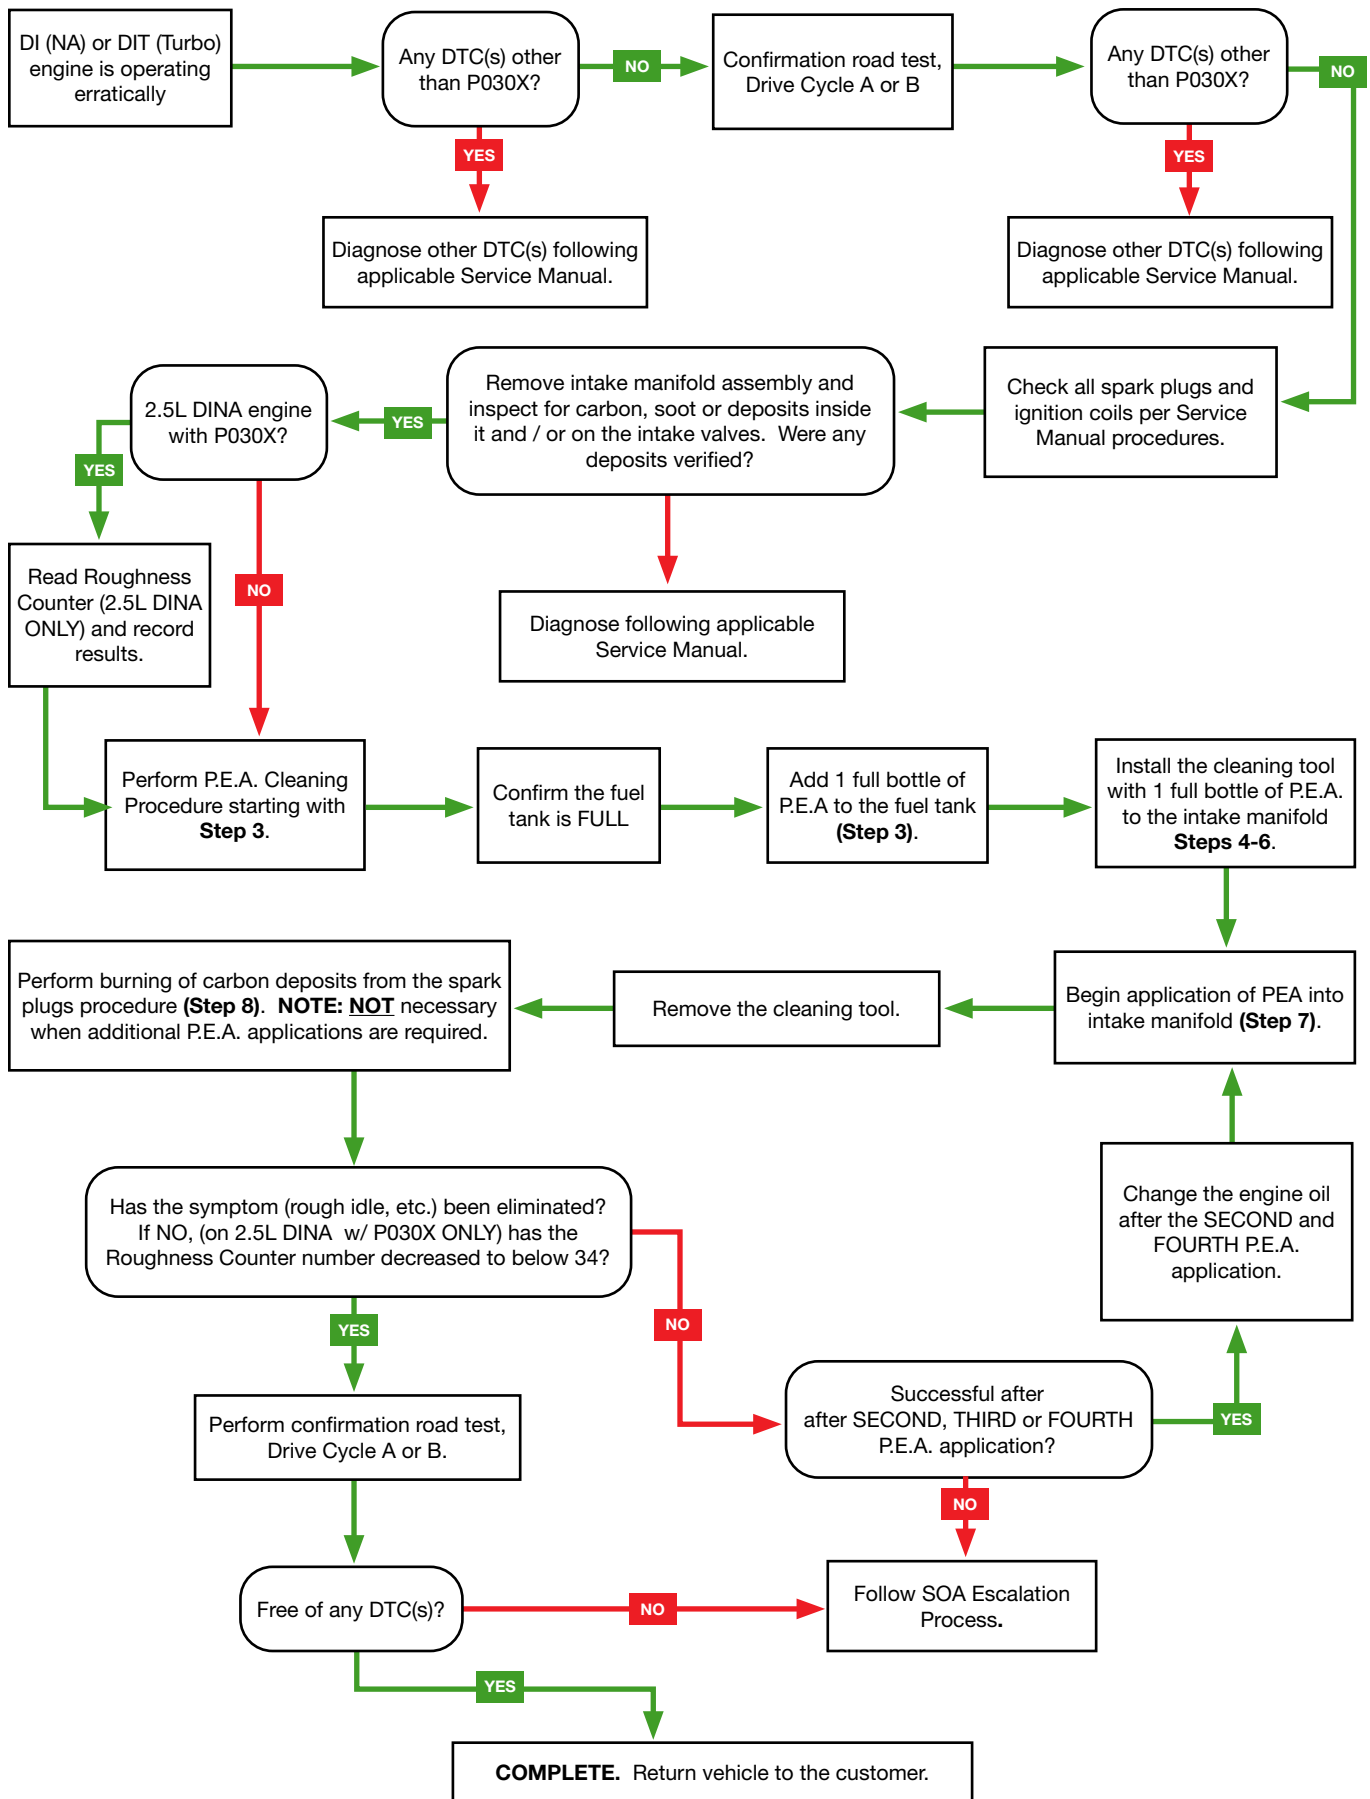
Appendix A: Service Procedure Flow Chart

VERY IMPORTANT: APPENDIX A has been added to the end of this bulletin (pg. 10) and it provides a Flow Chart for the overall Service Procedure described below. It is **STRONGLY RECOMMENDED** Technicians review the Flow Chart closely to ensure their understanding of the Service Procedure before proceeding further.
