July 02, 2021

Version 10

A/C Leak Detection

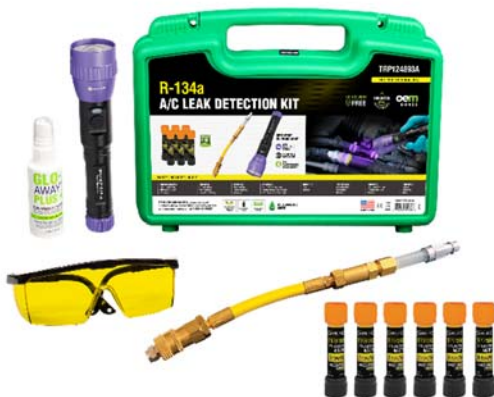
R-134a A/C Leak Detection Kit (P/N TRP124893A) includes these items:

- TPOPUVP OPTI-PRO™ UV Plus, rechargeable violet light LED leak detection flashlight (battery included)
- TRPTP3860P12 - (6) R-134a/PAG TRACER-STICK® Cartridges
- TRPTP19 - GLO-AWAY™ PLUS Fluorescent Dye Cleaner
- TRPTP9940 - Fluorescence-Enhancing Glasses
- TRPTP22 - (1) purge capsule (empty)
- TRPTP20 - R-134a hose with adapter/coupler/fitting
- TRPTP14 - USB charger (not pictured)

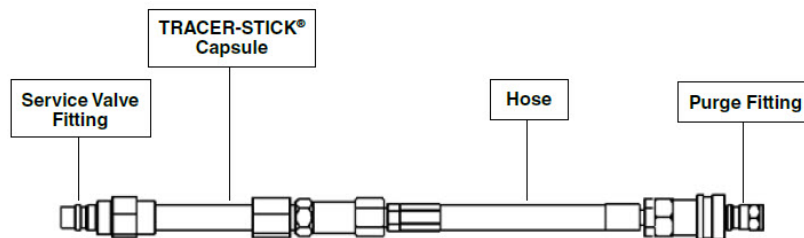
2.1. Assemble the injection hose as shown in the diagram using the EMPTY Tracer-Stick® capsule and the purge fitting

NOTE: Air and moisture must be evacuated from the hose assembly if it is being used for the first time, or if it has been stored with the control valve open. If the air and moisture have been evacuated, go to step 3; otherwise, do the following:

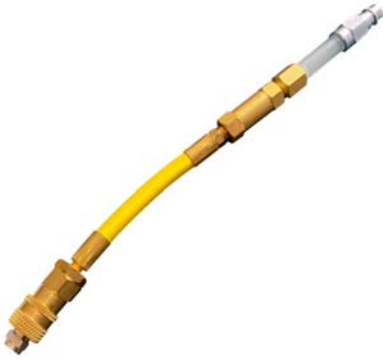
3. Connect the hose assembly and the Tracer-Stick® dye capsule:

3.1. For best results, the Tracer-Stick® should be connected so that the embossed arrow points toward the refrigerant flow.

3.3. Replace the cap the arrow points away from with the service valve fitting.

3.4. Remove the cap the arrow points toward and connect the stick to the hose.

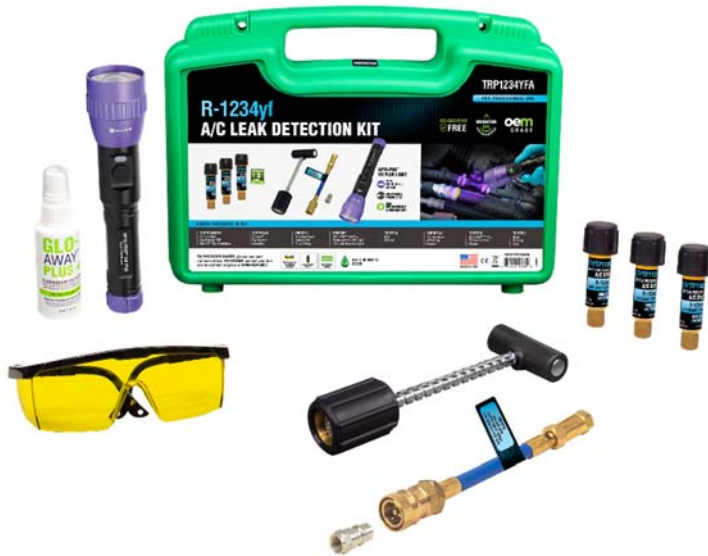
R-1234yf A/C Leak Detection Kit (P/N TRP1234YFA) includes these items:

- TPOPUVP OPTI-PRO™ UV Plus, rechargeable violet light LED leak detection flashlight (battery included)
- **TRPTP1108P12** - (3) R-1234yf Low Density POE Mini-EZ™ Dye Cartridges
- TRPTP9845 - EZ-Ject™ injector assembly
- TRPTP10 - R-1234yf hose/coupler with purge fitting
- TRPTP9940 - Fluorescence-enhancing glasses
- TRPTP19 - Glo-Away™ plus fluorescent dye cleaner
- TRPTP21 - Green carrying case
- TRPTP14 - USB charger (not pictured)

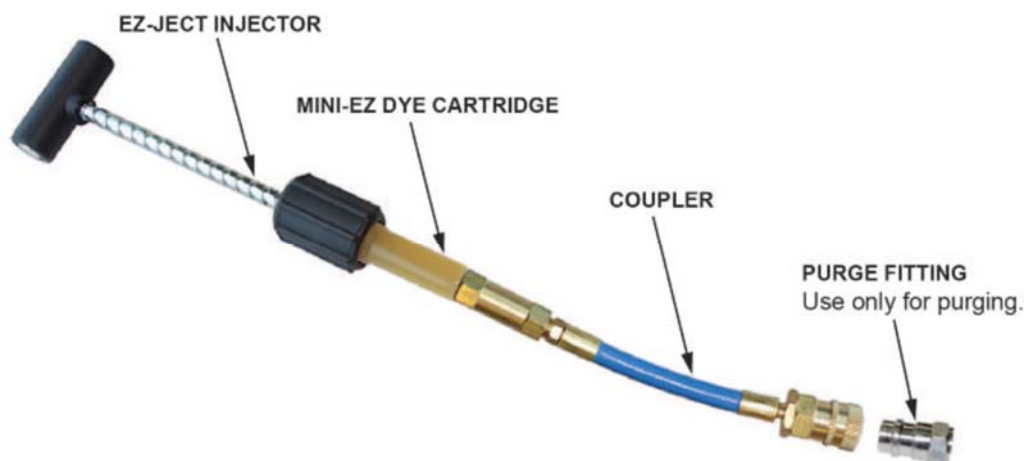
- If there is no dye in the system, go to step 2.
 - If there is dye in the system, go to step 13. **Do not add more dye.**
2. Unscrew the handle on the EZ-Ject injector completely, and screw in the Mini-EZ dye cartridge.

3. Holding the cartridge vertically, remove the cap and screw the cartridge firmly to the coupler.
4. Insert the adapter/purge fitting into the coupler.

5. Turn the handle to push forward the plunger until a small amount of dye exits the assembly.

6. Remove the adapter/purge fitting.
7. Clean any excess dye from the coupler.
8. The R-1234yf coupler is now purged, ready for use, and will be full of dye.
