## SERVICE BULLETIN

**NUMBER:** 09-74-21R

**SUBJECT:** Cleaning Procedure for Carbon Deposit Removal to Address Engine Misfire DTCs, Black Smoke from the Exhaust, Lack of Power, Knocking (Ping) and / or Rough Idle Concerns

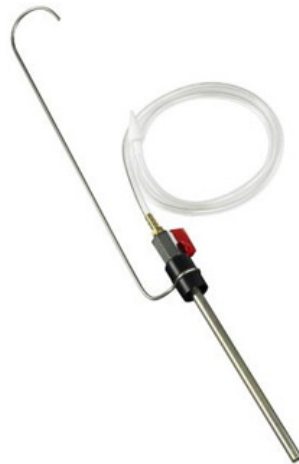
Use tool **SOA868V9430** with this black, long-neck style bottle only.

New tool **SOA868V9432** is to be used with these new shorter clear or black bottles only.

- The new (shorter) bottle contains the same amount of P.E.A. product (6.76 oz.) but utilizes the newer version (**SOA868V9432**) of the applicator tool which has a shorter siphon tube designed to work in conjunction with the new bottle.
- Be sure to use the correct tool for the corresponding bottle style. The siphon tube on the original (long-style) tool is approximately **7 5/8"** long while the new version for use with the shorter bottles measures **6 3/8"**.
- The end of the siphon tube on the tool should not contact the bottom of the bottle. If it does, the old tool is being used with the new style bottle.
- If the tool does not extract all the contents of the bottle, the new tool may have been used with the old bottle.
- Each retailer has been automatically shipped ONE of the new (shorter siphon tube) applicator tools at no charge.

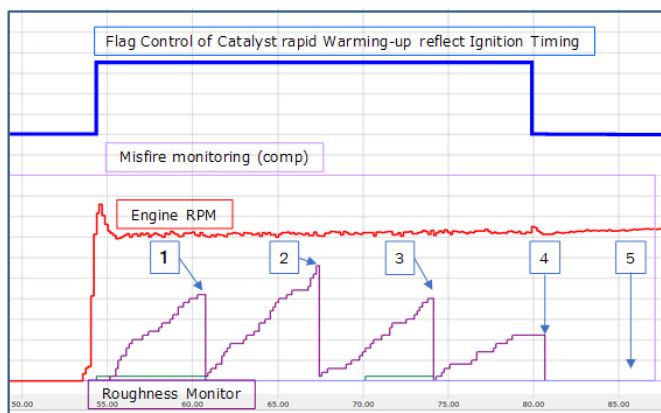
## EXAMPLE 2:

Cylinder:	Peak 1	Peak 2	Peak 3	Peak 4	Peak 5	Total:
#1 (Orange)	0	0	0	0	0	82
#2 (Blue)	1	0	1	0	1	
#3 (purple)	21	28	20	11	0	
#4 (Green)	0	0	0	0	0

- Flag control of Catalyst Rapid Warming-up reflect Ignition Timing
- Misfire Monitoring (comp)
- Engine RPM
- Roughness Counters #1, #2, #3 and #4.
- The roughness counter rises and resets (drops sharply) repeatedly which is the reason the signals form triangles. Read the peak values of each triangle on all cylinders until the “Misfire Monitoring (comp)” changes to “0” then, add all the values to get a “total” value. A **TOTAL** count of **34 or less** is to be considered acceptable.

- **EXCEEDS 34**, proceed to the P.E.A. cleaning procedure starting with **Step 3** below.
- **Is 34 OR LESS**, proceed to the Warranty and Claim Information and process a claim for Roughness Counter Inspection Only.

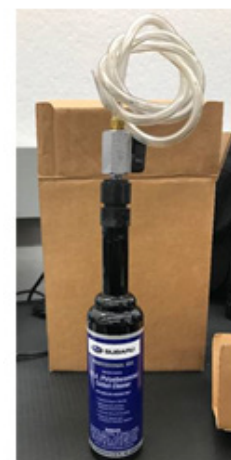
- **STEP 3 (all models):** Pour **ONE** full bottle of P.E.A. carbon cleaner into the vehicle's **FULL** fuel tank. **REMINDER:** The fuel tank **MUST** be **FULL**.
- **STEP 4:** With the valve **CLOSED** as shown below, remove the cap and thread the applicator tool onto the P.E.A. bottle. During use, try to keep the bottle vertical to insure all the contents are consumed.

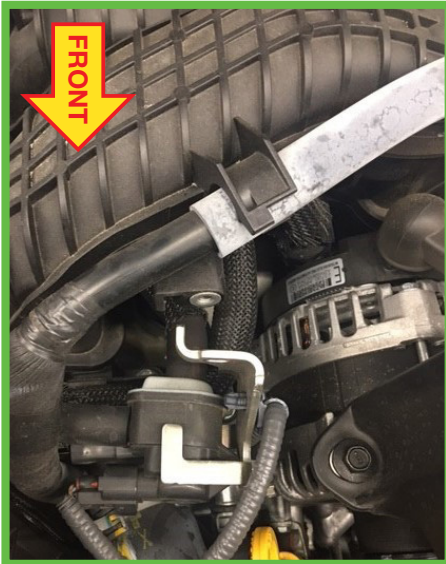
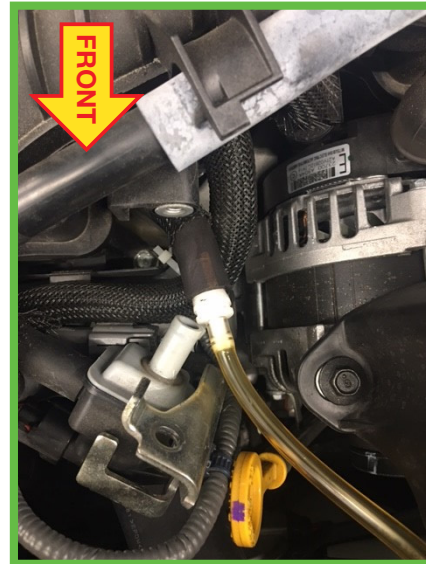
#### 2.4 DIT

- **STEP 6:** Remove the purge hose and connect the hose from the applicator tool. Refer to the images below for the hose locations.

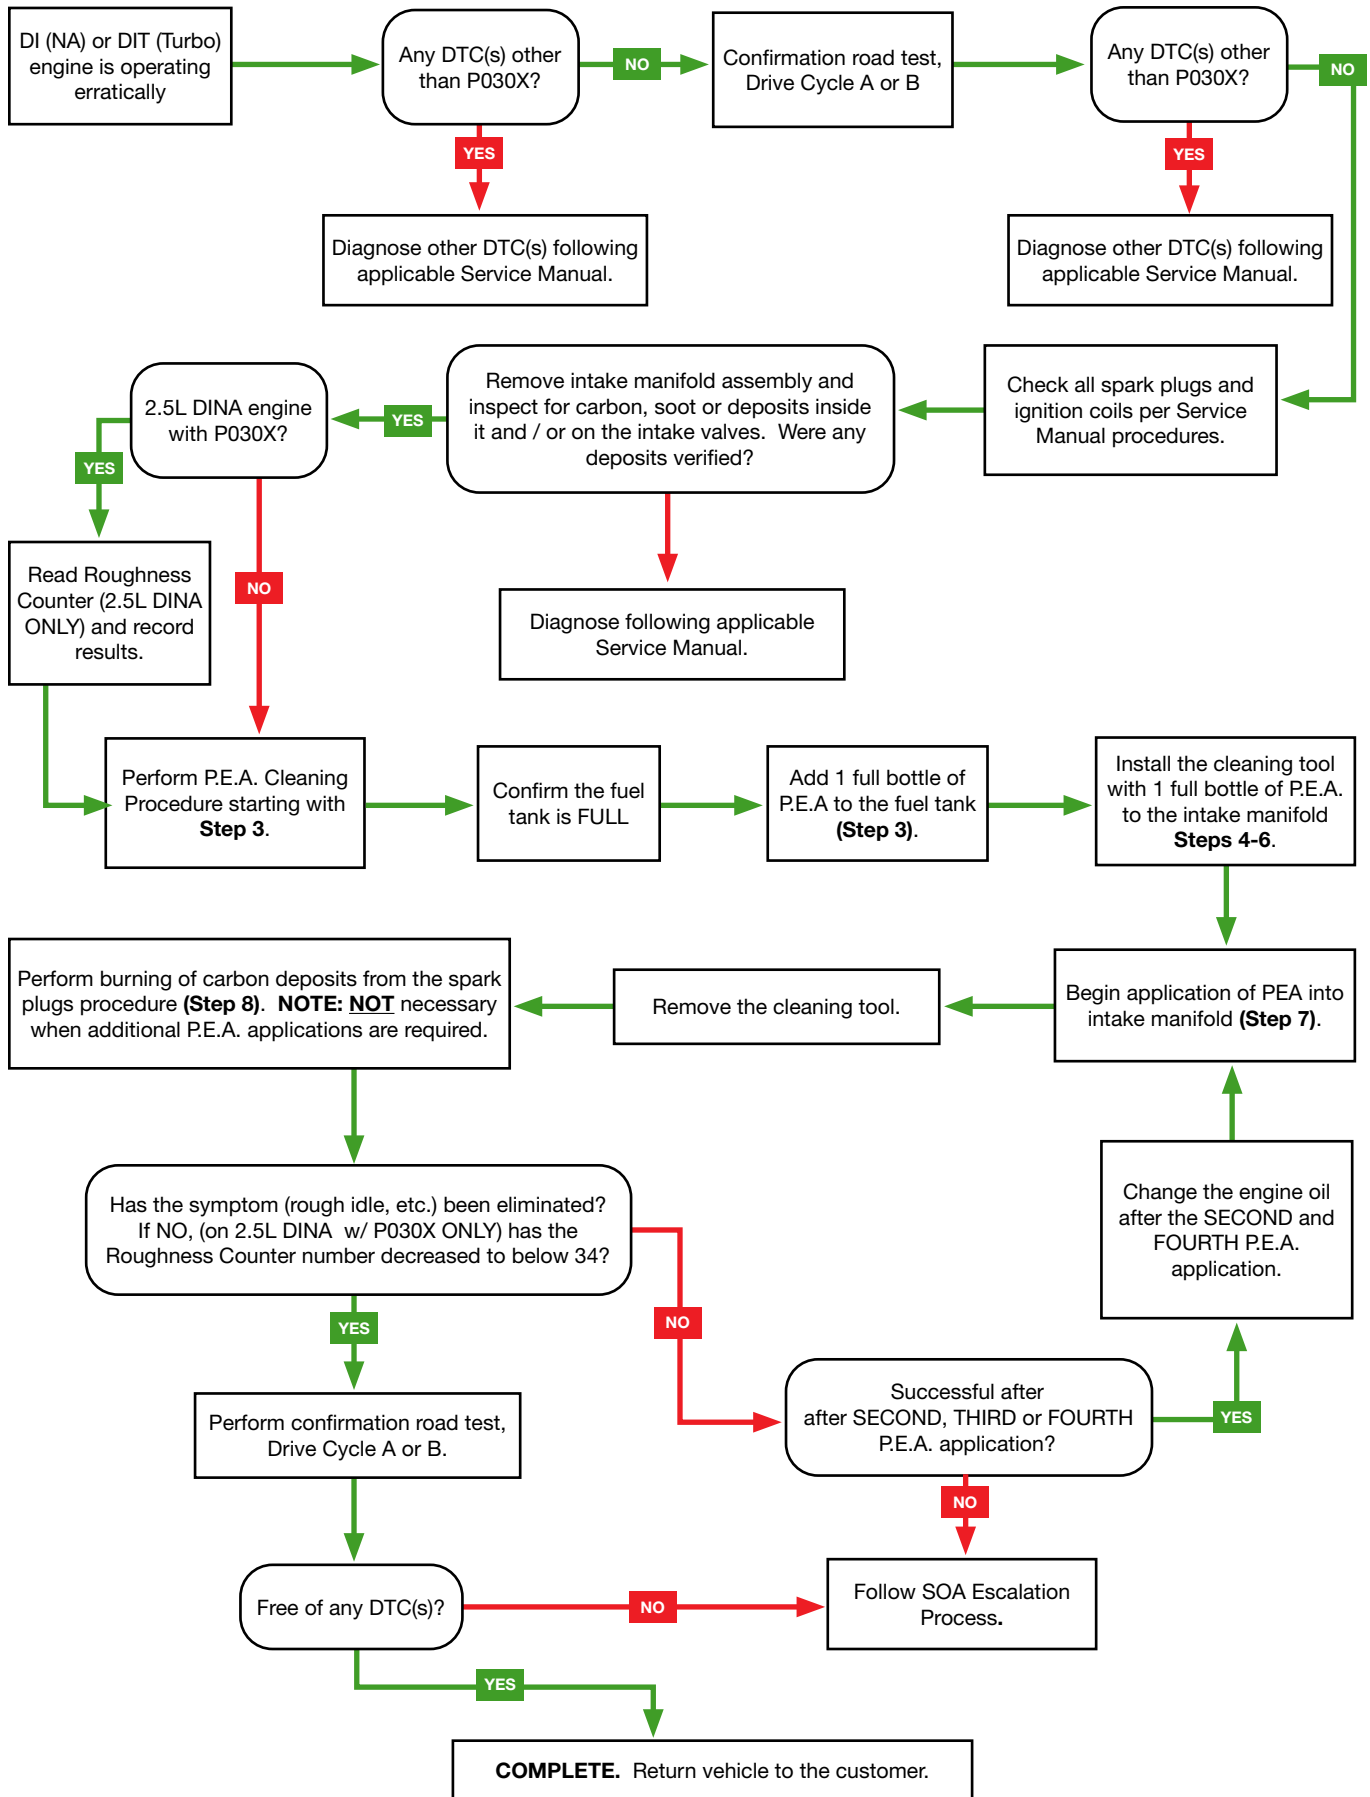
## Appendix A: Service Procedure Flow Chart

**VERY IMPORTANT:** APPENDIX A has been added to the end of this bulletin (pg. 10) and it provides a Flow Chart for the overall Service Procedure described below. It is **STRONGLY RECOMMENDED** Technicians review the Flow Chart closely to ensure their understanding of the Service Procedure before proceeding further.
