Service Bulletin

Subject: Fuel Odor During Fuel Filling or During Idle, Possible P0442 or P0455 DTCs Set

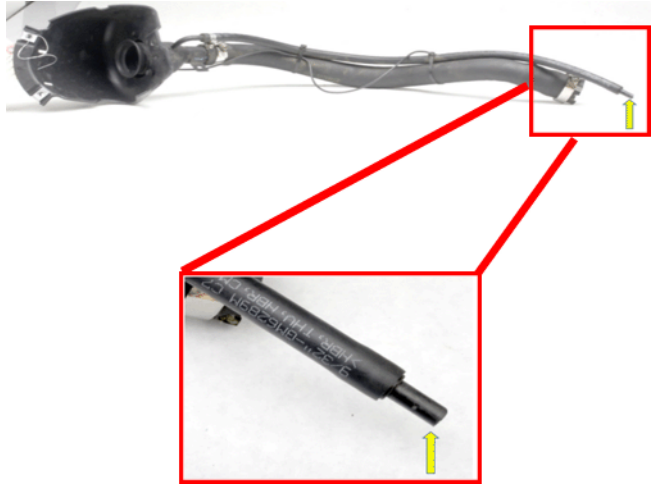
<p>This may be caused by the fracture or breaking of the gasoline filler neck recirculation line connector.</p>
---------------------	---

1. Raise the vehicle and visually inspect the fuel tank filler vent hose connector for damage. Refer to Lifting and Jacking the Vehicle in SI.
 - If connector is damaged, replace the fuel tank filler vent hose. Refer to Fuel Tank Filler Vent Hose Replacement in SI.
 - If there is no damage to the connector, continue diagnosis referring to SI.
