Service Bulletin

Subject: Clunking Noise from Front of Vehicle During Turns and/or Bumps

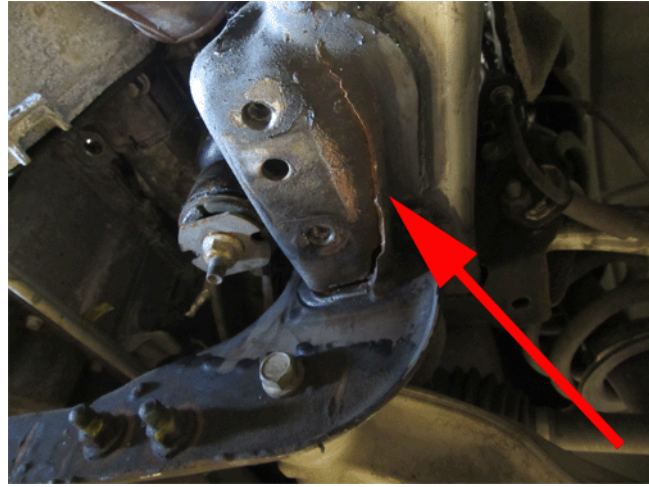
This may be caused by a damaged stabilizer shaft frame bracket. There have been some cases in which the bracket is cracked, as shown. This condition has been found to be the result of insufficient welds between the bracket and frame rail. There have been some cases on older vehicles of corrosion affecting the bracket.

If you encounter a vehicle with the above concern, follow the procedure below to install a new stabilizer shaft bracket to the frame.

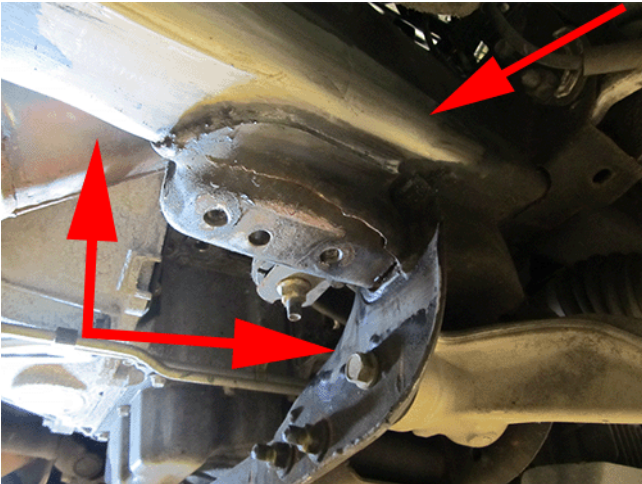
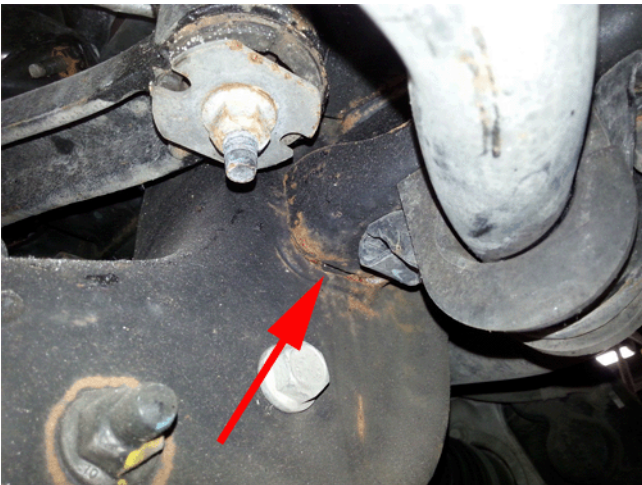
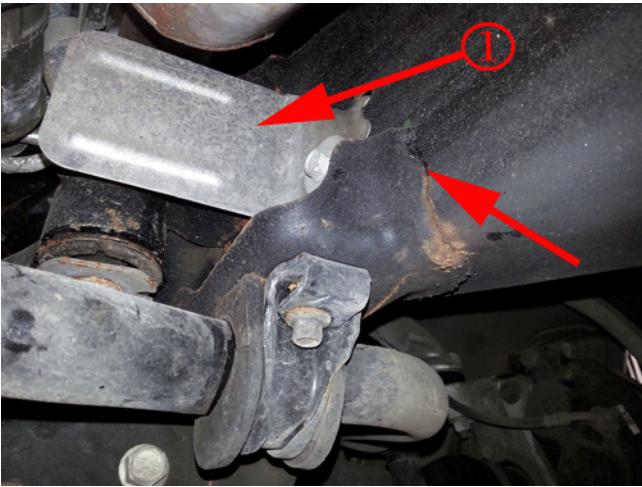
2. Raise the vehicle in the air and inspect the stabilizer shaft frame brackets (both left and right) for any abnormalities or cracks and inspect welds to ensure good alignment and integrity. Refer to Lifting and Jacking the Vehicle in SI.

Note: Be sure to inspect frame rails for any cracks or damage in relation to the stabilizer bracket. If the frame rail itself is cracked or damaged, repair should not be attempted.

3. Once verified that the bracket is damaged or the welds are insufficient, remove the stabilizer shaft. Refer to Stabilizer Shaft Replacement in SI.
4. On 4WD models, once the stabilizer shaft is removed also remove the front frame/front axle mount exhaust heat shield (1) located above the stabilizer bracket.
5. With the stabilizer shaft and shield removed, using a rag and wax/grease removing solvent, remove the wax coating and any grease, oil, or undercoating from the truck frame in the affected repair area.

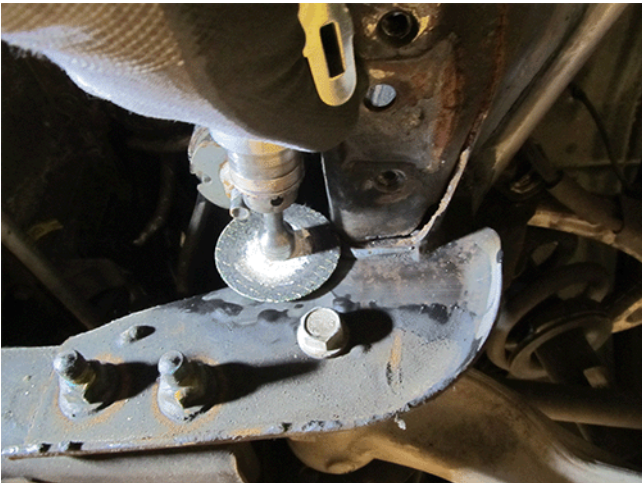
6. After all the wax coating is removed, using a cut off wheel, remove the old bracket from the frame.

Important: Be sure to not cut the frame in process of removing the bracket.

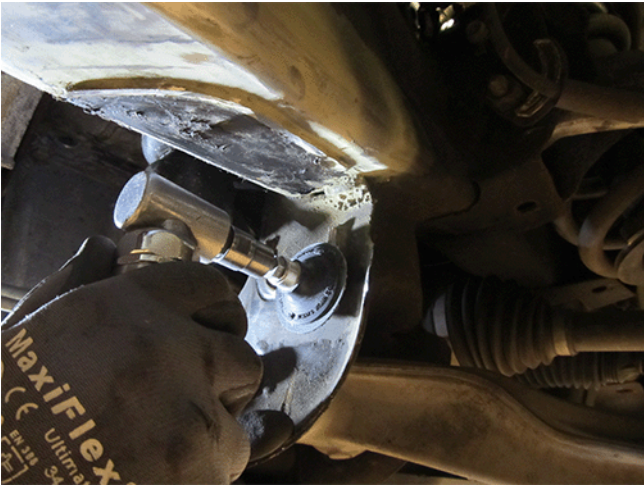
7. After the bracket has been removed, using an angle grinder with 24 grit sand paper or equivalent clean the areas of any excess bracket weld material from the frame so that the new bracket can sit flush in the location of the old one.

Important: Be sure to not grind away any frame material, only remove the weld material.

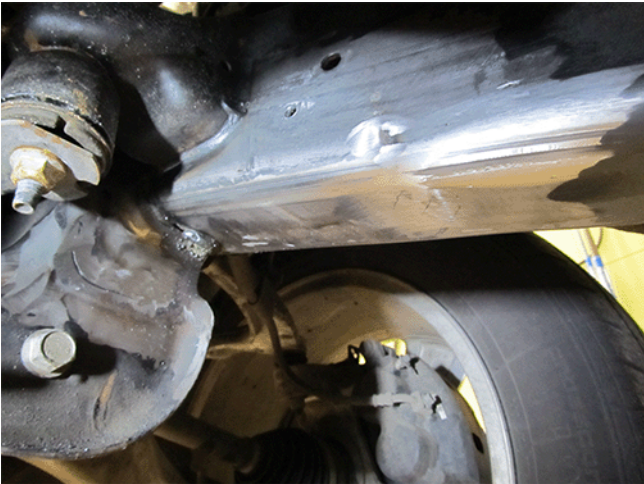
8. Clean the area of all debris in preparation of the new bracket to be welded to the frame.

Important: Be sure to inspect frame rails for any cracks or damage in relation to the stabilizer bracket. If the frame rail itself is cracked or damaged, repair should not be attempted.

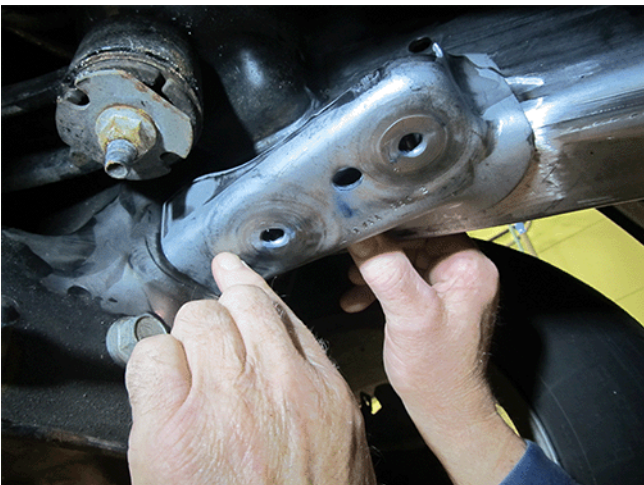
9. After the area is clean of all debris, place the new bracket in the location of the removed one. The bracket should seat against the frame crossmember bracket in the most forward position, along the lower surface of the frame rail, and along the inner surface of the frame rail in the rear.

Note: The new bracket will need the welding locations stripped of all coating. Be sure to grind all edges of the new bracket so that the quality of the weld will not be affected.

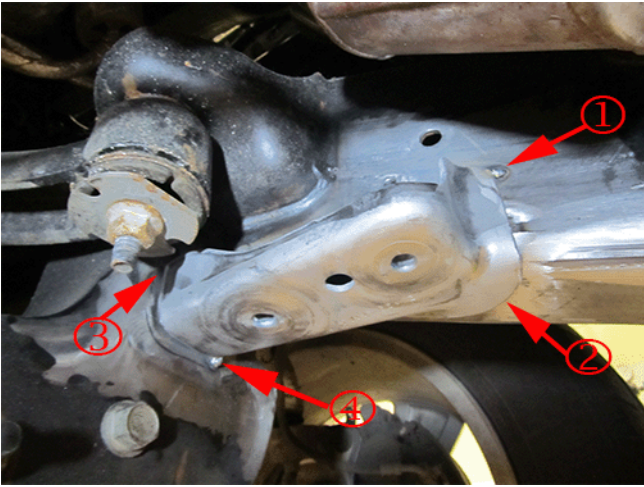
10. After the bracket is in location, tack weld the bracket to the frame in all 4 corners of the bracket. This will keep the bracket from moving while welding the bracket fully to the frame.

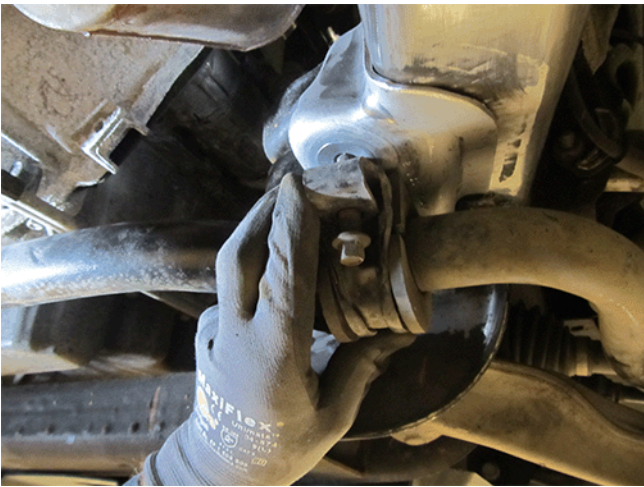
11. After the bracket is tack welded in the location, loosely position the stabilizer shaft to verify that the bracket is in the correct location. Refer to Stabilizer Shaft Replacement in SI.
12. After verifying that the bracket is in the correct location, remove the stabilizer shaft. Refer to Stabilizer Shaft Replacement in SI.

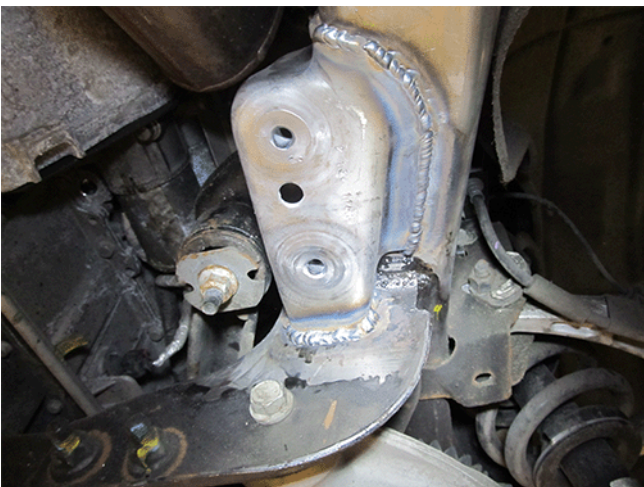
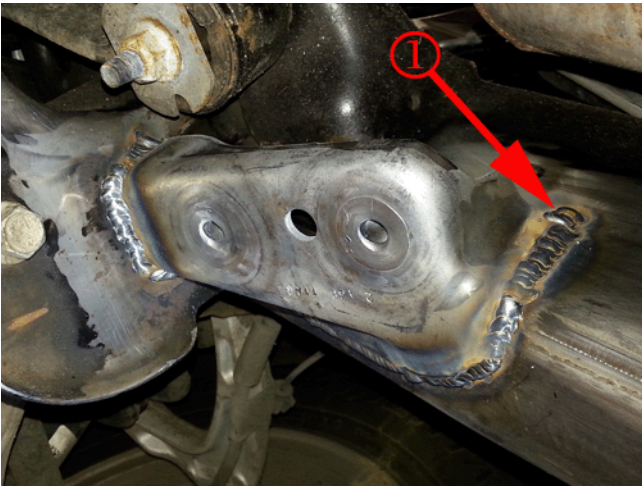
13. Continuous-weld the new bracket into position. Ensure the rear vertical weld (1) is extended approximately 15mm above the edge of the bracket.

Note: When welding, be sure to start from the bottom of the bracket and work your way upward.

Note: Gas metal arc weld using ER70S-3 electrode and an Argon CO2 protective gas mixture. Alternatively, meeting AWS 7013.

Note: Provide a continuous weld around the bracket. If access does not permit a continuous weld, make a 6 mm minimum overlap of adjacent welds.

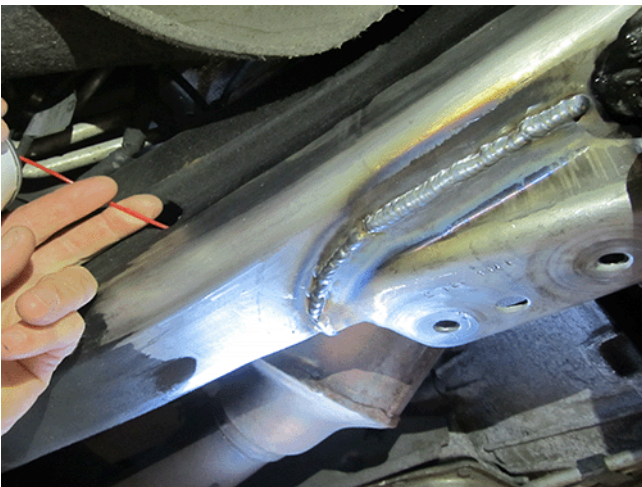
17. Apply a light flash-coat of Lloyds Kryptonite Metal Treatment P/N 36502 Life Long Rust Protection (14 ounce aerosol), or equivalent, to all bare areas of the frame where the wax coating was removed. This first coat should flash in approximately 3-5 minutes. Apply a light flash-coat to the inside of the frame rail using existing access holes, as shown. Insert the straw of the aerosol can as far as possible, and slowly work the straw back out while applying material.

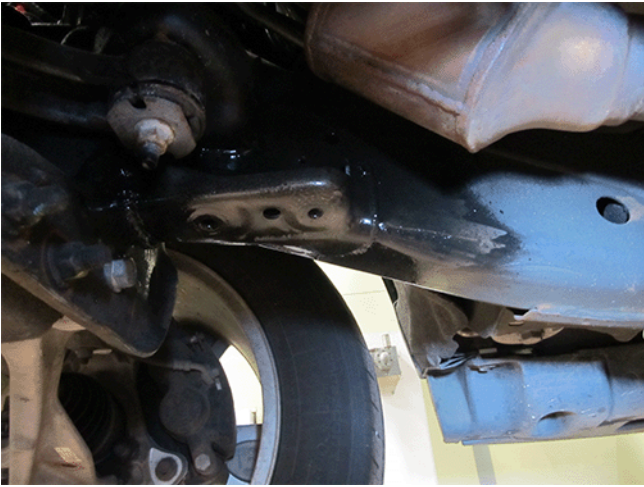
18. Apply a second coat of Lloyds Kryptonite. This can be a heavy coat; double and triple passes with this product, over a light first coat, are not a problem.

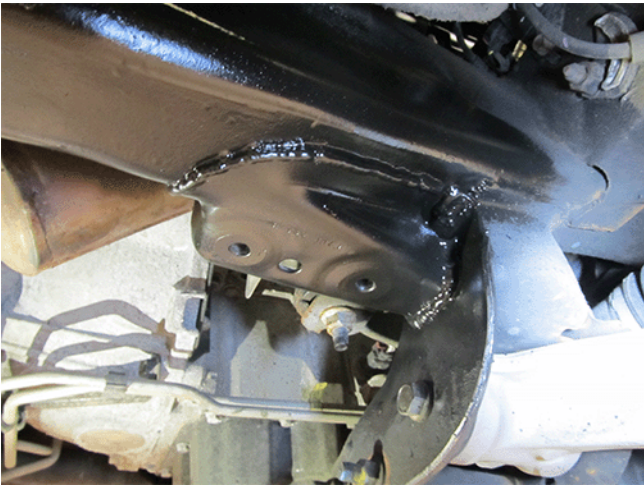
- 19. We suggest top coating the Lloyds Kryptonite with Daubert Nox-Rust® P/N X-121B “One Coat Rust Preventative Coating” (aerosol), or equivalent.
- 20. Reinstall the stabilizer shaft with new stabilizer shaft clamp bolts. With new stabilizer thread cutting bolts, drive the bolts to cut the new threads, then loosen the bolts two turns and then torque to 50 Y (37 lb ft). Refer to Stabilizer Shaft Replacement in SI.
Note: The stabilizer shaft clamp bolt attachment holes on the new bracket are not threaded, the clamp bolts are thread cutting.
- 21. On 4WD models, install the front frame/front axle mount exhaust heat shield.
- 22. Reconnect the negative battery cable. Refer to Battery Negative Cable Disconnection and Connection.
